## THE VILLAGE OF OAK PARK PARKING STRUCTURES

OAK PARK, ILLINOIS

WRC PROJECT NO. 31-8130.00  
MAY 2017

CONDITION ASSESSMENT

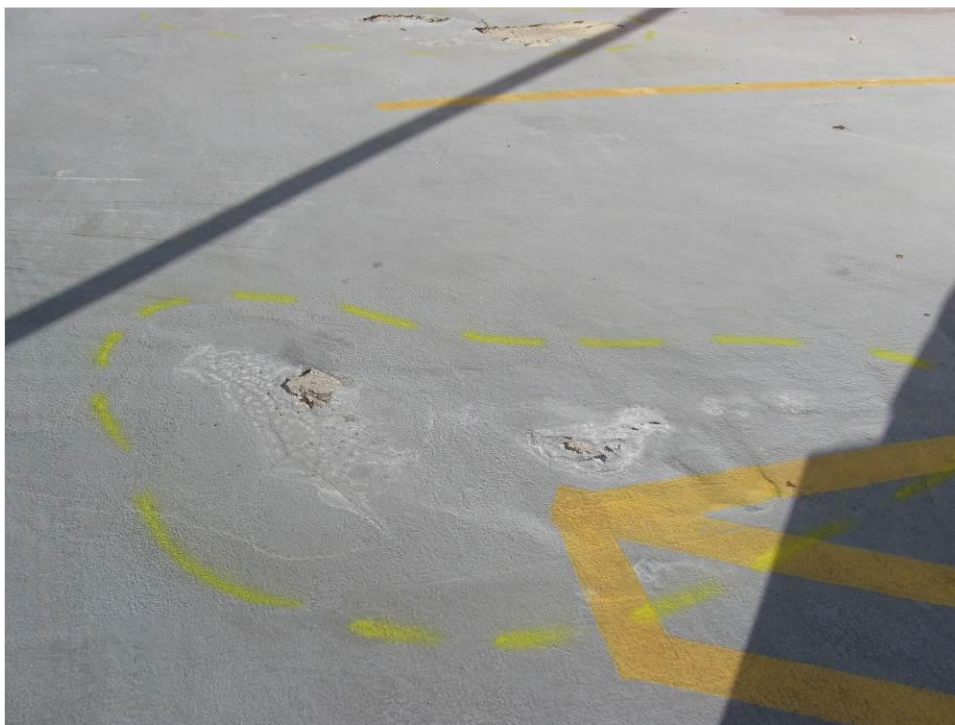
Photo 2 – Concrete deterioration in floor slab under traffic topping.

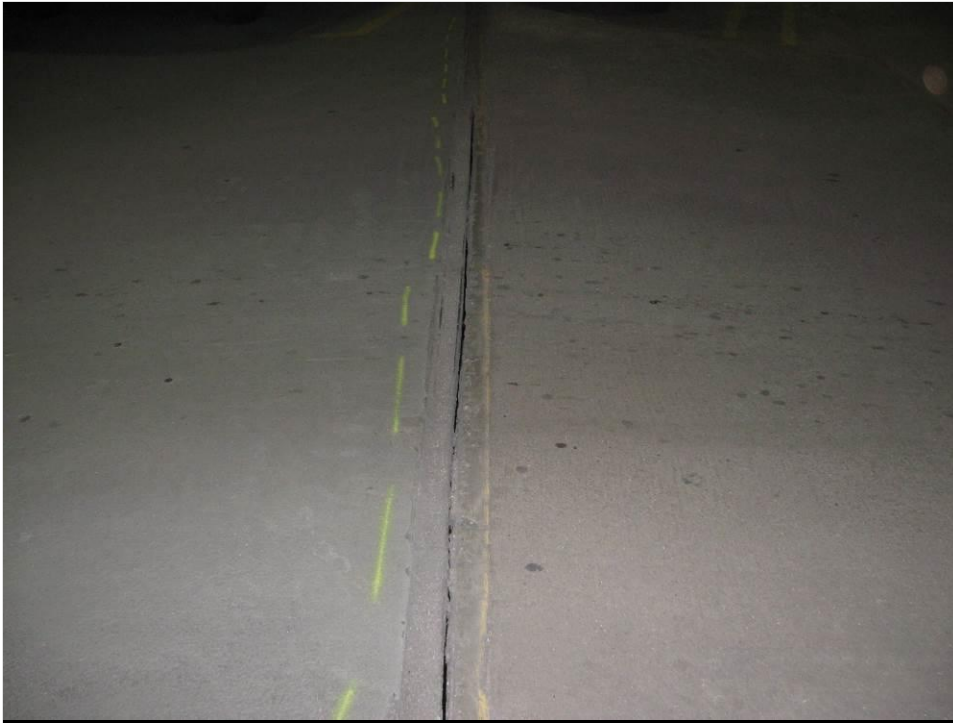
Photo 9 – Severely deteriorated expansion joint on Second Floor.

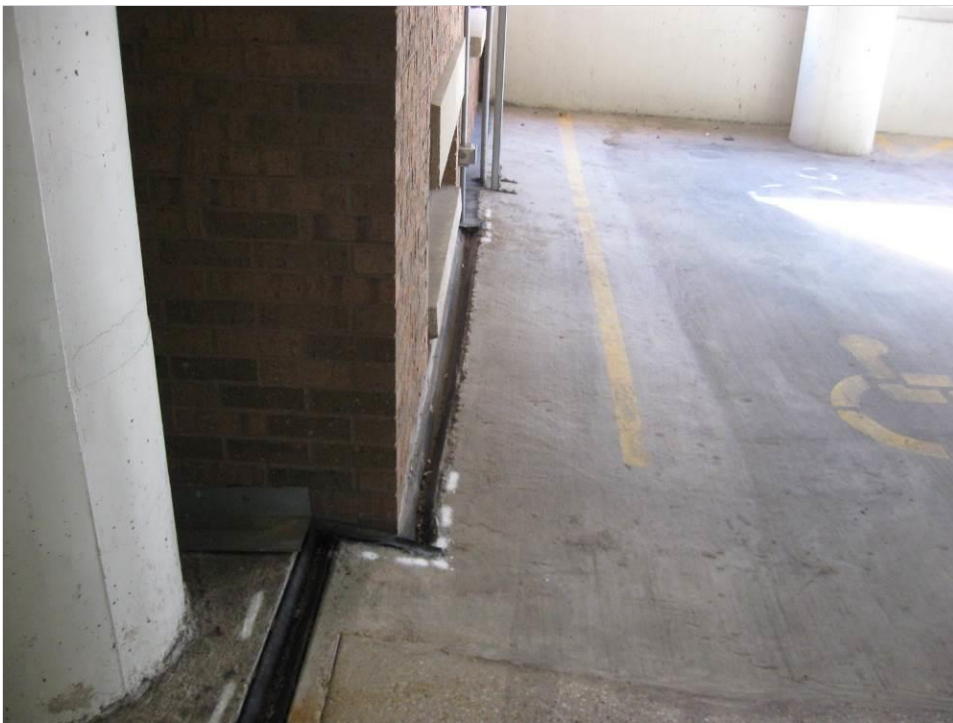
Photo 10 – Severely deteriorated expansion joint around stair tower.

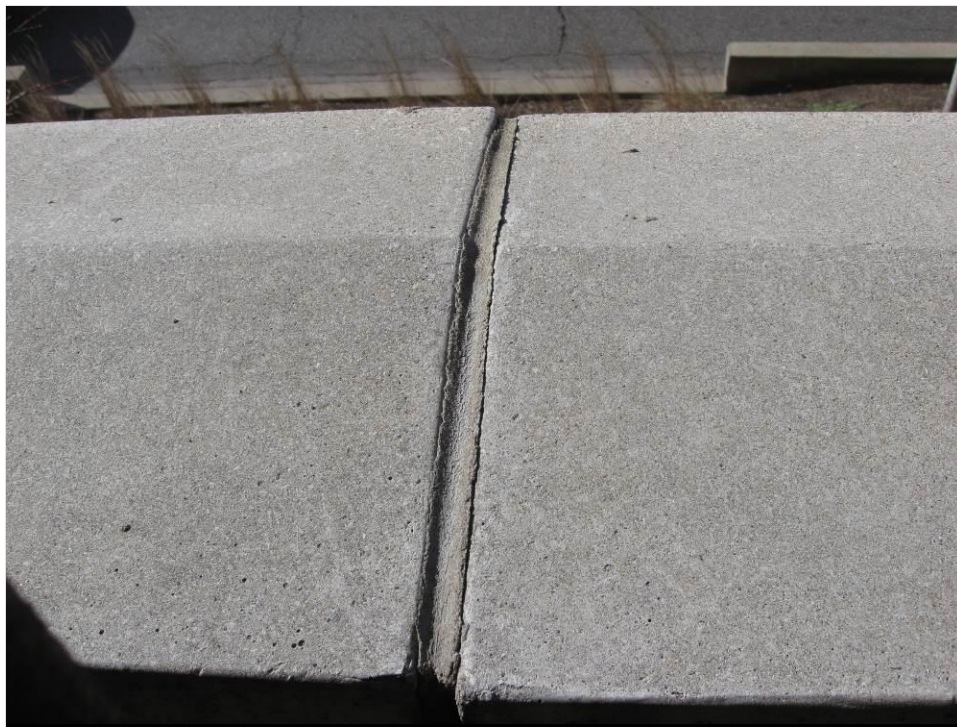
Photo 17 – Severely deteriorated mortar joint on cap stone.

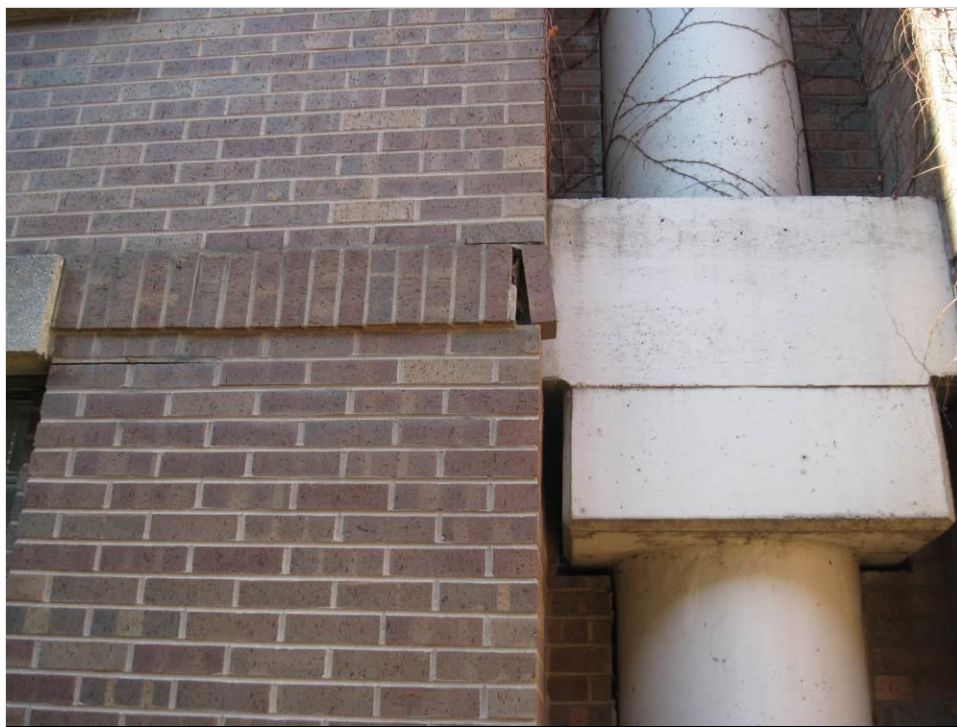
Photo 18 – Loose masonry on façade.

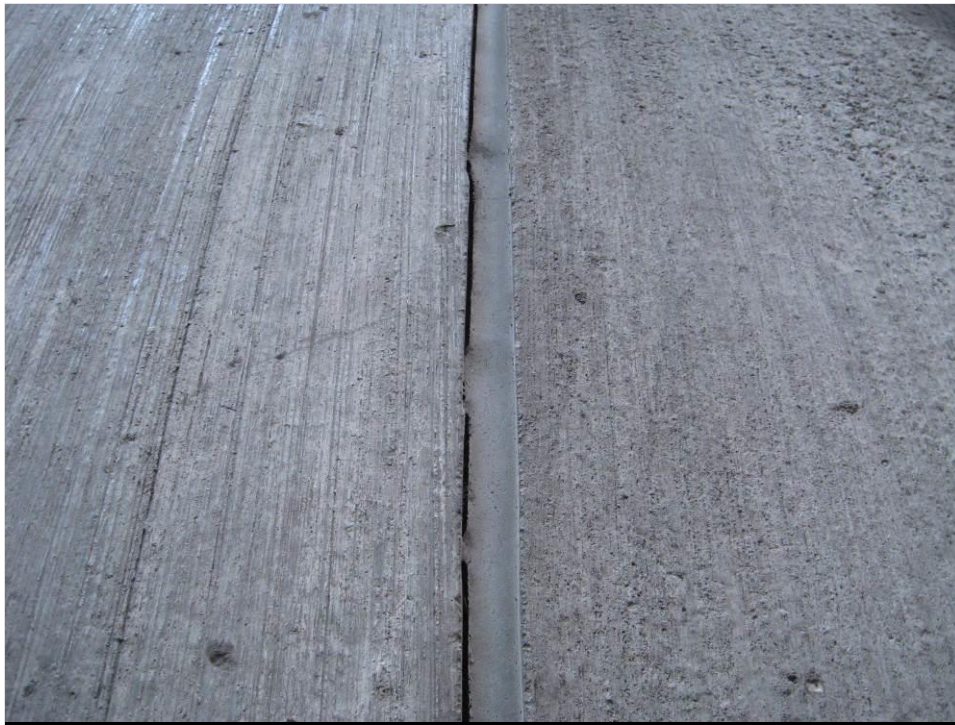
Photo 1 – Adhesion failure of tee-to-tee joint sealant.

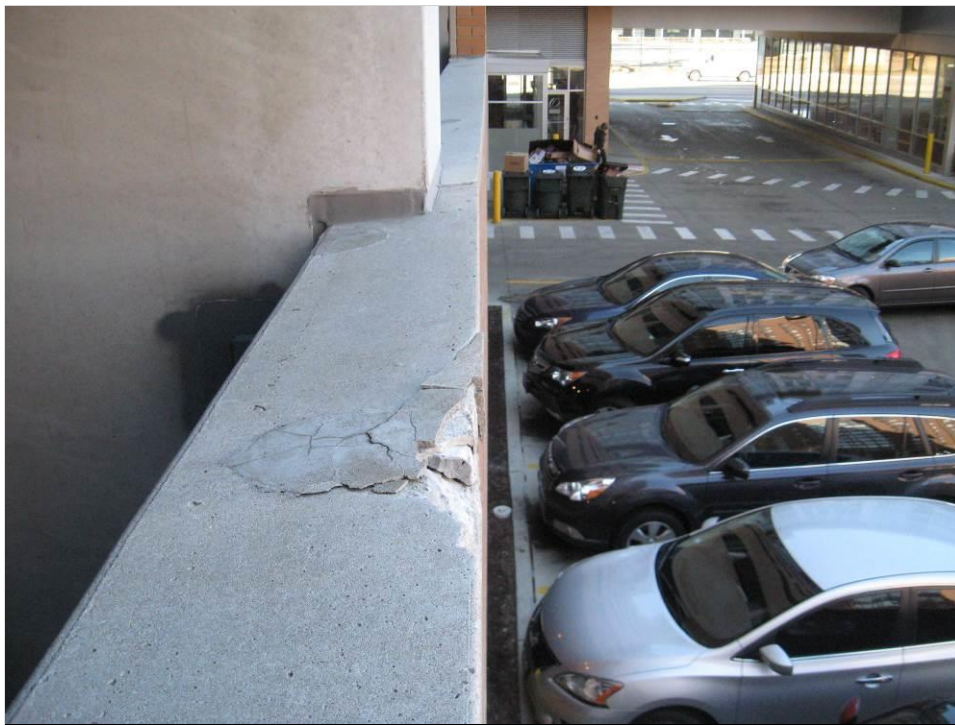
Photo 2 – Minor deterioration on façade wall.

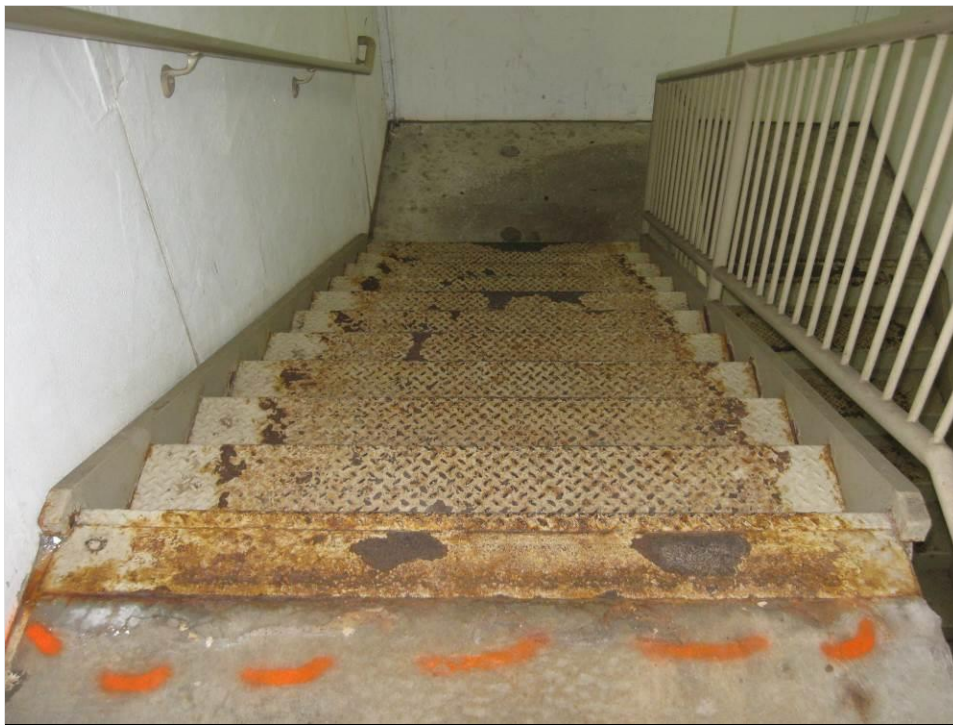
Photo 2 – Corroding stairs within stair tower.
