# Oak Park Police Department Space Needs Analysis

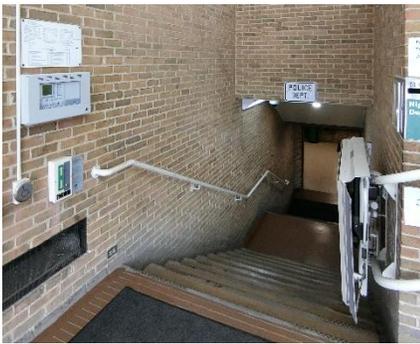
*Non-functioning ADA chair lift*

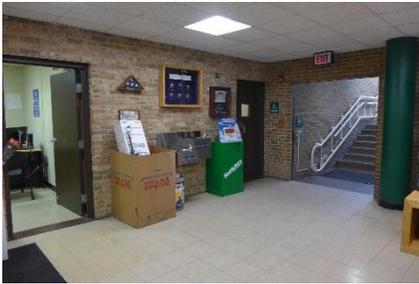
Missing fire doors at stairway

- The fire doors at the bottom of the main public staircase have been removed thus eliminating the required fire separation between floor levels.
- The fire rated door at the Parking Enforcement Office has been converted to a Dutch door and is usually propped open. This door does not maintain the fire rating that is required at this location.
- Several doors within the Building Maintenance Department are lacking the required fire rating. In one instance the fire rated door is being propped open and in violation of the building code.

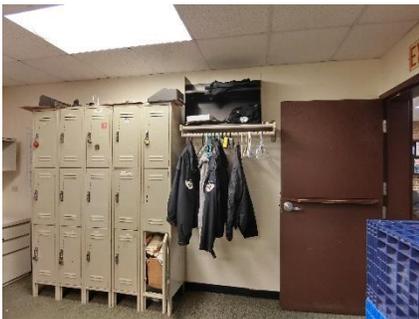
Non-compliant fire rated Dutch door at Parking Enforcement

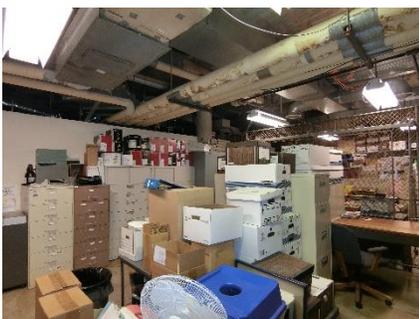
Non-compliant fire rated wall at record storage.

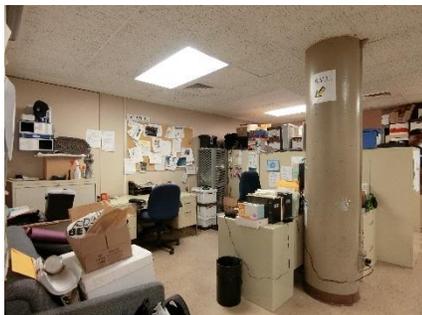
*Cords dropped over furniture within Investigation Department*

- Due to age of building there is a lack of electrical and data outlets, cords are draped over furniture and across cabinets throughout the building.
- Within the Administration Department extension cords are lying across walkways creating a tripping hazard.
- Within the lobby conference room, temporary partition walls have been added to the west and south walls creating mechanical and electrical closets. These closets lack the required signage and fire ratings.
- A mechanical closet is located within the Crime Analyst's Office. This equipment should be accessible from the main corridor and not require access through a private office.

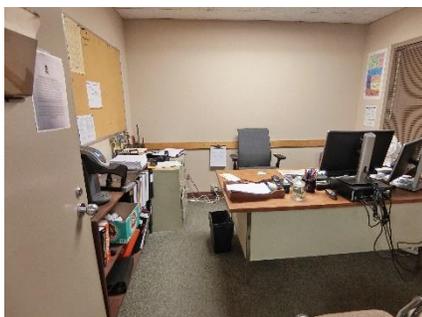
*Extension cords laying on floor due to insufficient electrical outlets*

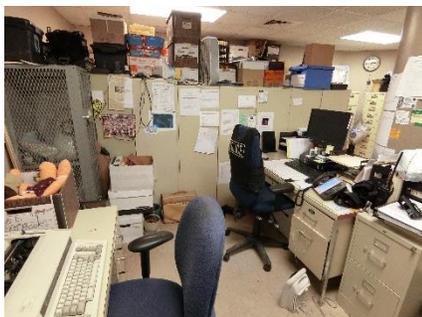
- Files and boxes being stored within 24" of ceiling
- Lighting levels within the Building Maintenance Department are too low.
- There is no free exit from the Mechanical Room. This door requires free egress.

*Boxes being stored too close to the ceiling*

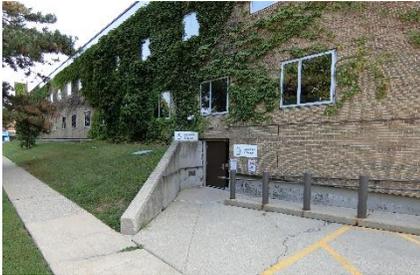
*Lack of wayfinding to ADA ramp*

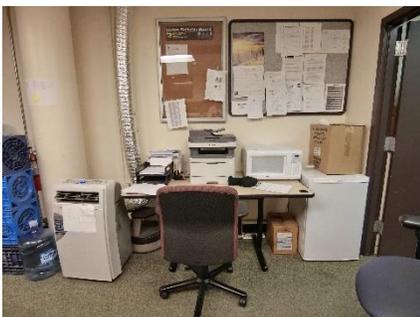
*Air conditioner overloading the circuit*

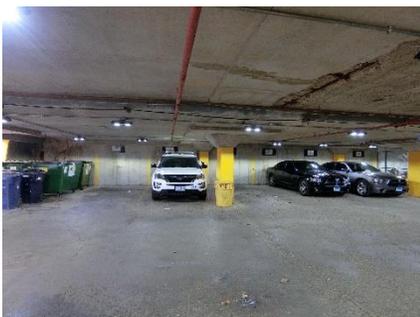
Spalled concrete within parking garage

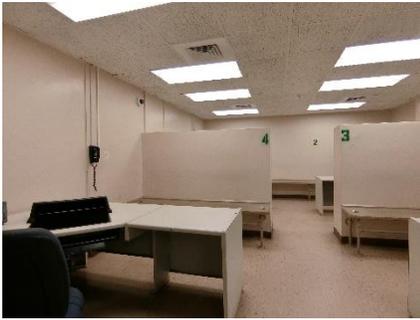
- The prisoner processing area is not secure and is remote from booking.
- The security glazing on the lock-up cell is damaged and cloudy making it difficult to monitor prisoners within.
- There is a water leak above the report room as witnessed by damaged ceiling tiles.

*Unsecured prisoner processing area*

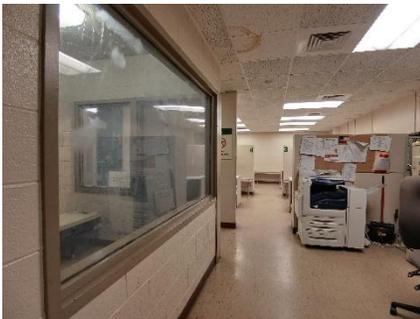
*Security Glazing on lock up cell is damaged and cloudy*

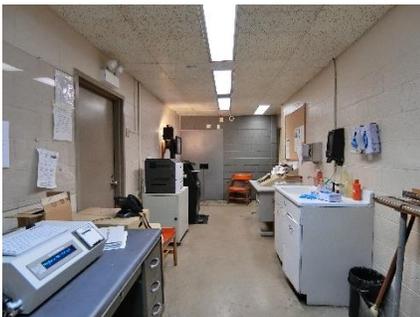
*Insufficient space within Booking Area*

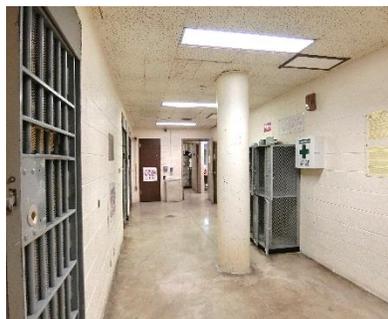
*Damaged ceiling tiles within detention area*

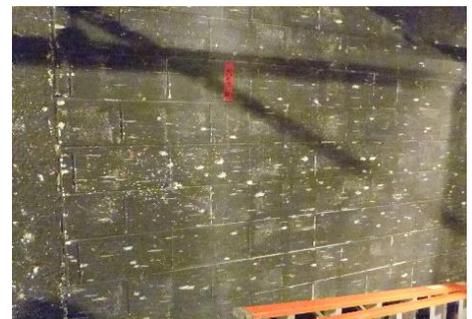
*Unprotected CMU walls in Firing Range*

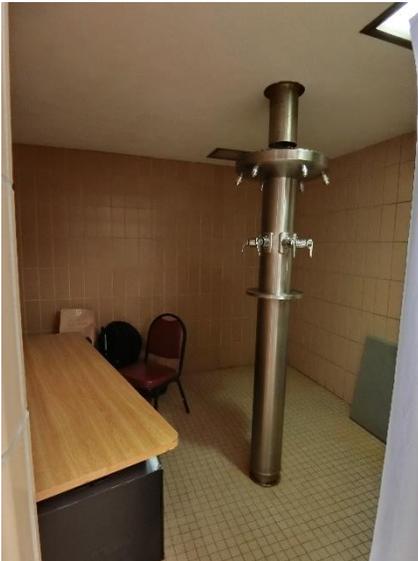
*Women's Shower being used for storage*

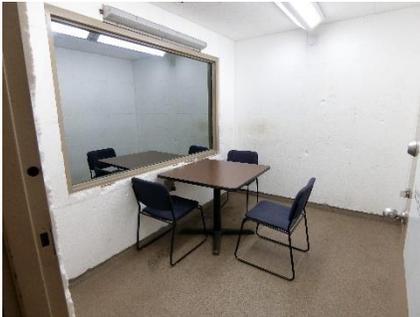
*Damaged acoustical walls within interview rooms*

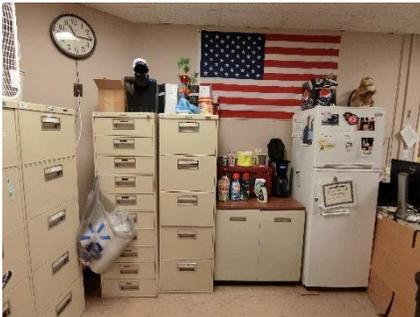
*Lack of storage and break areas*

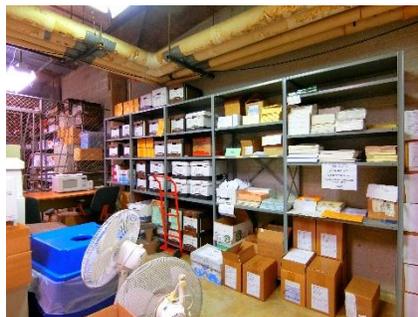
- There are several large pipes running above the main records storage area. The pipes show signs of previous water leaks.
- Within the records department the desks are located close together and do not allow for adequate circulation space throughout the department.
- The air circulation within the department is poor, several fans have been located throughout the space to help move the air.

*Water damaged pipes above record storage*

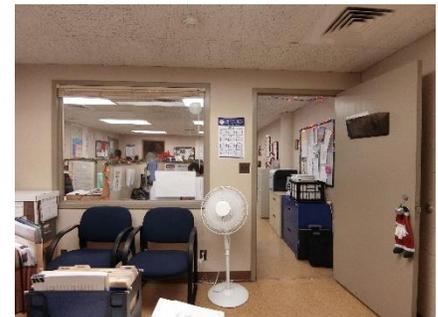
*Insufficient air circulation*

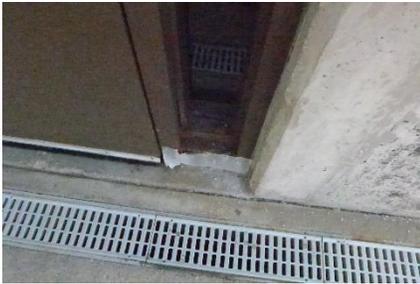
*Steel door frame is corroding*

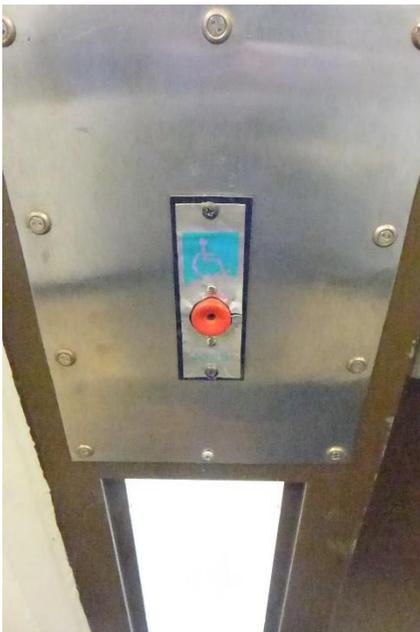
- The exterior elevator buttons are damaged.
- The elevator serving the police station is not designed for gurneys (stretcher size). While not a code requirement in Oak Park, a stretcher size elevator is recommended as they are safer for emergency response staff for moving the injured or sick and allow a person on a gurney to be moved without unnecessary trauma, for example, being shaken when carried up a stairway.

*Damaged buttons at elevator*

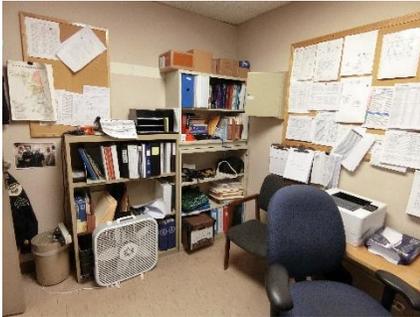
*Supplemental fans  
located throughout  
building to help circulate air*

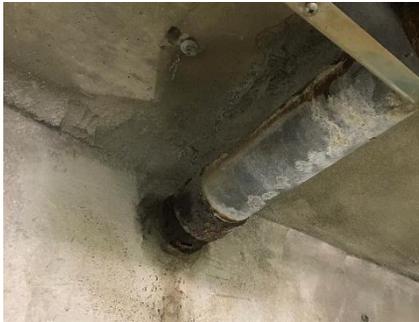
Repaired conduit within garage

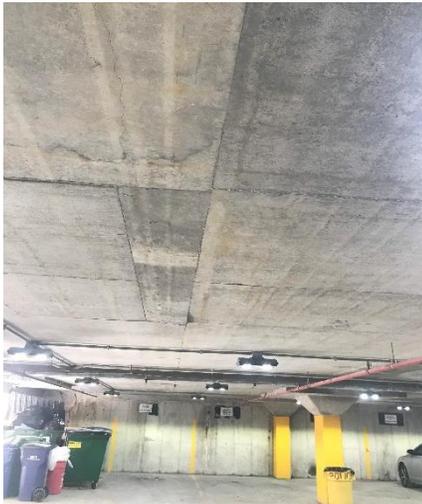
*Repaired concrete deck at garage*

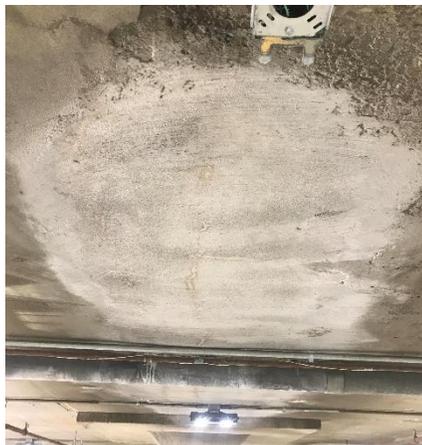
*Area of patched concrete deck at garage*

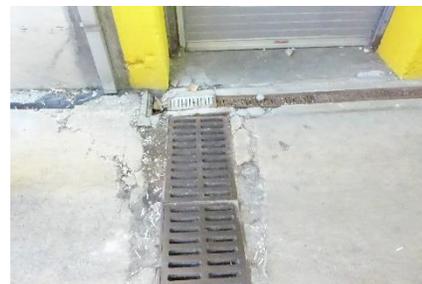
*Broken concrete at trench drain*

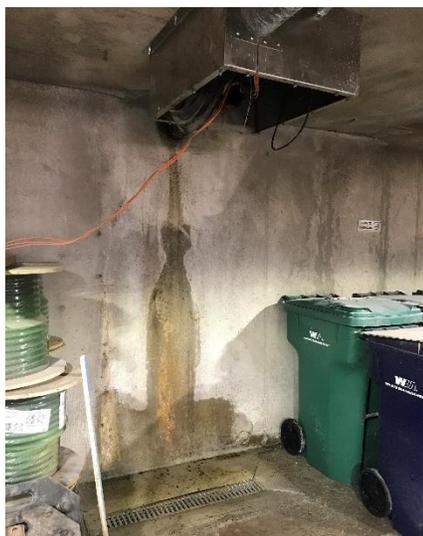
*Water infiltration at pipe penetration*

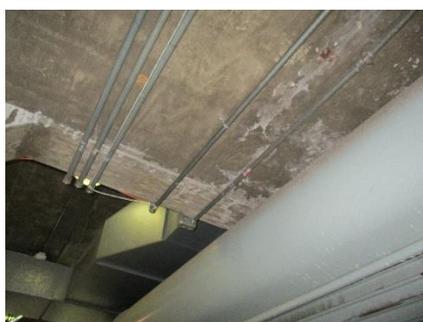
*Efflorescence in hall at Sally port*

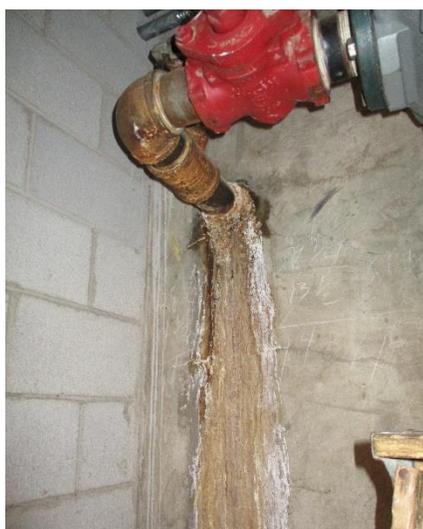
*Water infiltration and corrosion at pipe in mechanical room*
