CONDITION ASSESSMENT

THE VILLAGE OF OAK PARK PARKING STRUCTURES

OAK PARK, ILLINOIS

WRC PROJECT NO. 31-8130.00
MAY 2017

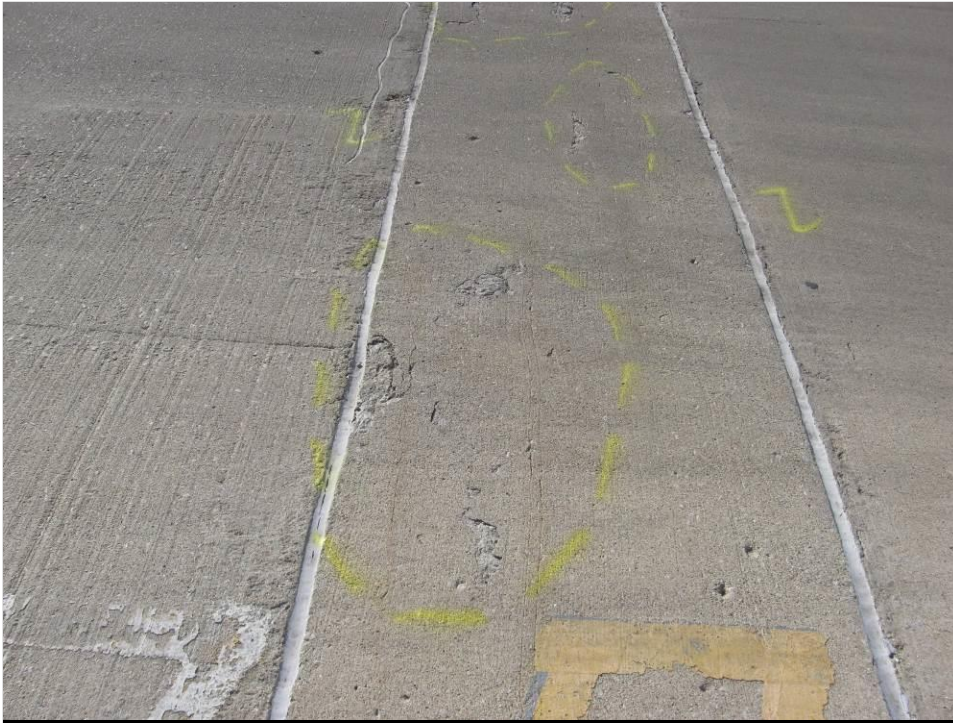
Photo 1 – Typical concrete delamination and cracking in floor slabs at pour strips.

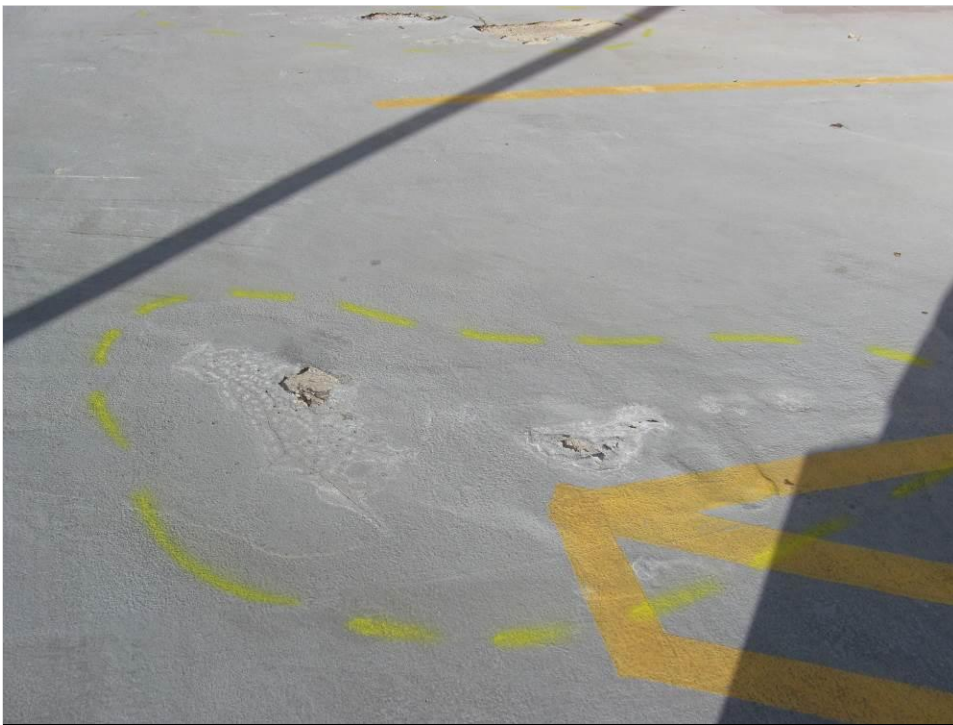
Photo 2 – Concrete deterioration in floor slab under traffic topping.

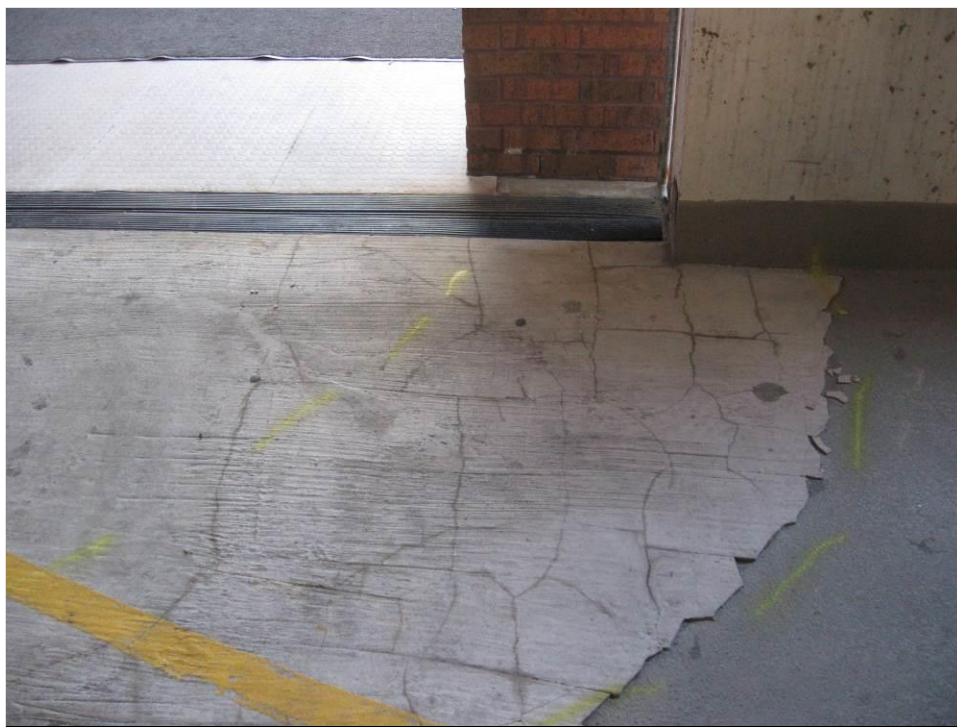
Photo 3 – Floor slab deterioration at entrance to elevator tower.

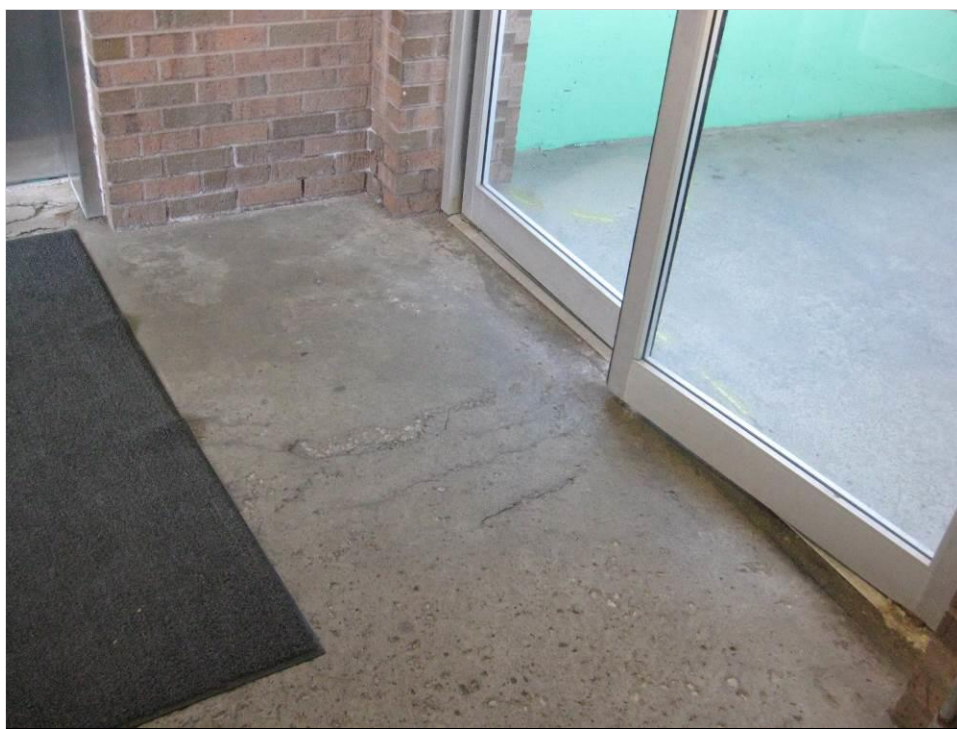
Photo 4 – Floor slab deterioration within stair/elevator tower.

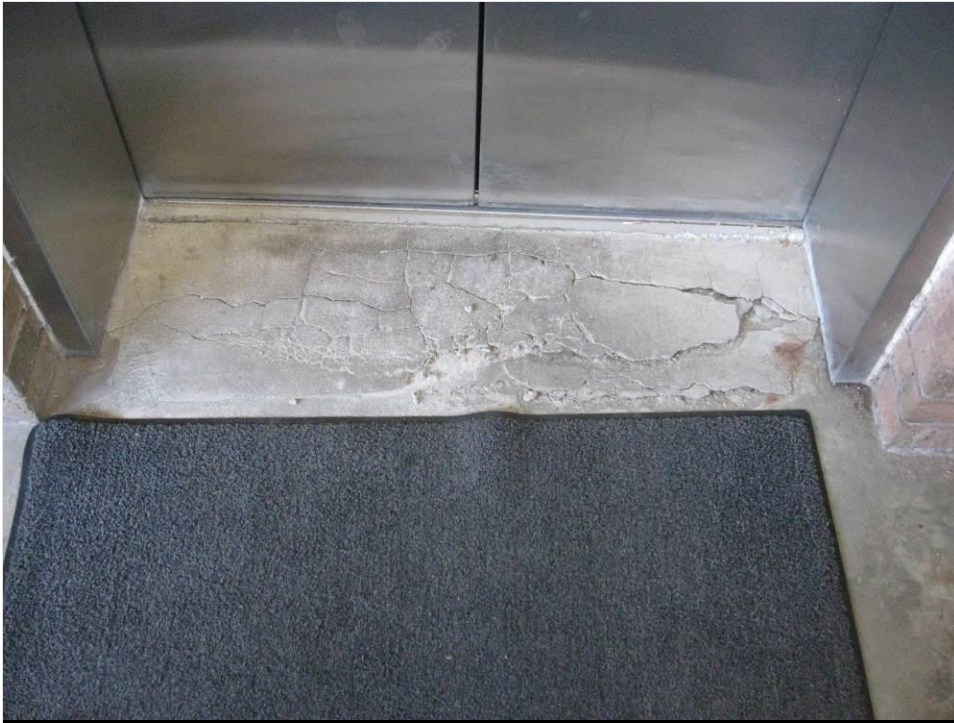
Photo 5 – Floor slab deterioration at elevator landing.

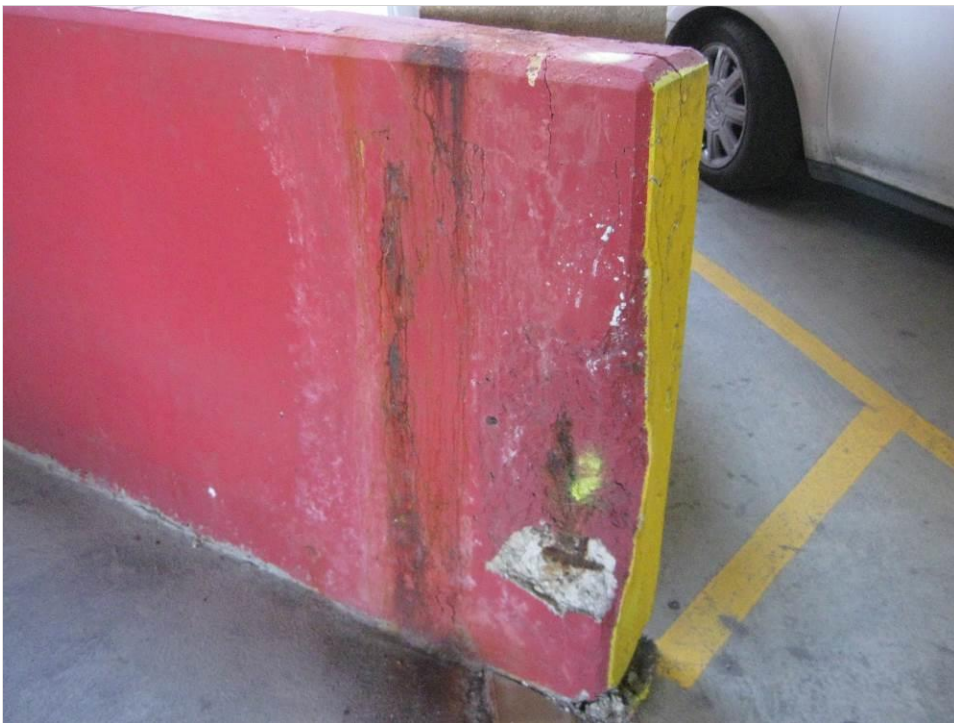
Photo 6 – Typical wall deterioration.

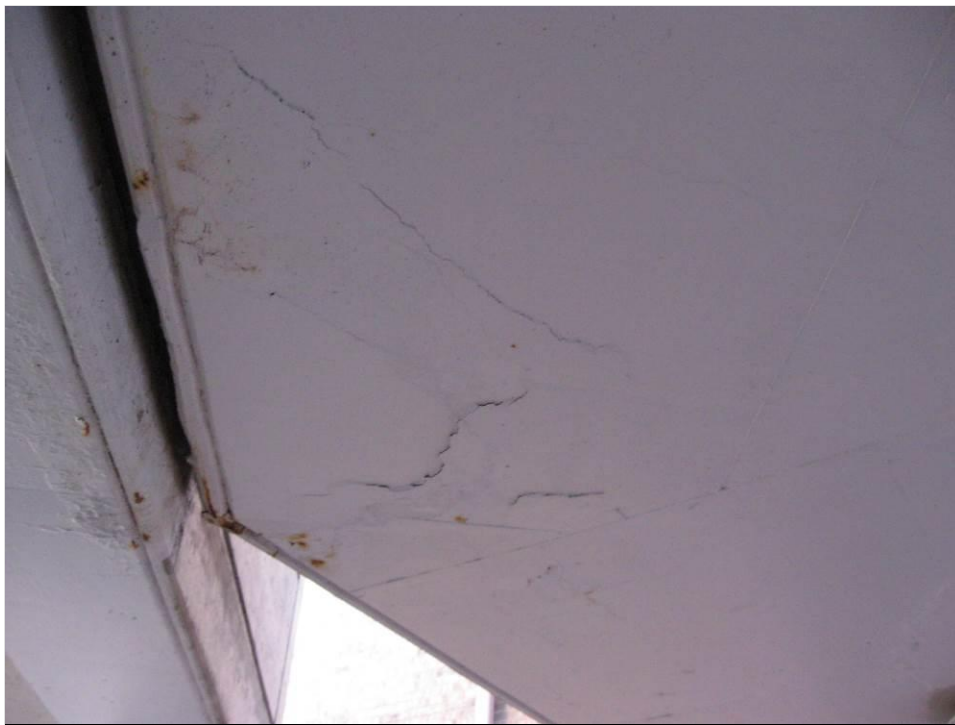
Photo 7 – Typical ceiling delamination.

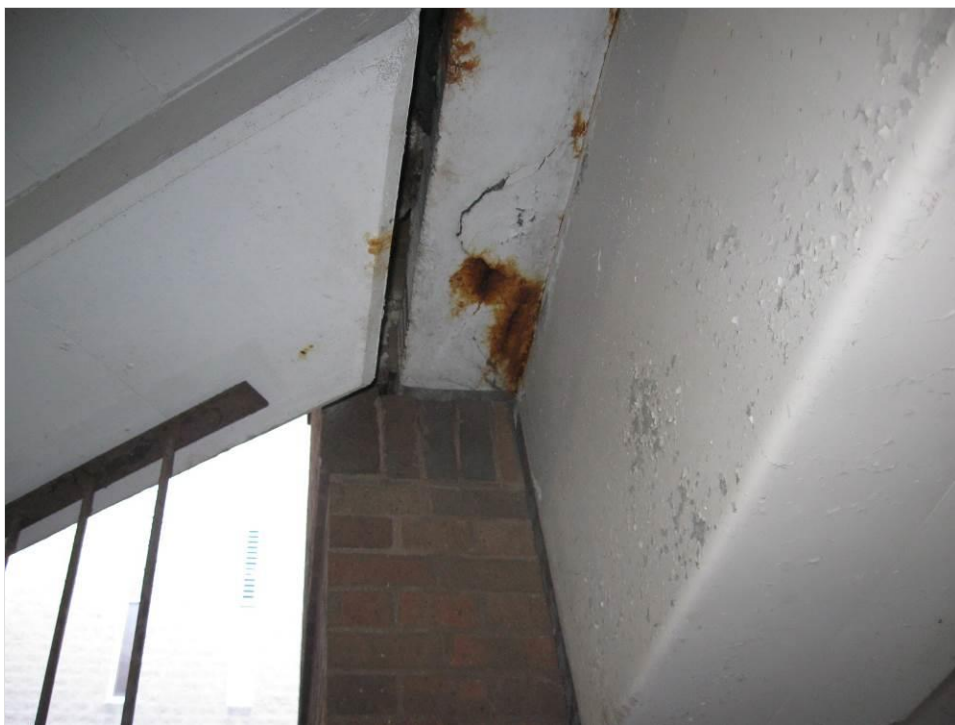
Photo 8 – Typical delaminated beam at stair tower.

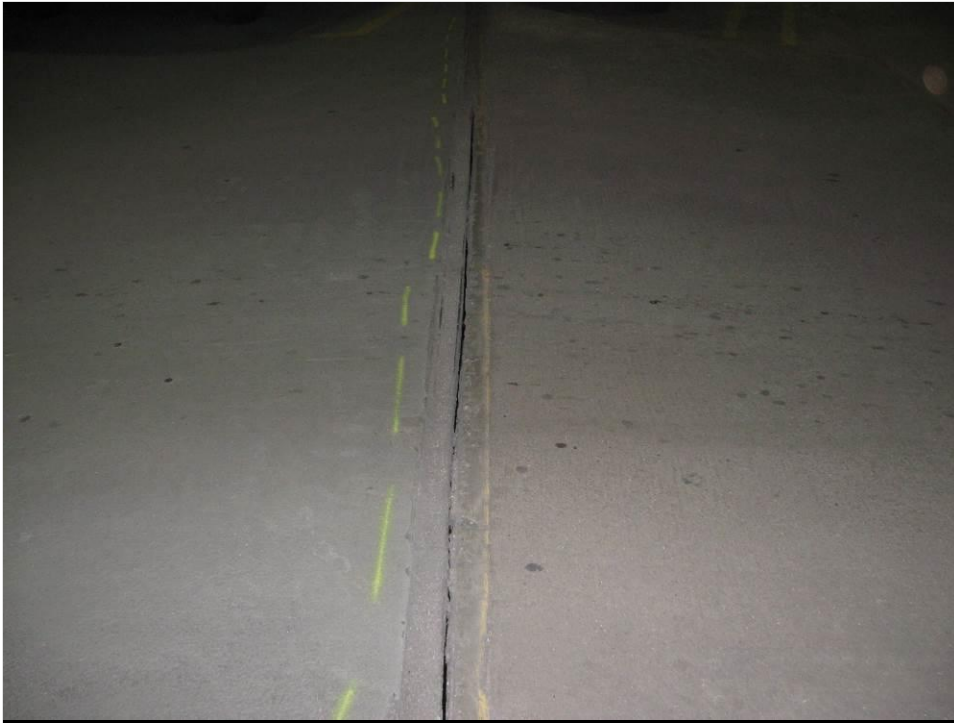
Photo 9 – Severely deteriorated expansion joint on Second Floor.

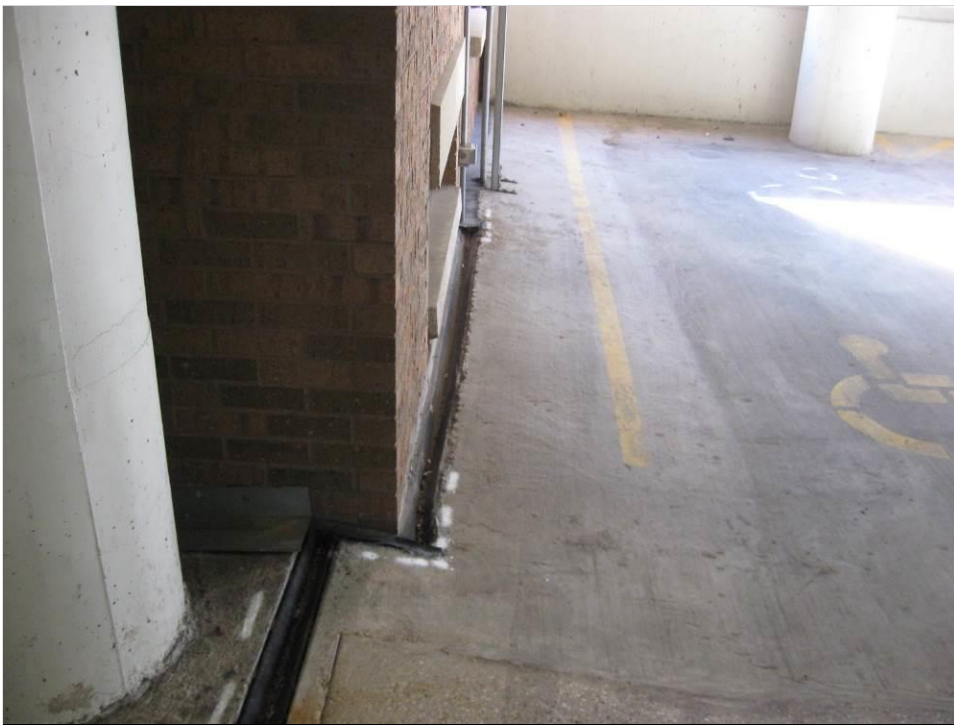
Photo 10 – Severely deteriorated expansion joint around stair tower.

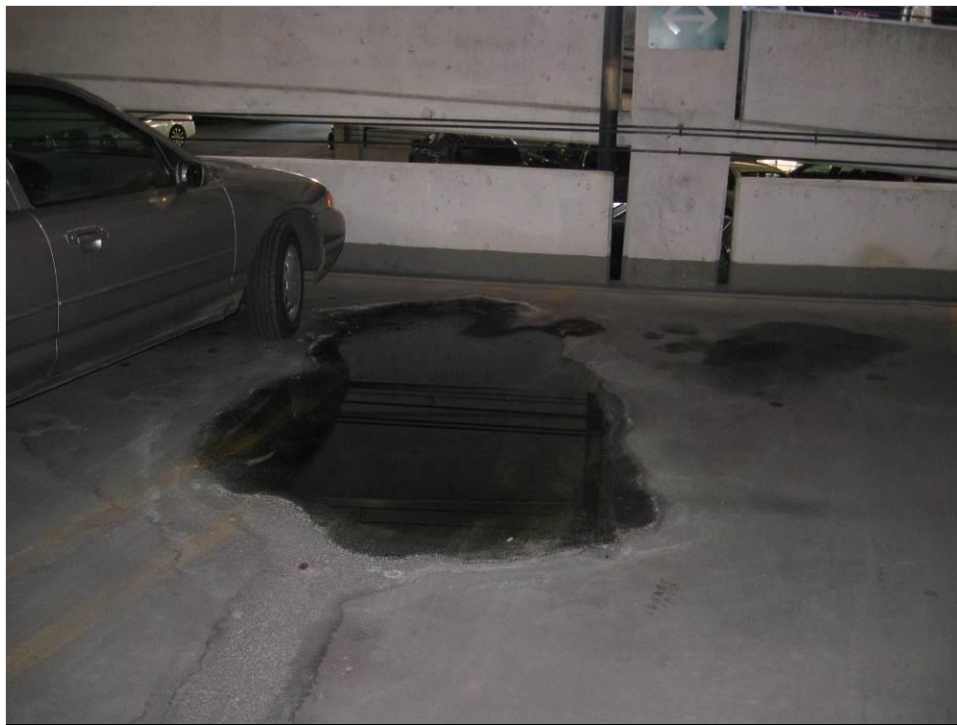
Photo 11 – Area of ponding water of supported slab.

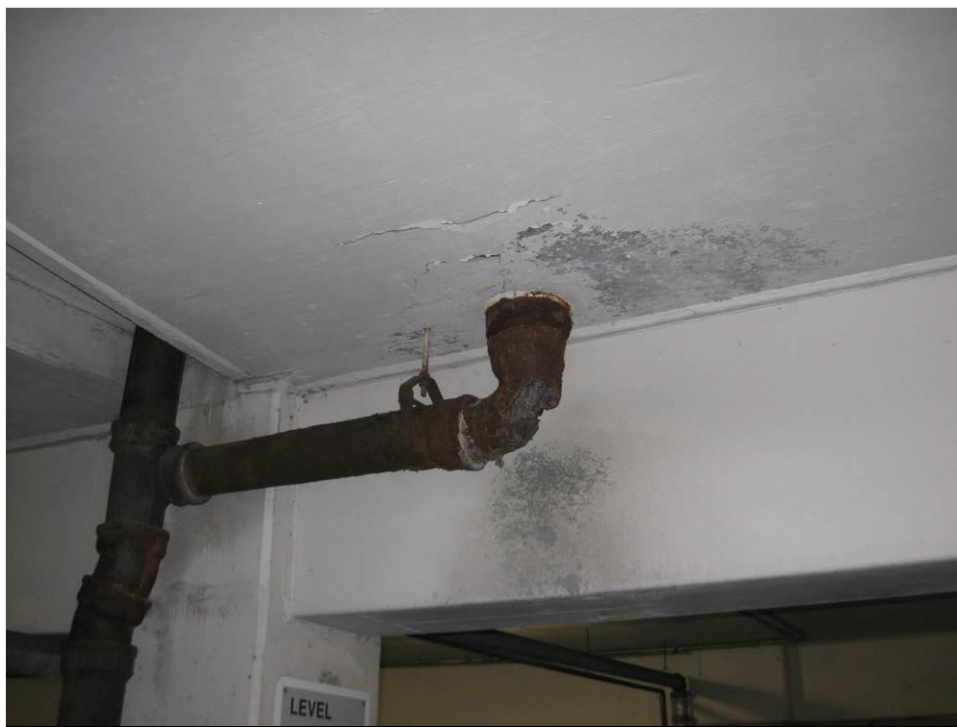
Photo 12 – Broken elbow on floor drain.

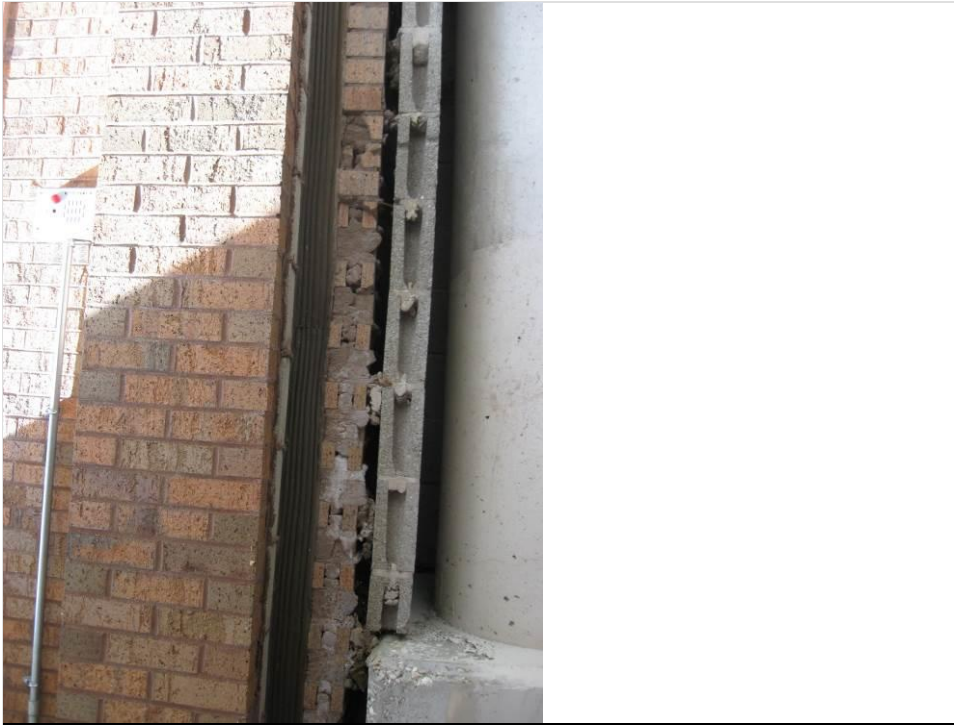
Photo 13 – Open joint at elevator tower.

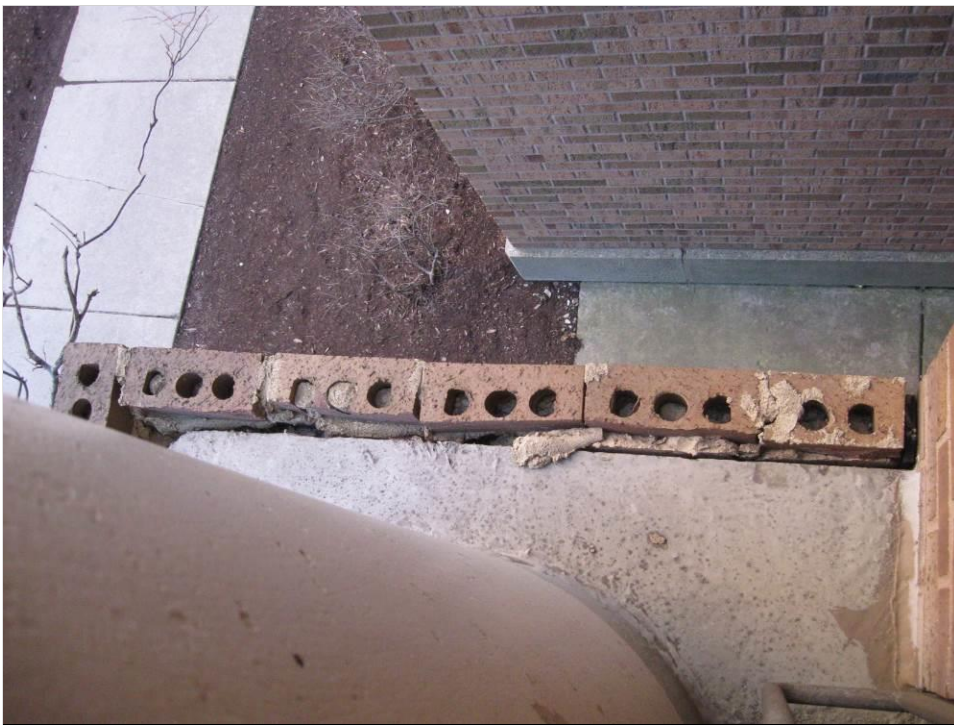
Photo 14 – Masonry wall without any cap stones.

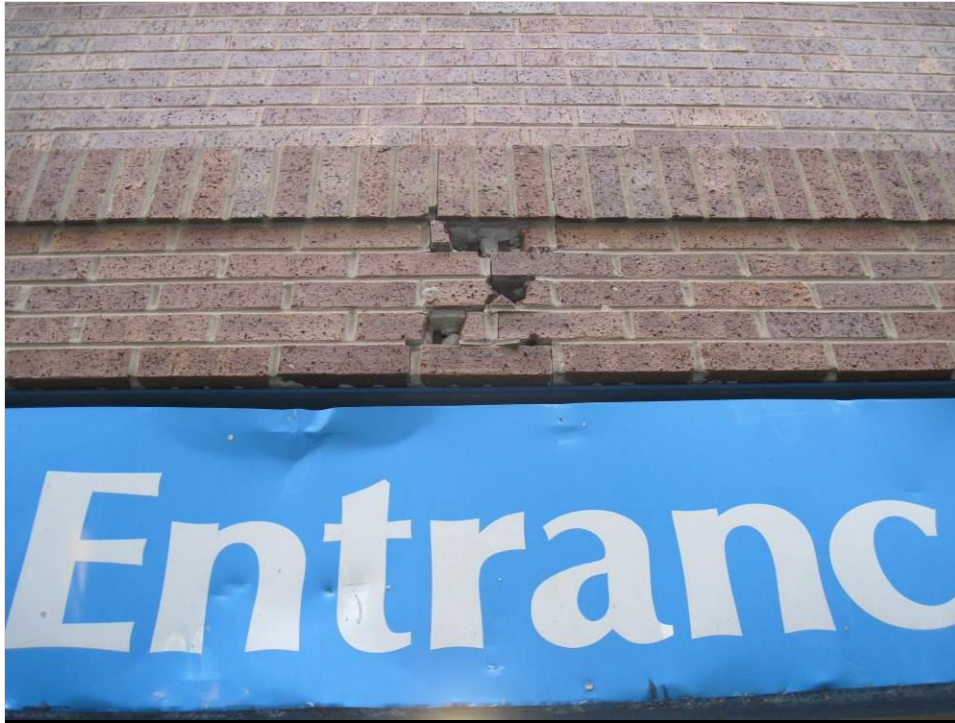
Photo 15 – Damaged masonry façade at entrance.

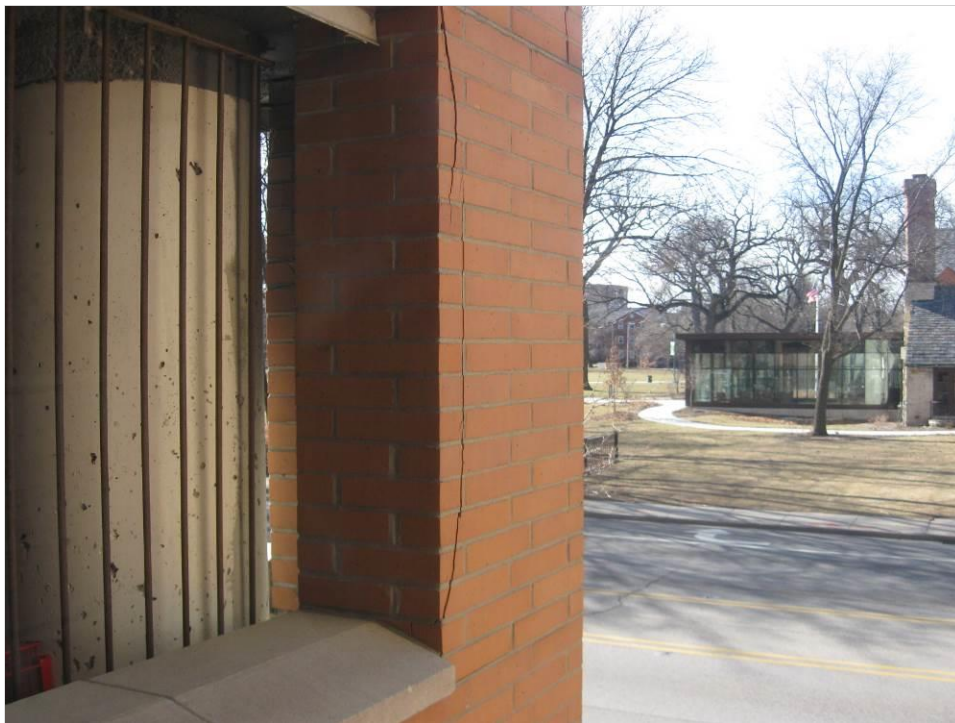
Photo 16 – Crack in masonry façade.

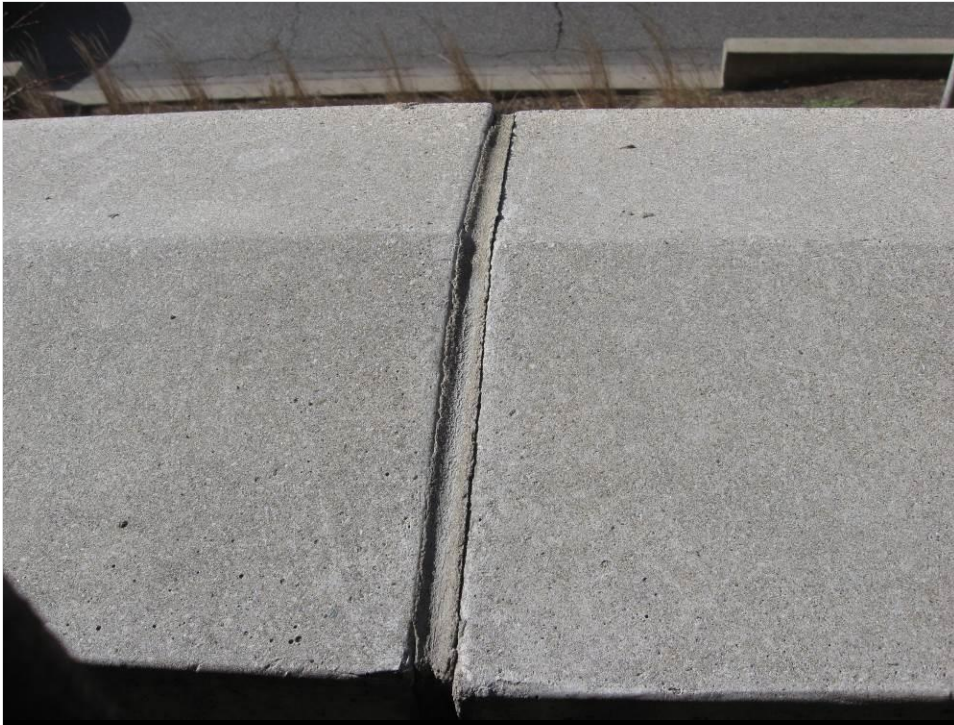
Photo 17 – Severely deteriorated mortar joint on cap stone.

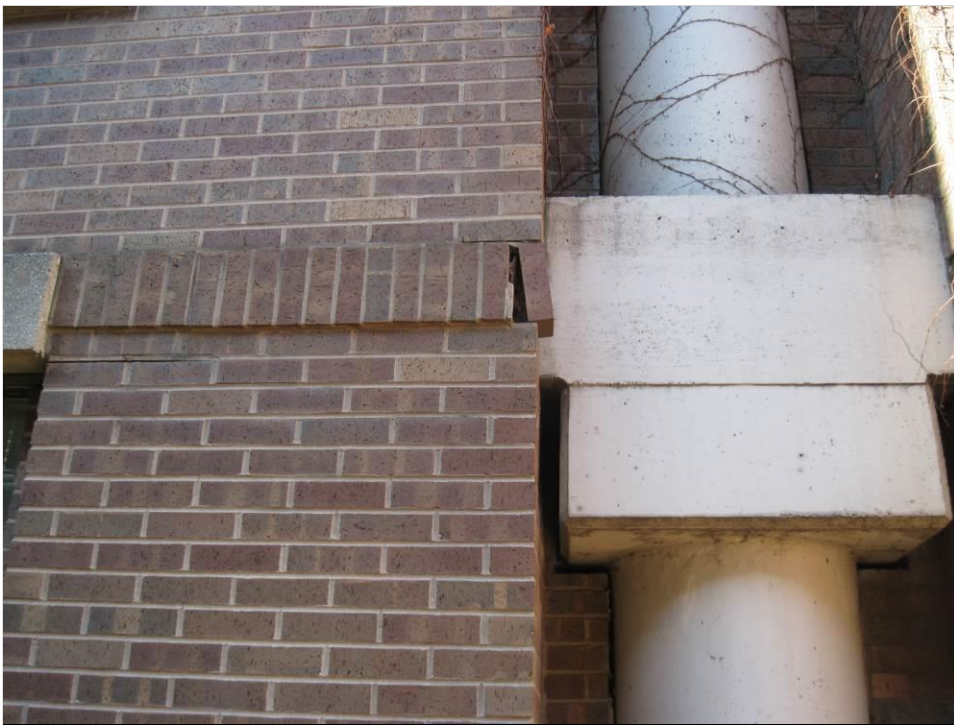
Photo 18 – Loose masonry on façade.

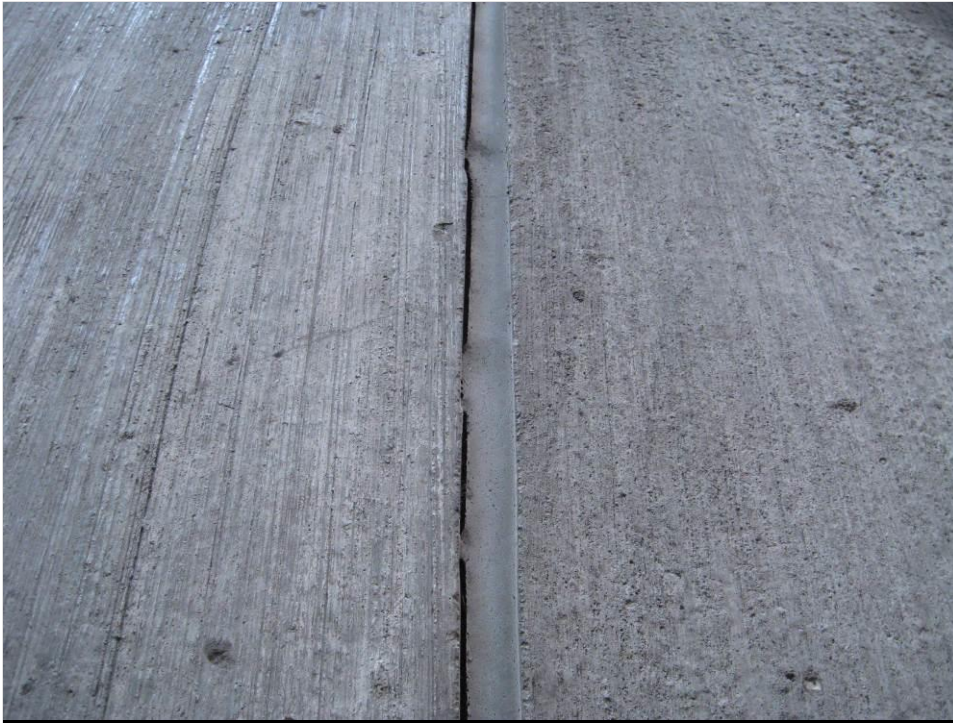
Photo 1 – Adhesion failure of tee-to-tee joint sealant.

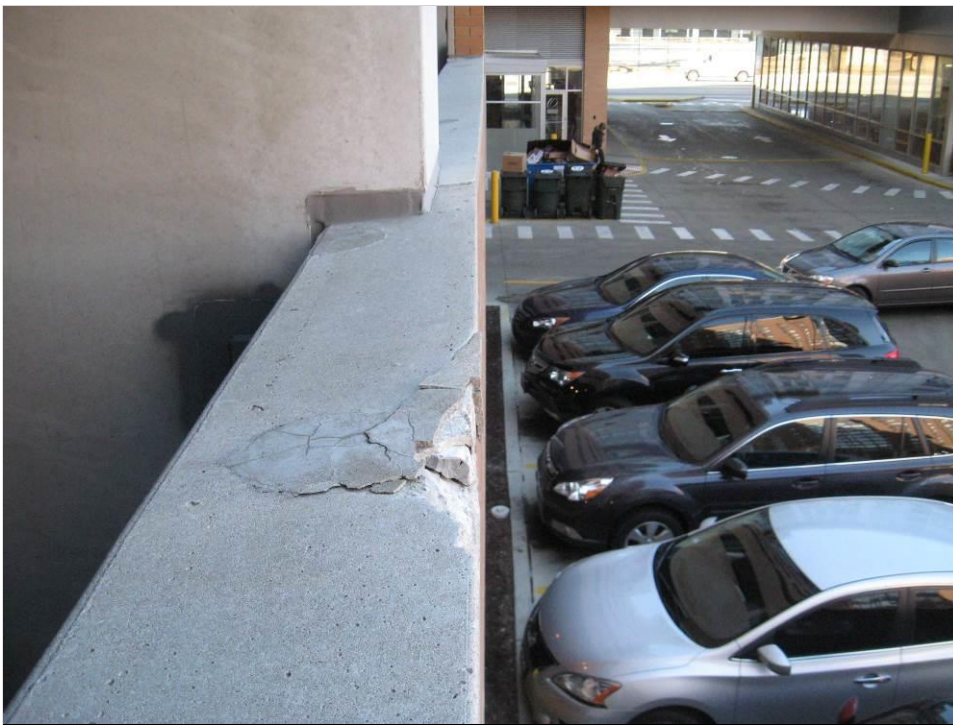
Photo 2 – Minor deterioration on façade wall.

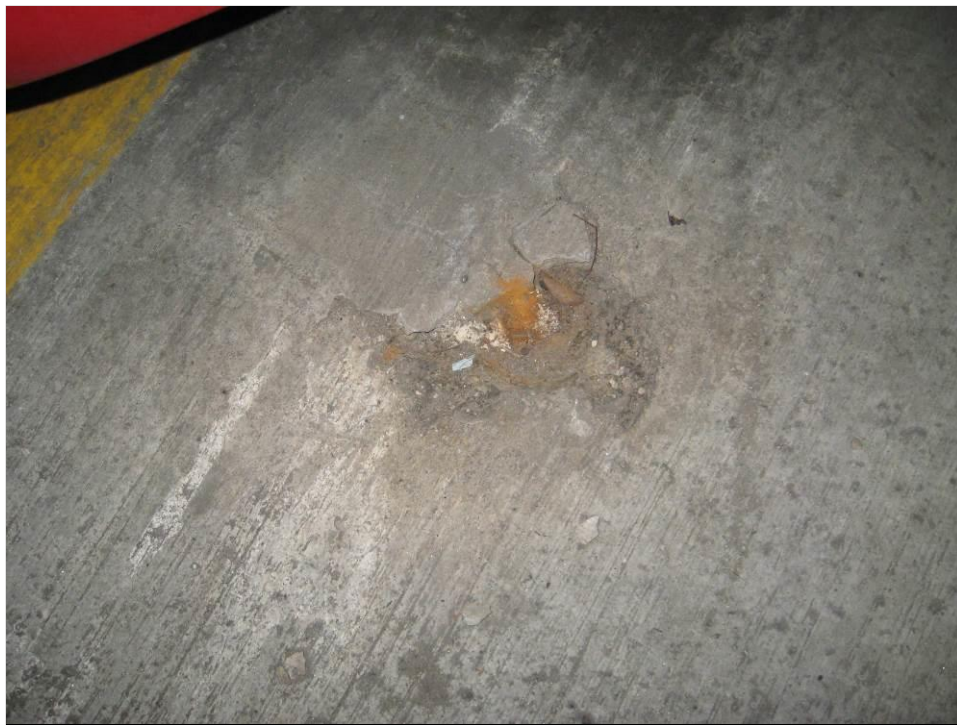
Photo 3 – Minor floor spall of precast tee.

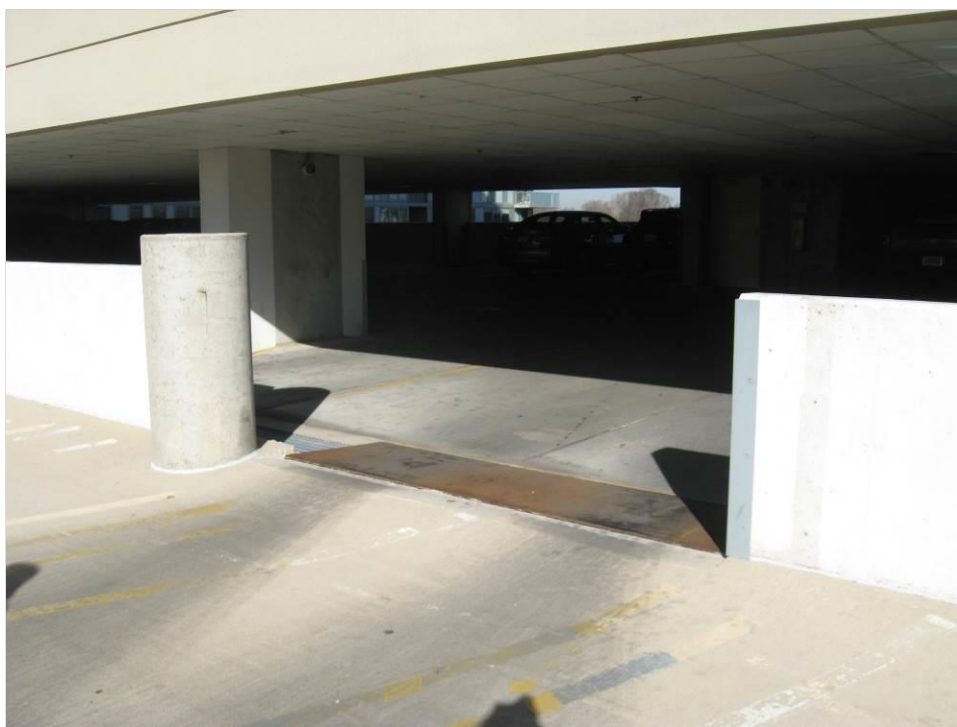
Photo 4 – Open gap area between both structures.

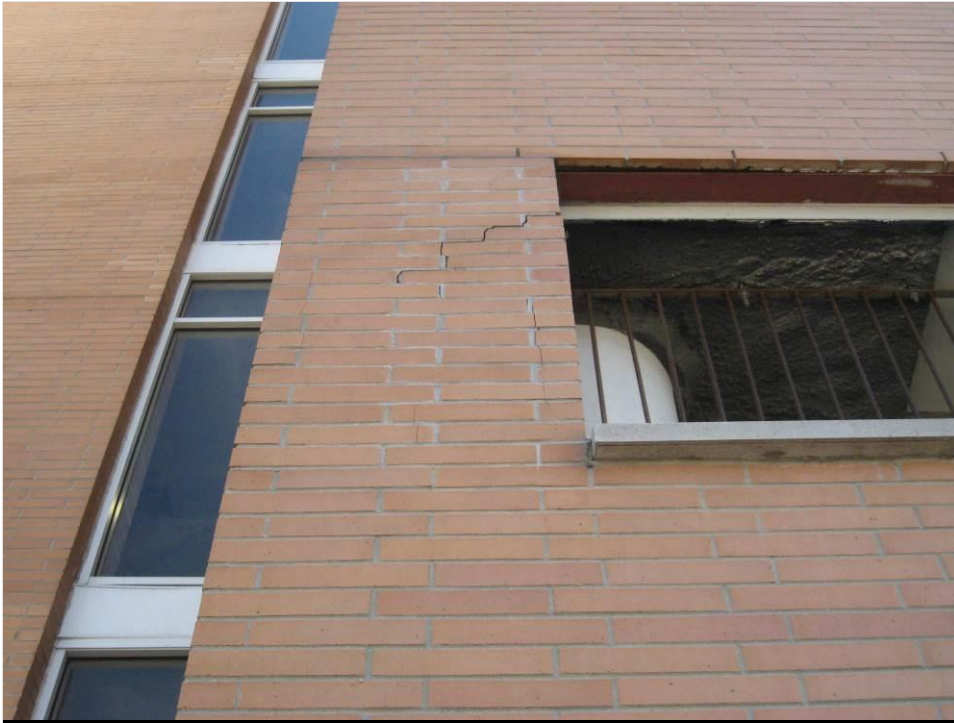
Photo 5 – Crack in masonry on façade.

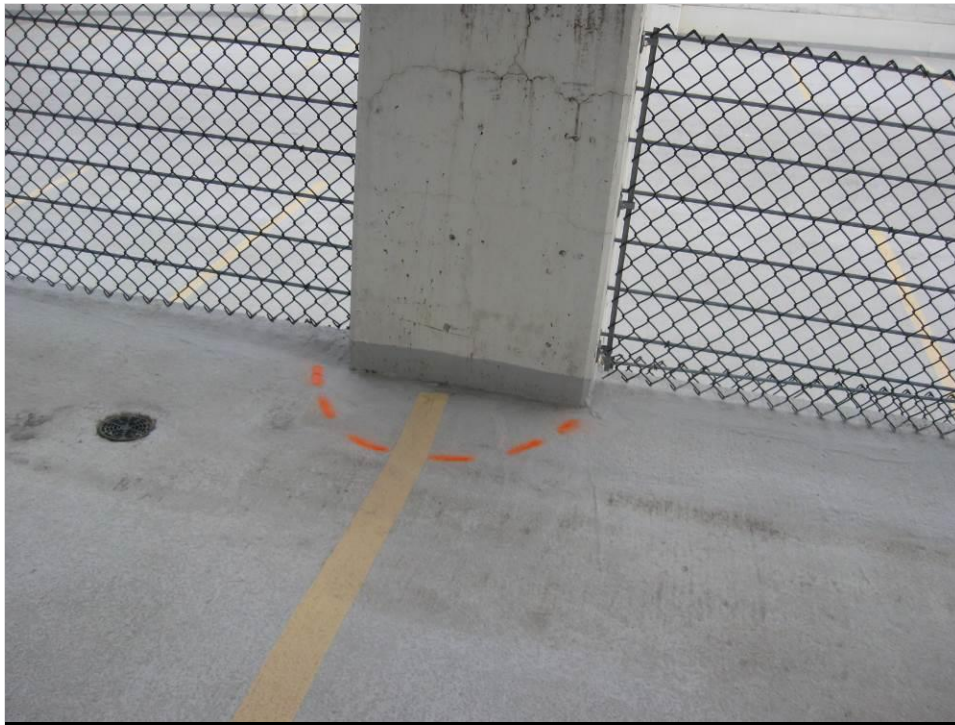
Photo 1 – Typical concrete delamination on floor slabs over top of post-tensioned beams.

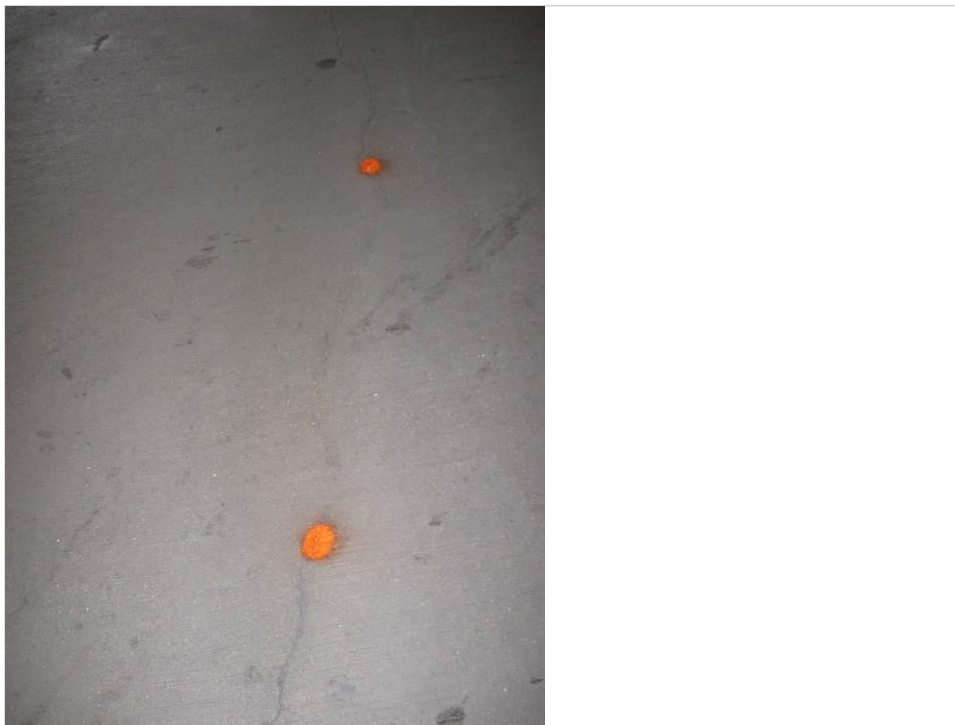
Photo 2 – Typical random floor crack in floor slab.

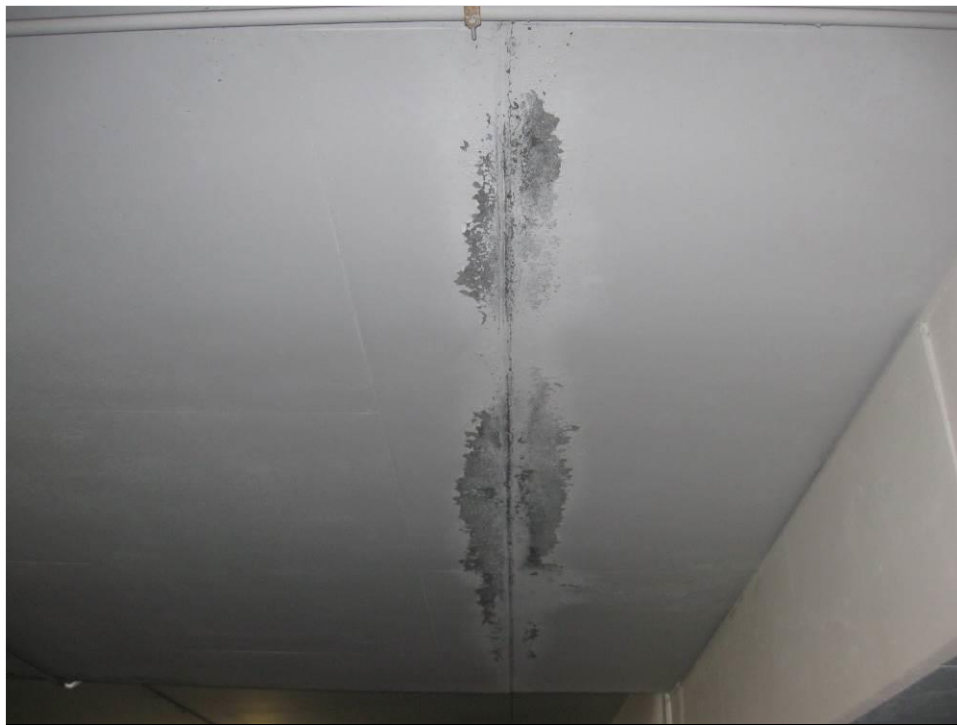
Photo 3 – Active leaking construction joint seen from below slab.

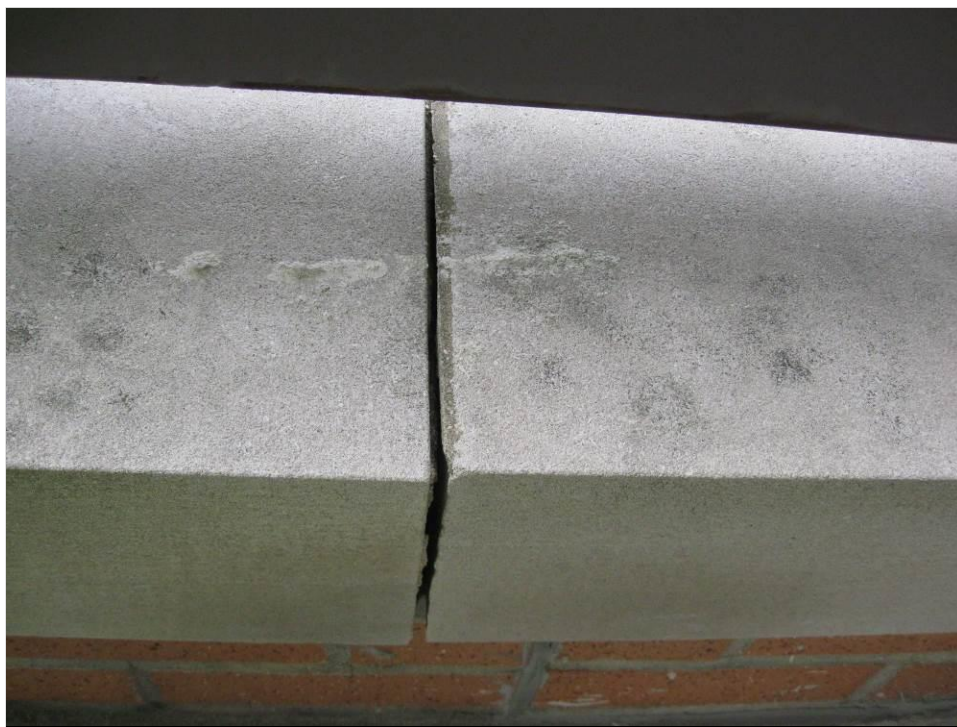
Photo 4 – Typical severely deteriorated mortar joint on cap stone.

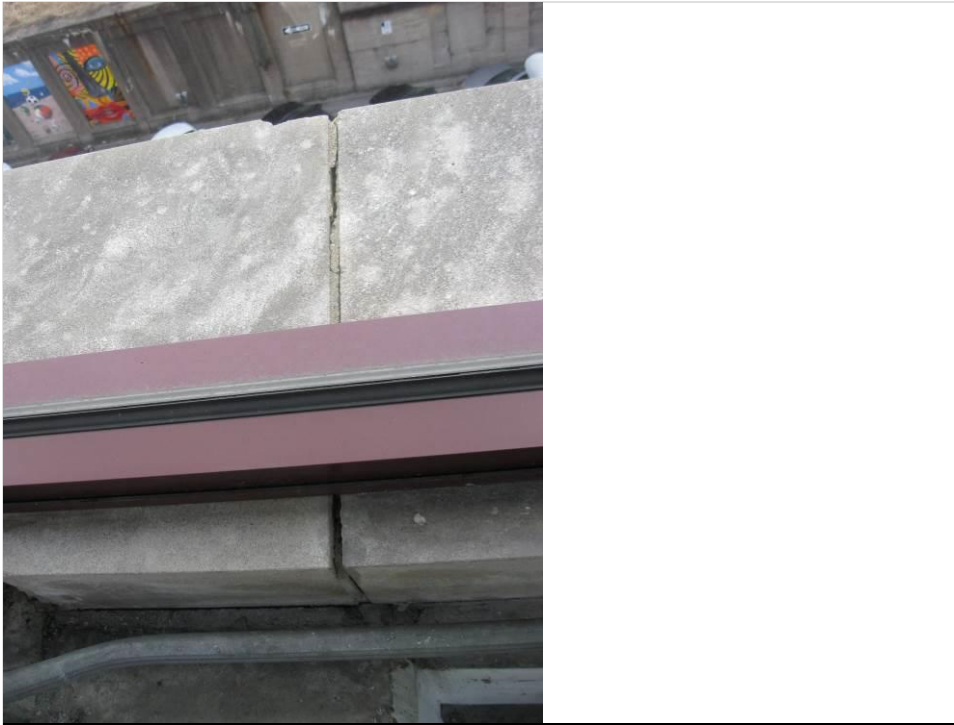
Photo 5 – Severely deteriorated mortar joint under window mullion on stair tower.

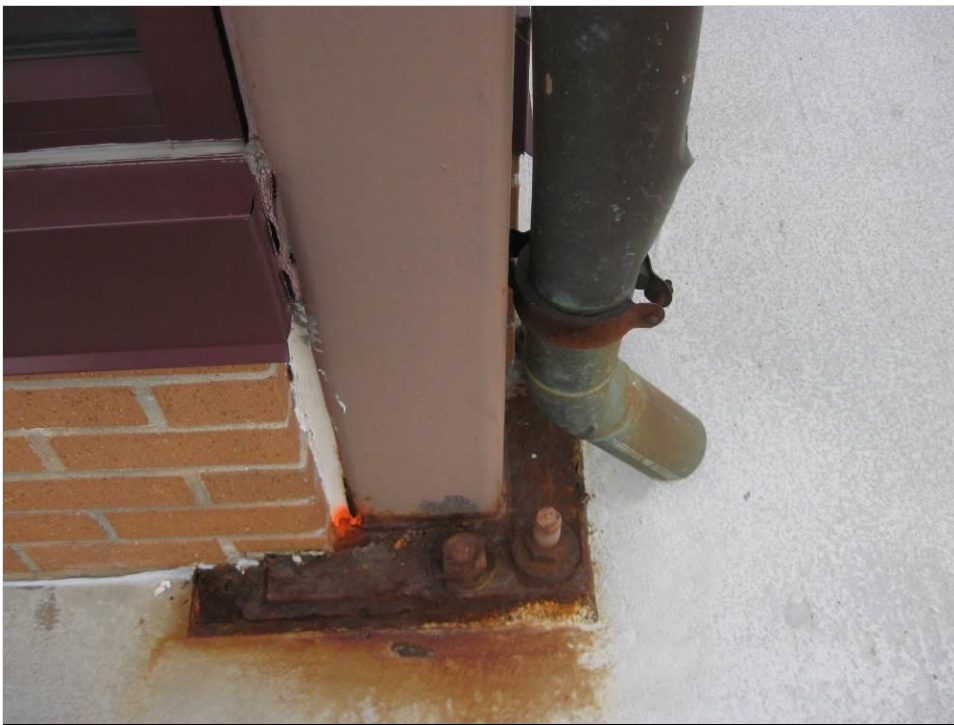
Photo 6 – Severely deteriorated vertical joint sealant on stair/elevator tower.

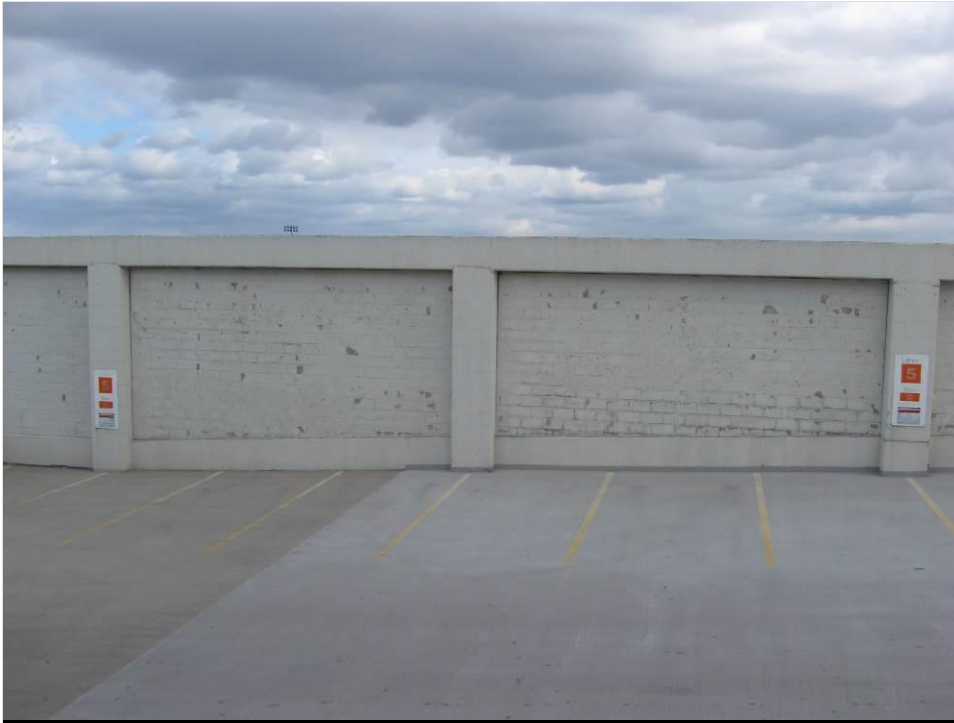
Photo 7 – Severely deteriorated painted masonry wall at Roof Level.

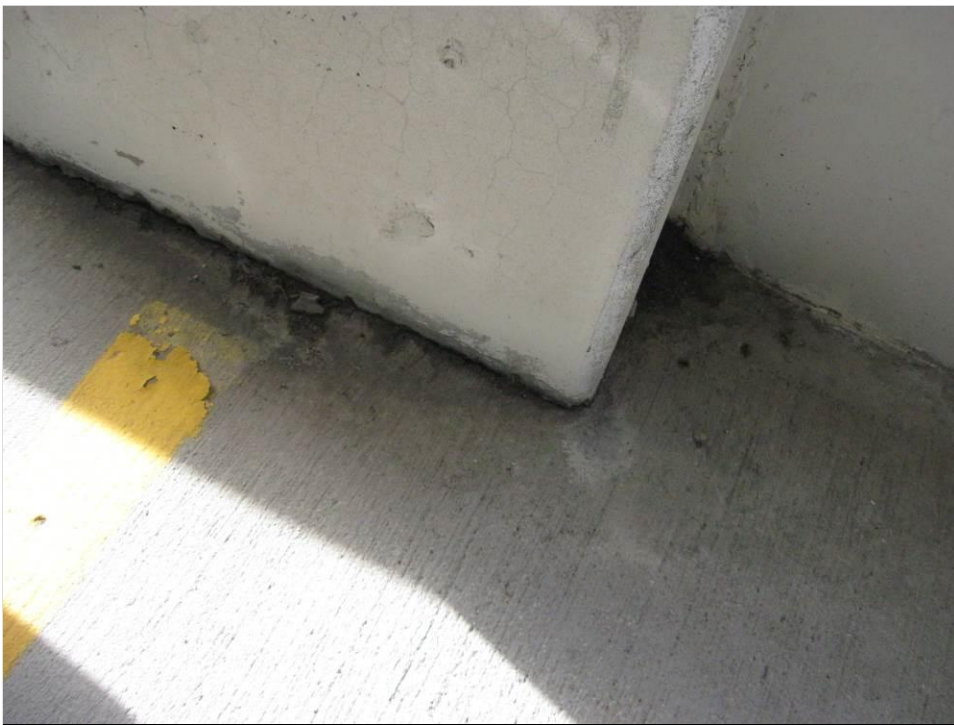
Photo 8 – Typical, no cove sealant between column and floor slab.

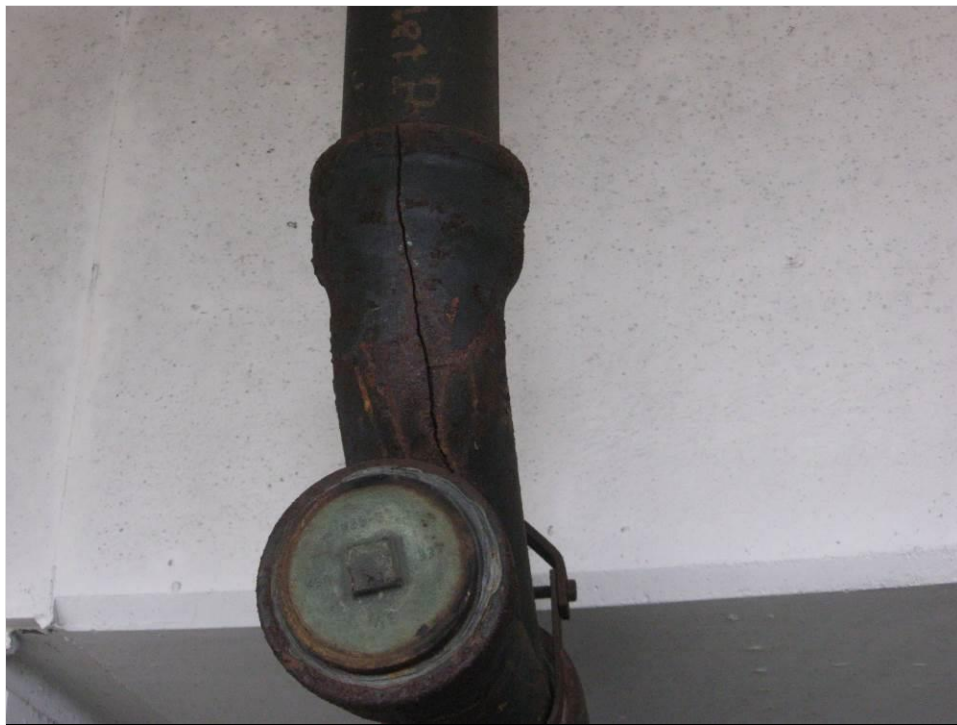
Photo 9 – Crack in drain pipe.

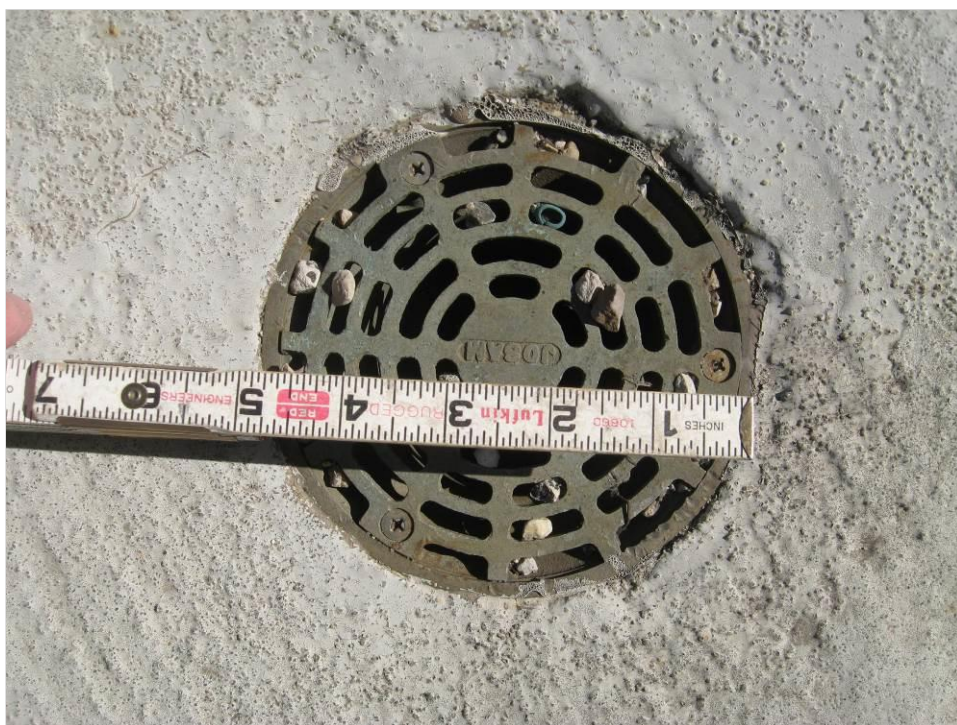
Photo 10 – typical inadequate size floor drain.
