CONDITION ASSESSMENT

THE VILLAGE OF OAK PARK PARKING STRUCTURES

OAK PARK, ILLINOIS

WRC PROJECT NO. 31-8130.00
MAY 2017

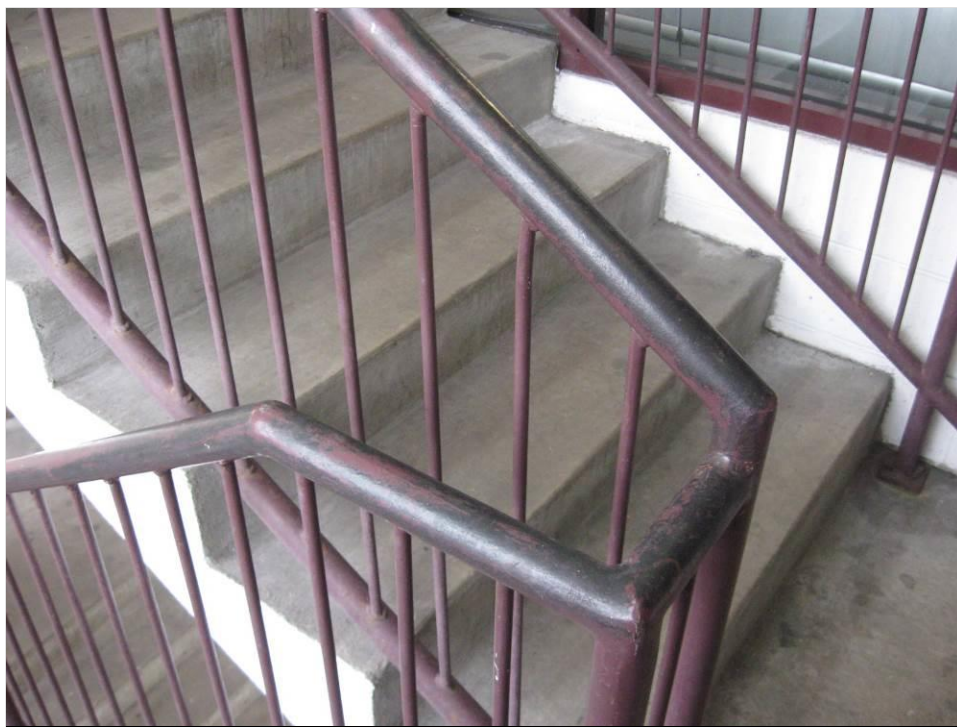
Photo 11 – Worn off paint on stair tower handrails.

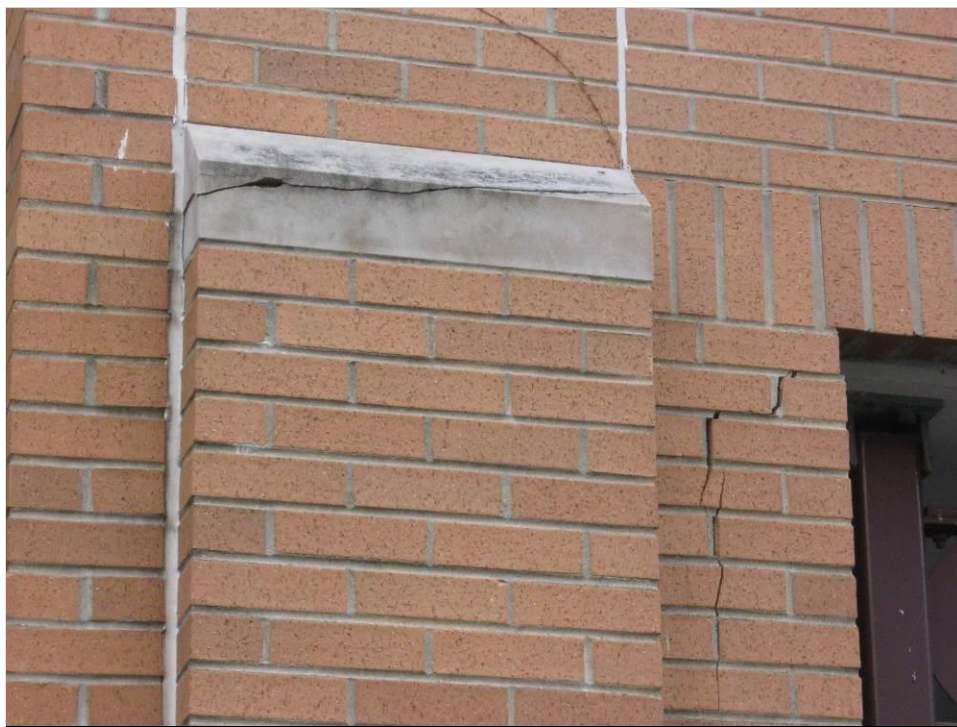
Photo 12 – Broken cap stone and cracked masonry.

We did note a condition that we recommend that should be addressing immediately. The two capstones that are cracked and broken cap stones, on south façade elevation along North Avenue, should be removed until repairs can be done. Refer to photographs 12 and 13 for Avenue Parking Structure in Appendix A.

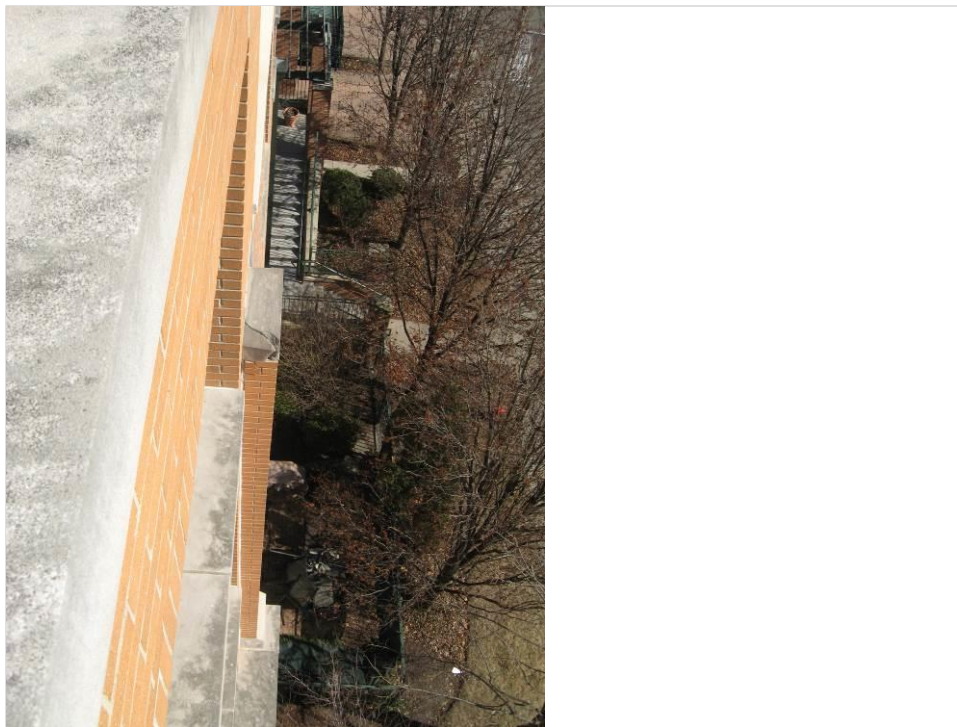
Photo 13 – Broken cap stone with the potential to fall off, south elevation.

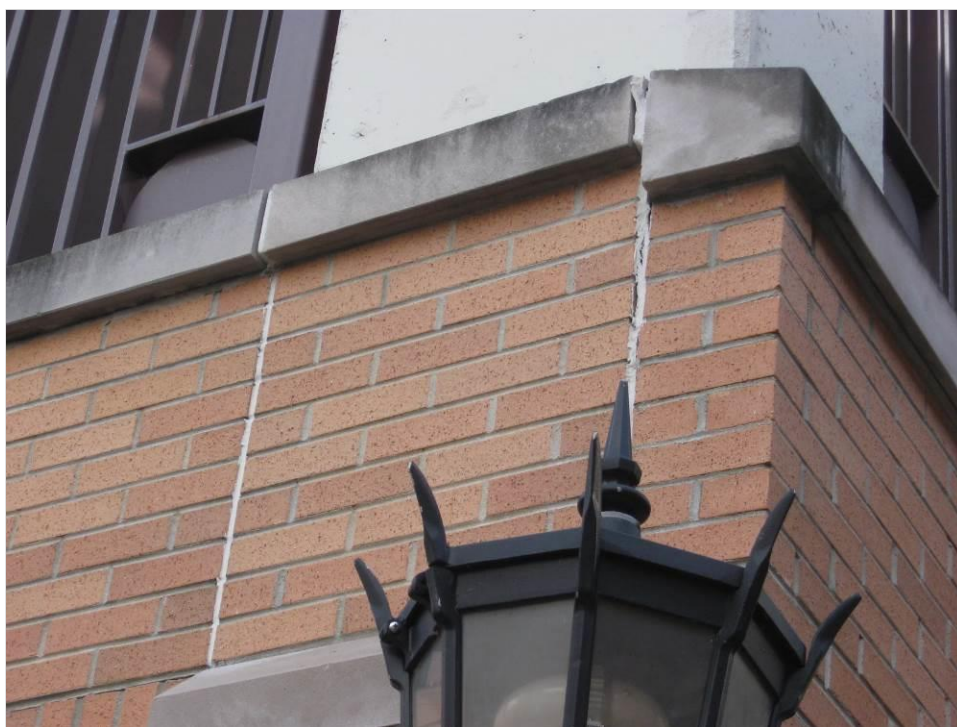
Photo 14 – Severely deteriorated vertical joint sealant on exterior masonry wall.

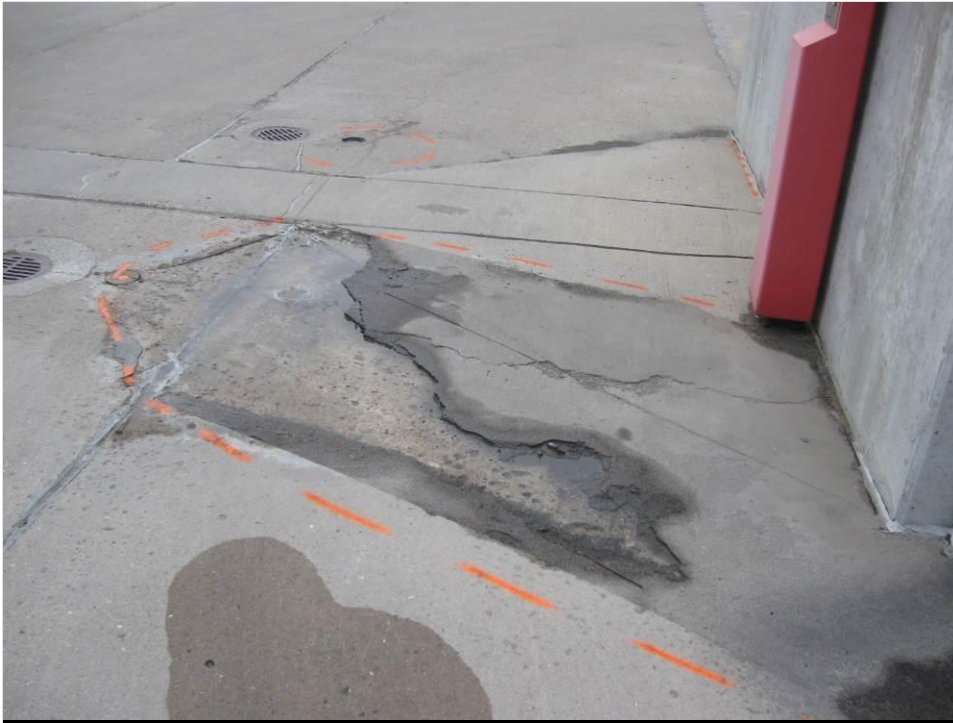
Photo 1 – Typical concrete delamination and spall at cast-in-place wash area.

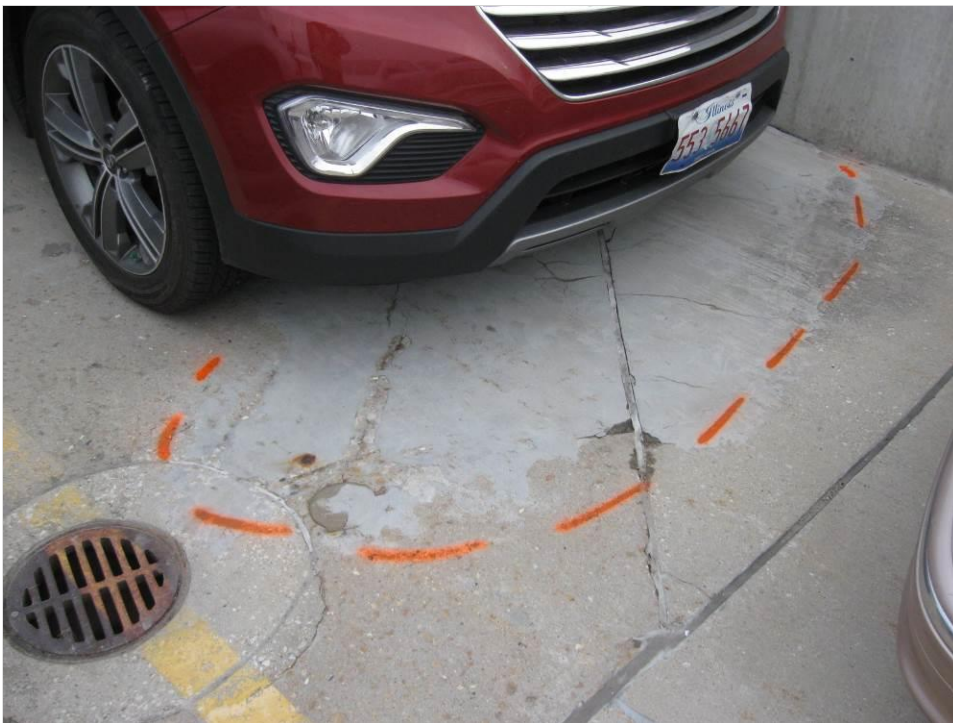
Photo 2 – Typical concrete delamination and deterioration at cast-in-place washes.

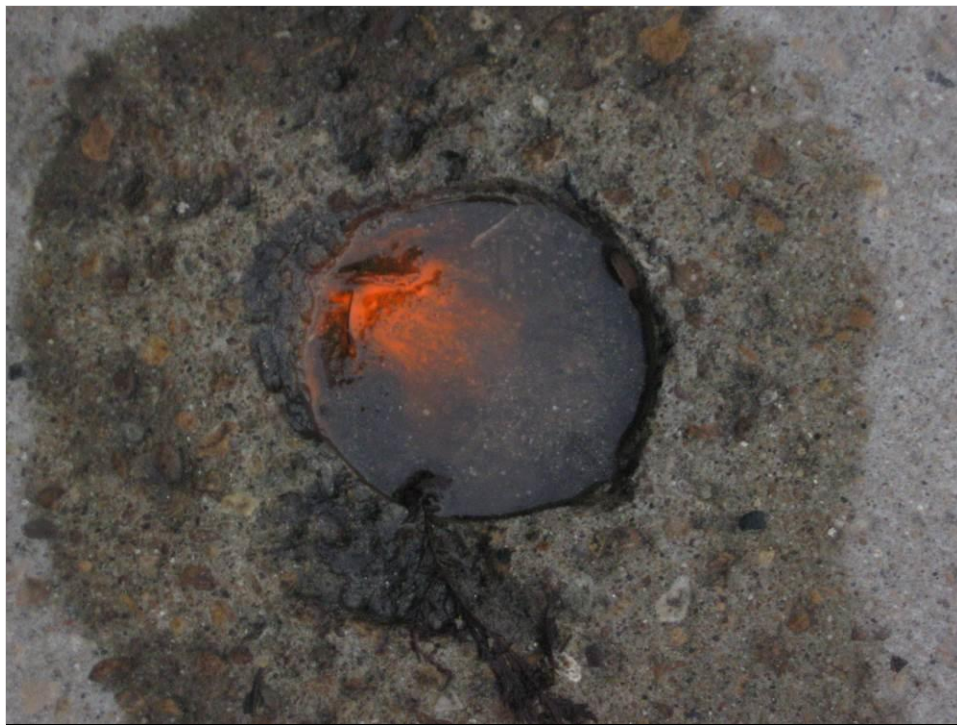
Photo 3 – Floor delamination over lifting loop.

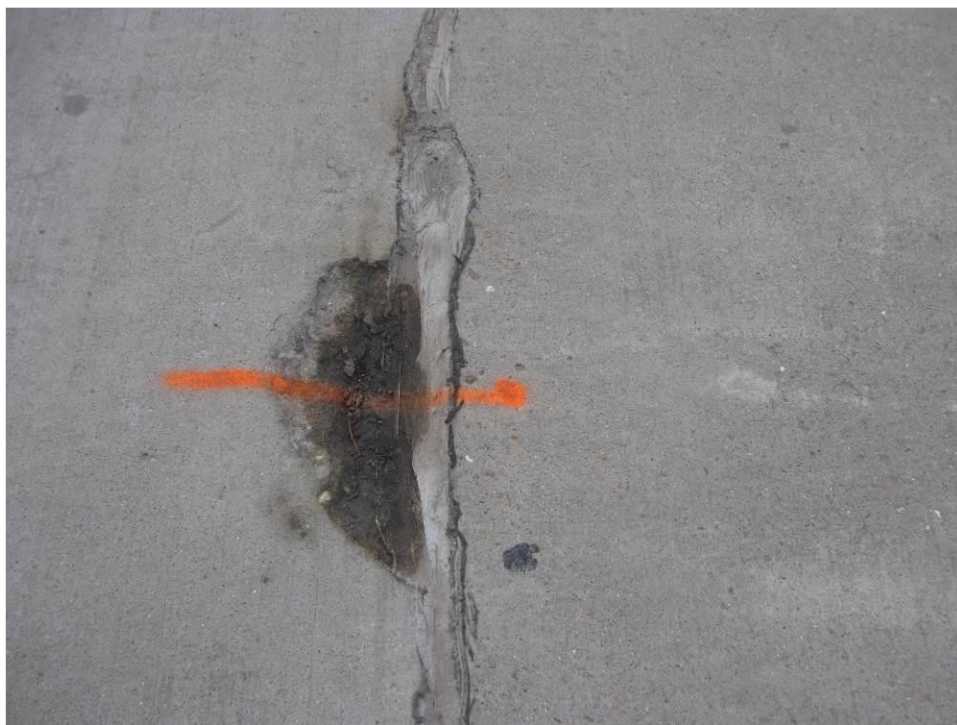
Photo 4 – typical floor spall over shear connector.

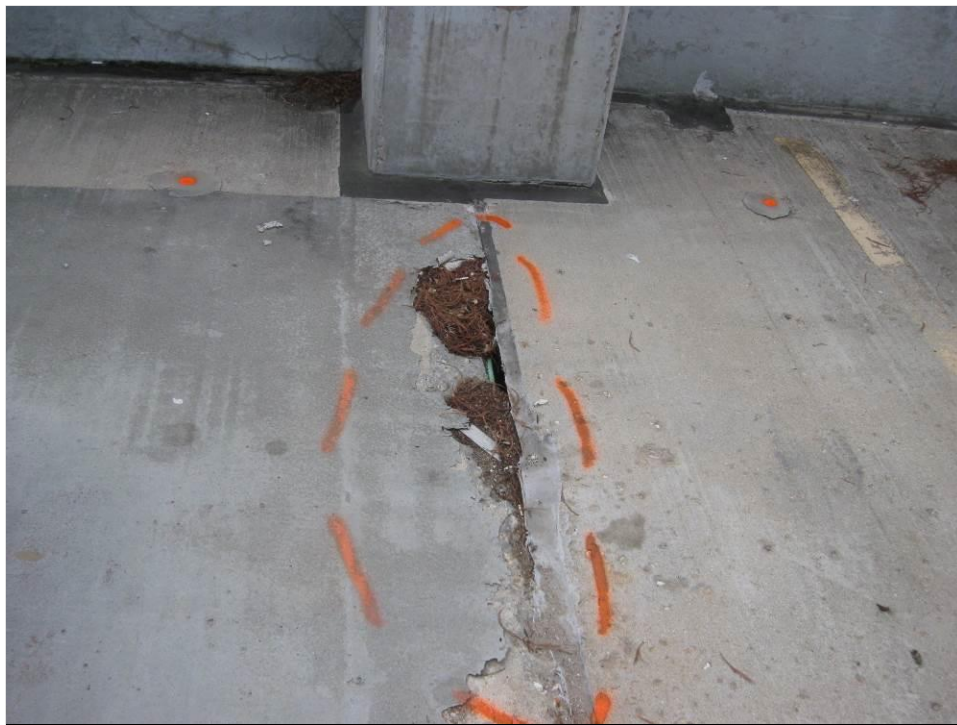
Photo 5 – Hole in the flange.

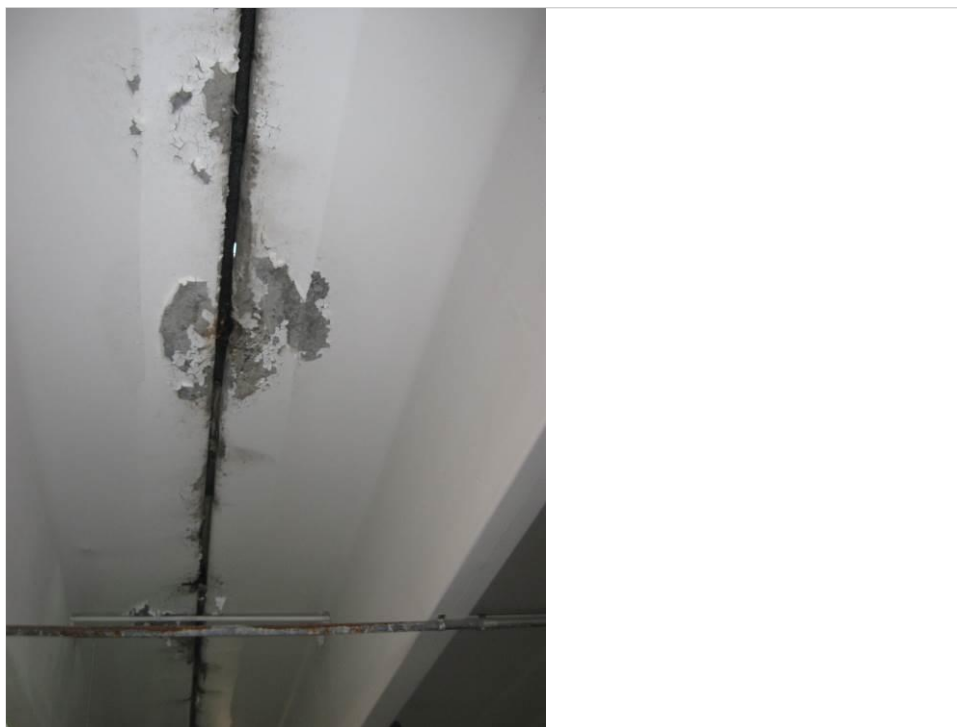
Photo 6 – Concrete spall at underside of precast tee flange.

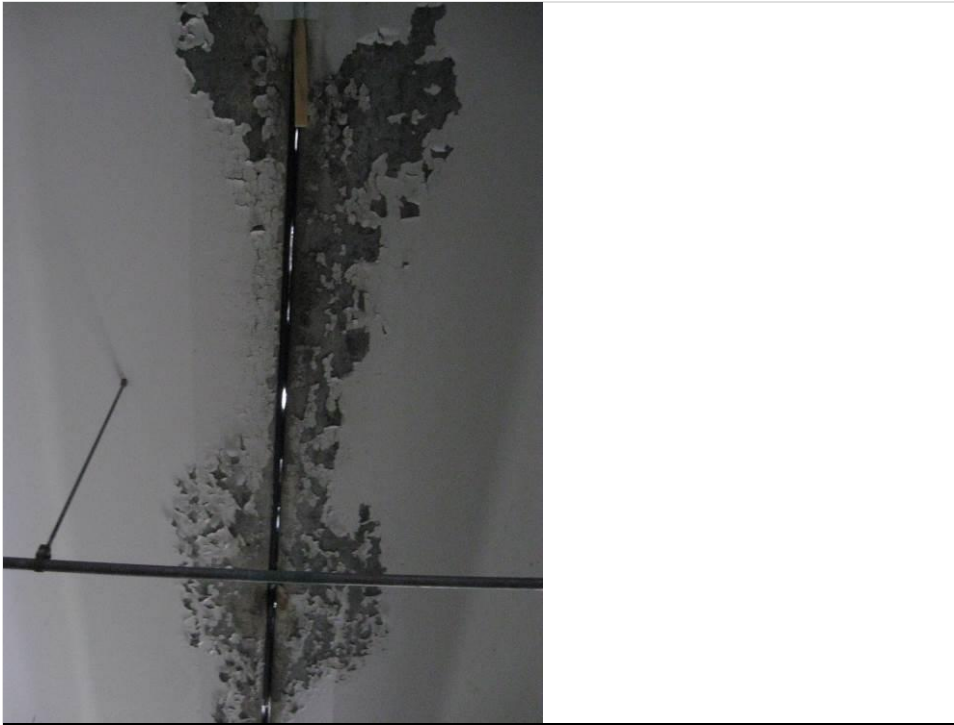
Photo 7 – Corroding tee-flange-to-tee-flange shear connectors at joint with severely deteriorated sealant.

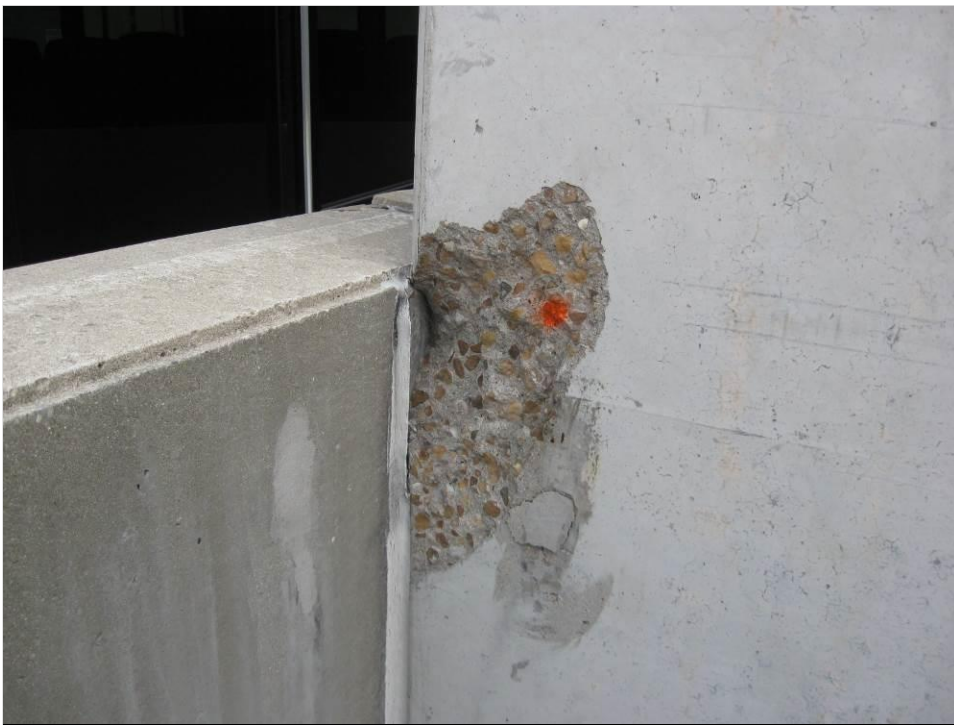
Photo 8 – Spall on the side of a column.

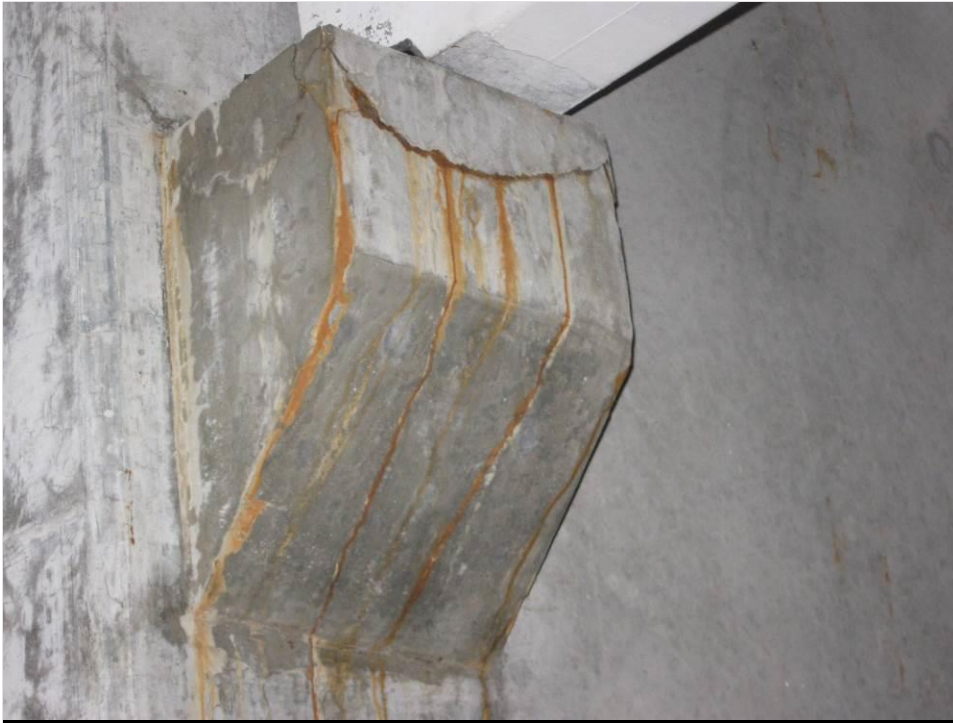
Photo 9 – typical concrete delamination at haunch for tee stem bearing.

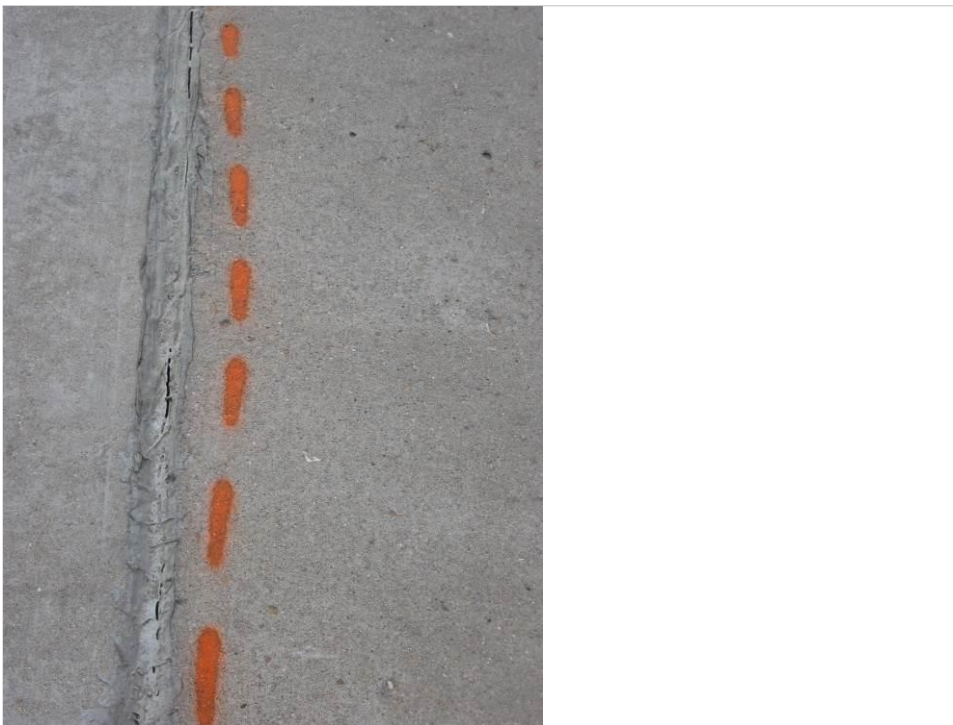
Photo 10 – Typical severely deteriorated tee-to-tee flange joint sealant.

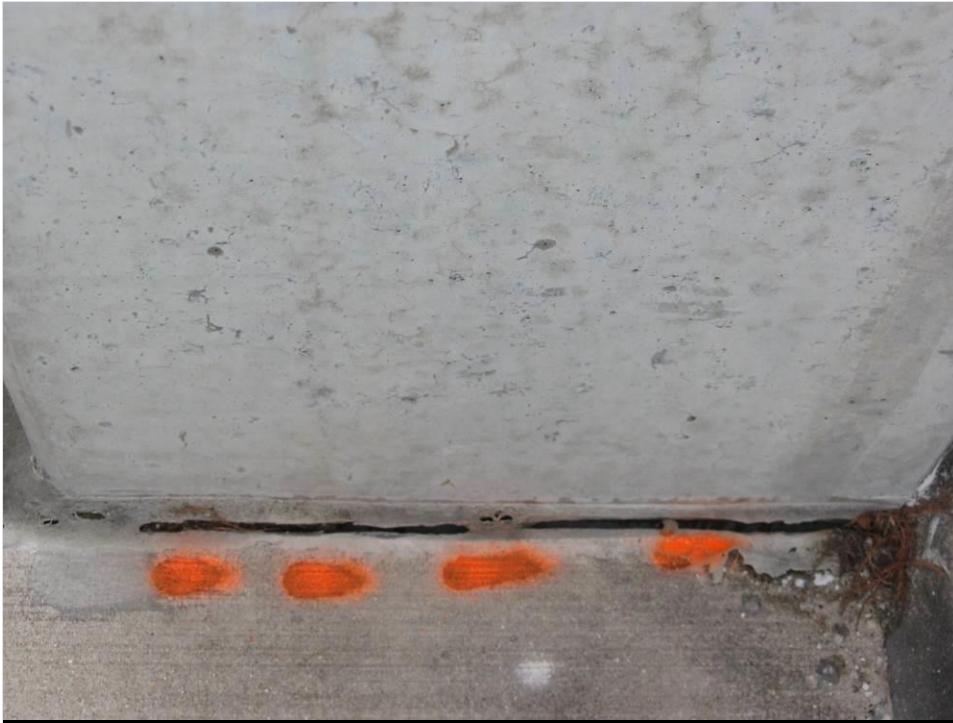
Photo 11 – Typical severely deteriorated cove sealant around column.

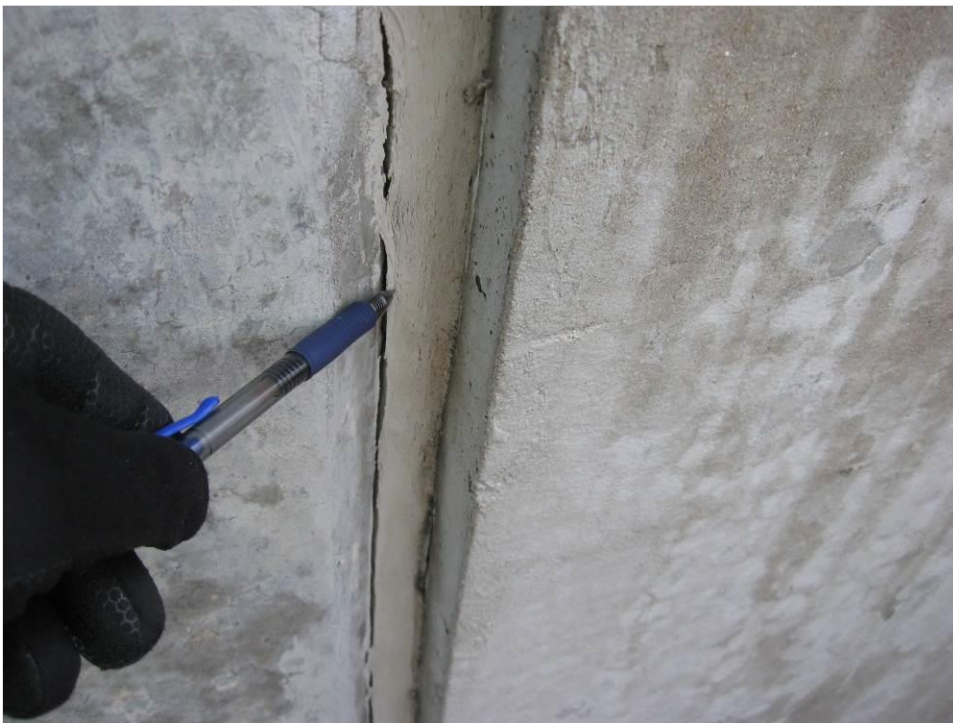
Photo 12 – Typical severely deteriorated vertical joint sealant at perimeter wall.

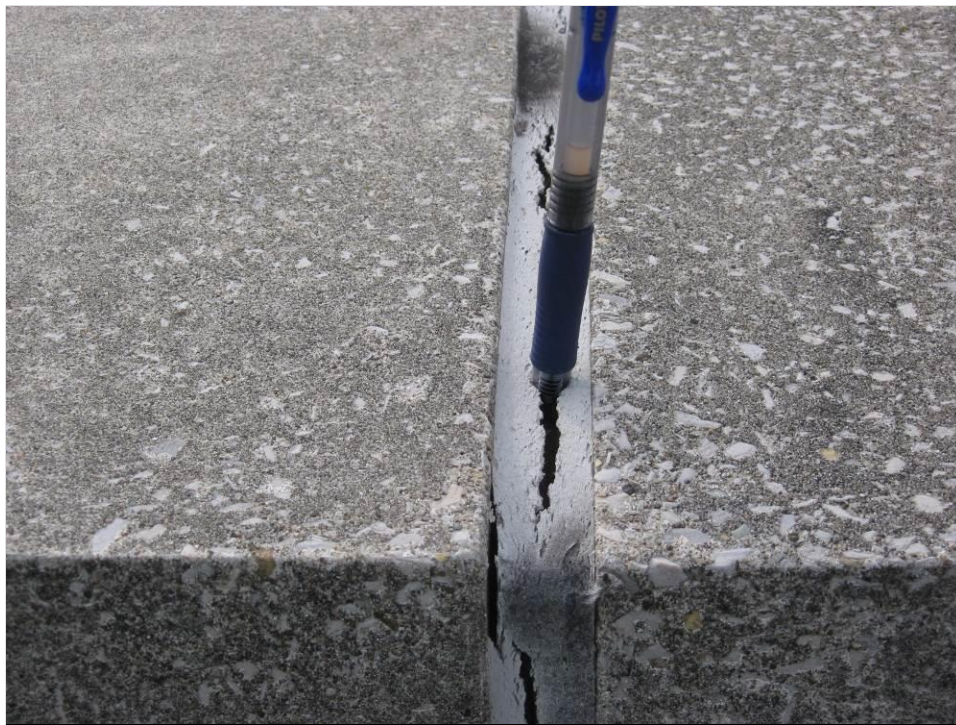
Photo 13 – Typical severely deteriorated cap stone joint sealant.

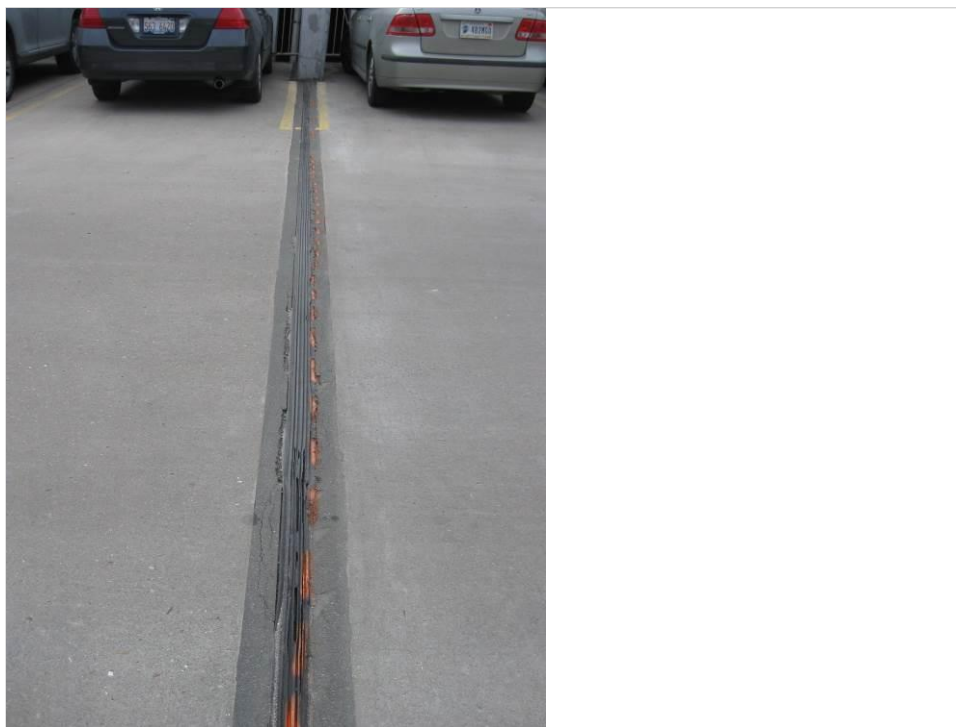
Photo 14 – Severely deteriorated expansion joint at grade slab.

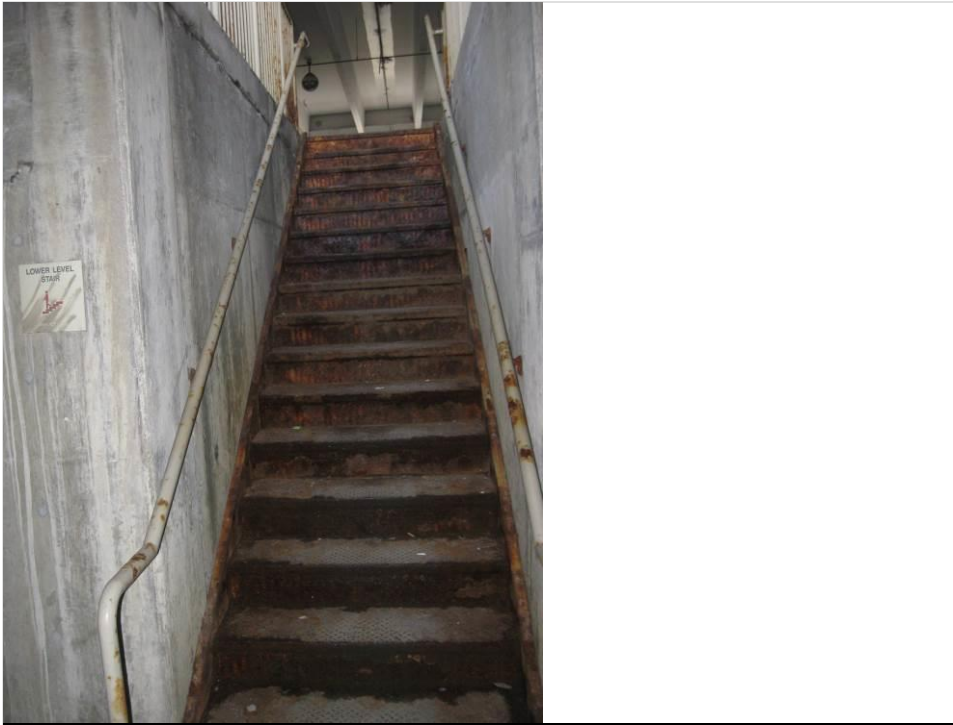
Photo 1 – Severely corroded stairs from Lower Level to First Level.

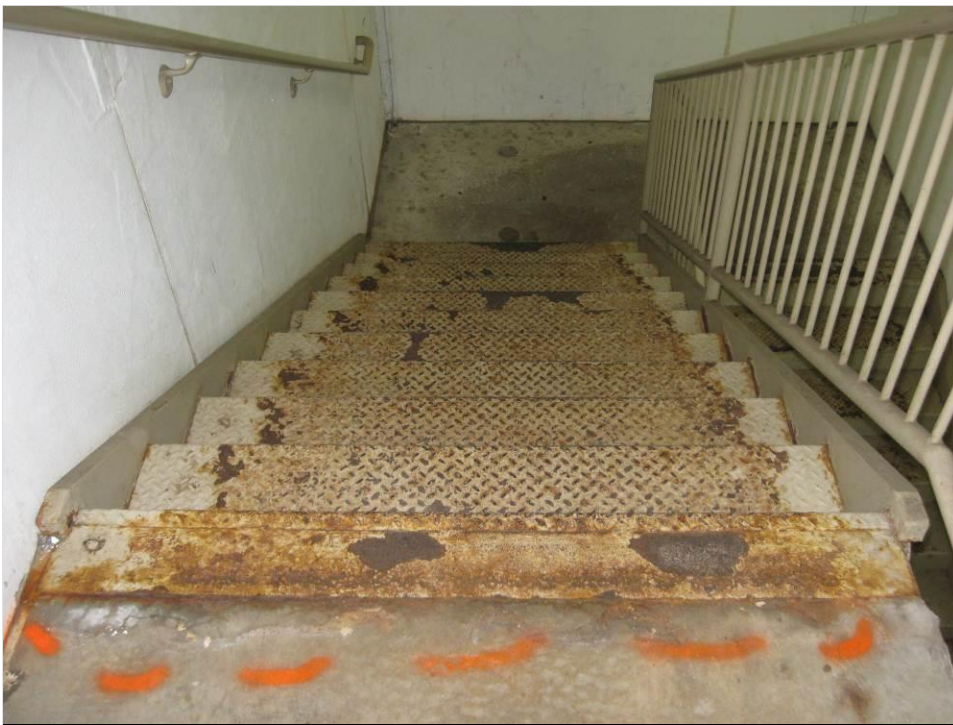
Photo 2 – Corroding stairs within stair tower.

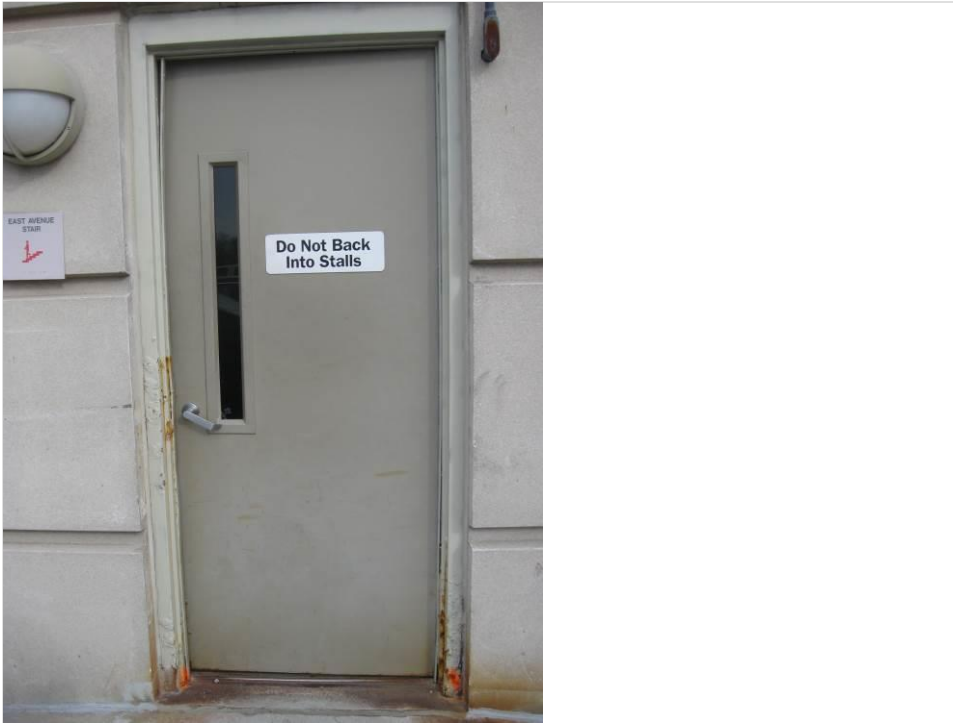
Photo 3 – Severely corroded door and frame.

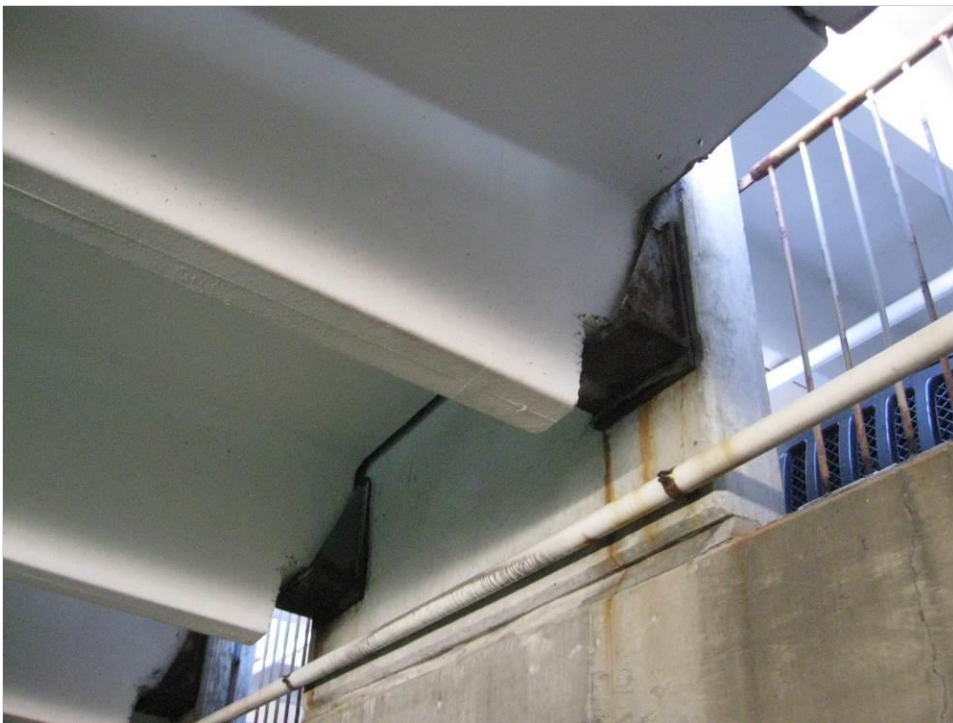
Photo 4 – Corroded tee stem support angles.

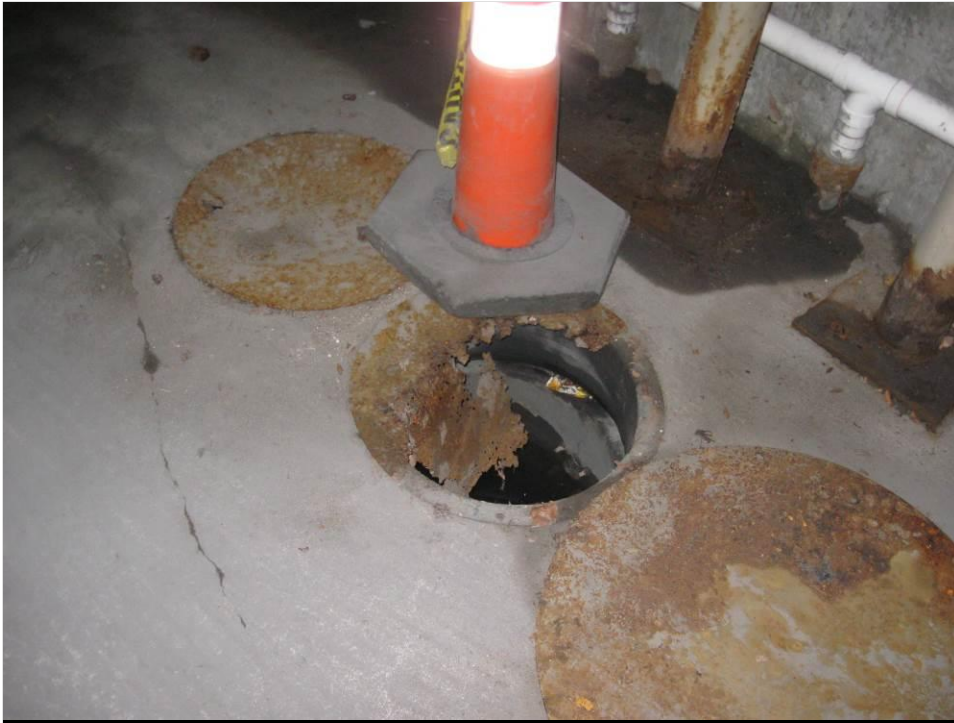
Photo 5 – Corroded cover on triple basin.

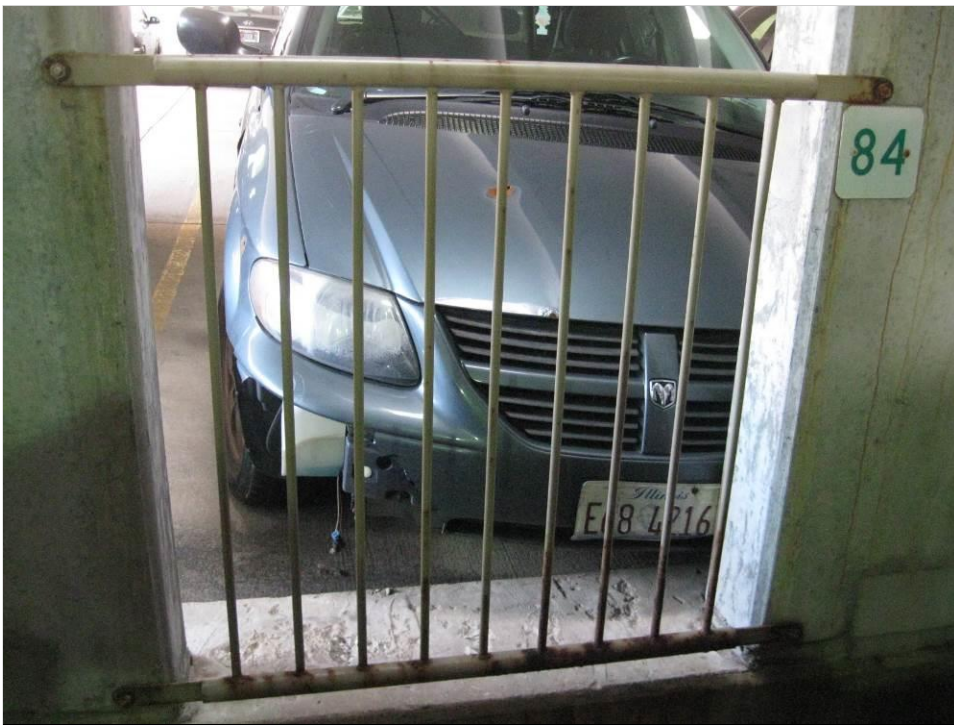
Photo 6 – Typical corroding guard rail on light wall.

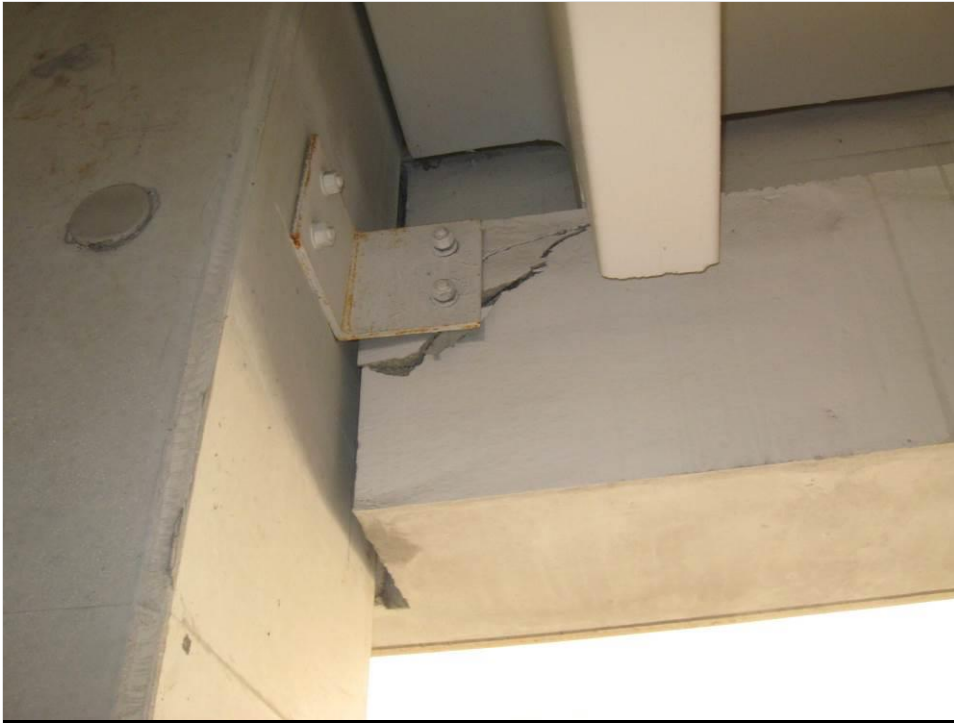
Photo 7 – Broken connection on façade panel.

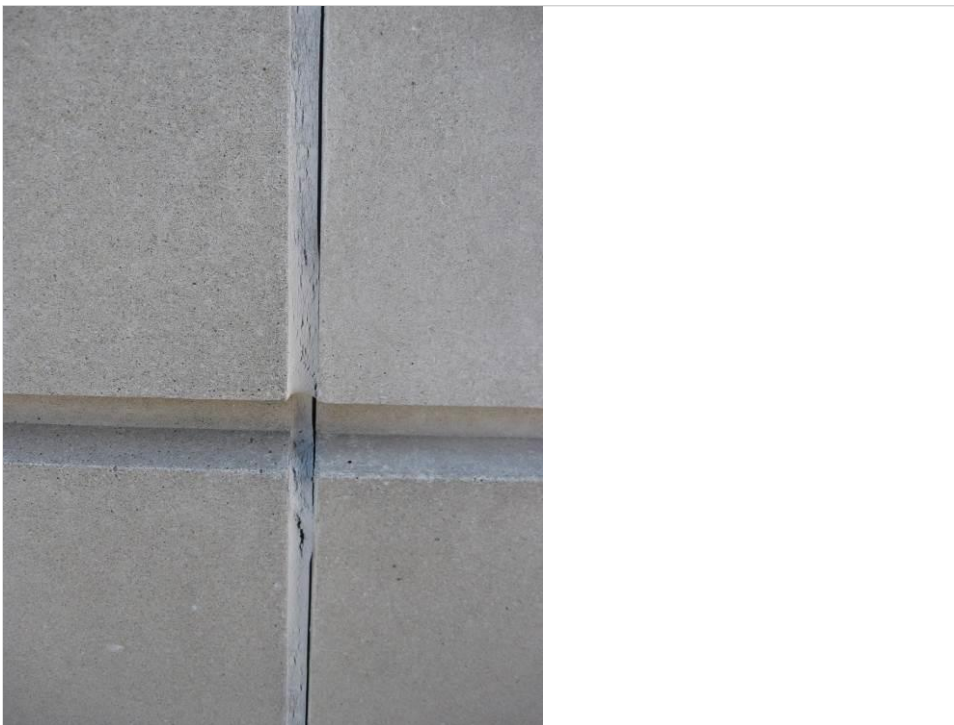
Photo 8 – Severely deteriorated vertical joint sealant on façade panel.

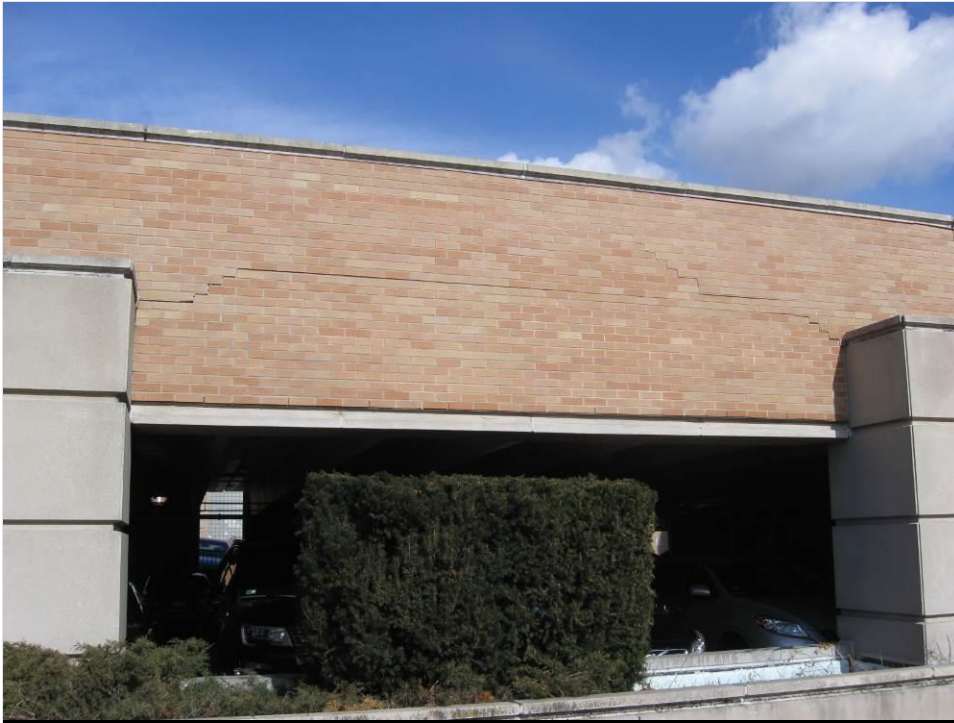
Photo 9 – Severely deteriorated masonry section on façade panel along south wall.

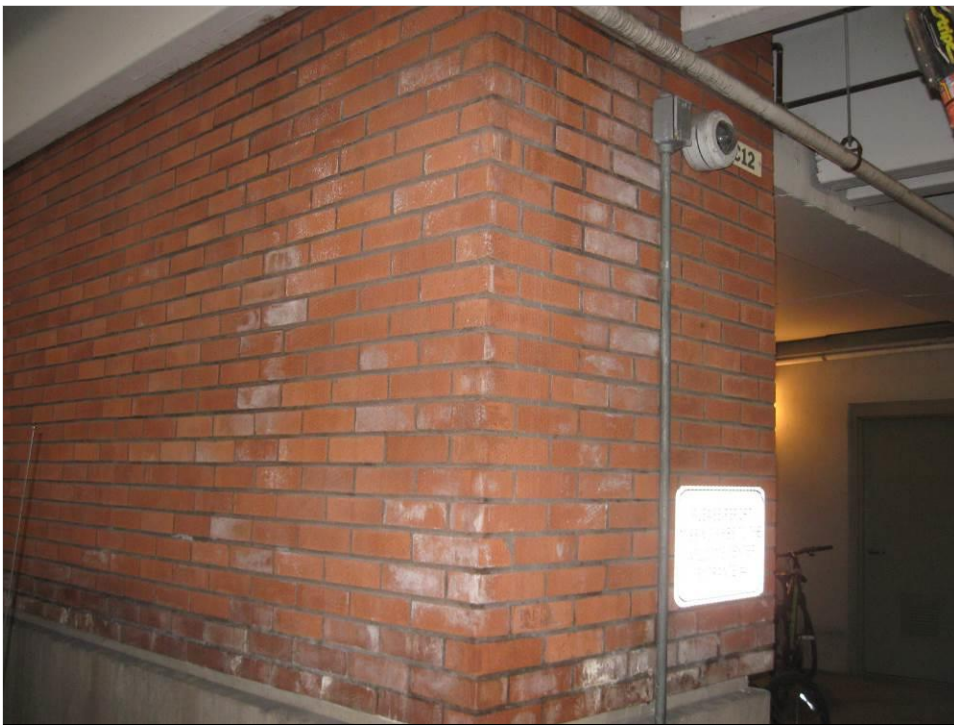
Photo 10 – Efflorescence on masonry due to water infiltration.
