**PROGRAM VALIDATION REPORT**

24 January 2025

Village of Oak Park Project 23-130

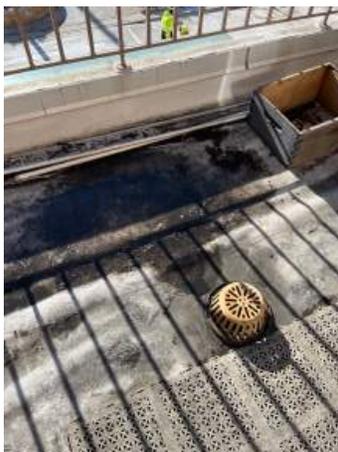
The low slope membrane roofs are in poor to fair condition. There is ponding water on the roof over the vestibule on the south side of Village Hall, an indication that the roof is not properly sloped. The membrane is also no longer adhered to the tapered insulation below and there are several air pockets. Although maintenance staff confirmed there are no active leaks at this roof, staining on the ceiling below indicates that the roof has leaked in the past. The EPDM roofs above the Council Chambers are in fair to poor condition with the small roof at the north corner in the worst condition with severe ponding. The skylight is a single glazed wire glass system and is in fair condition with no broken glass and sealant intact but aged. The gutter and downspout at the southeast corner of the Council Chamber roof is deteriorated and allowing water infiltration at the corner of building.

Figure 1 Vestibule Roof.

The surface of the existing terne metal roof should be thoroughly cleaned, all corrosion should be removed, areas of minor damage should be patched with new metal sheet and soldered to match the existing terne coating. A transparent, protective coating should be applied on top of the terne metal to enhance longevity and weather resistance.

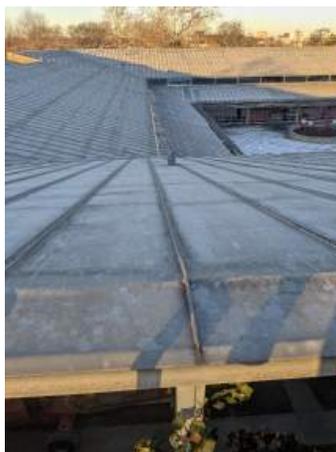
The sloped, standing seam terne-coated steel roofs are in fair condition. While there does not appear to be any large holes or open seams in the roof, there are several areas where surface corrosion was observed, especially at the standing seams and roof edge. These are areas where the terne coat has deteriorated and the steel is now exposed.

Figure 2 - Terne Roofing.

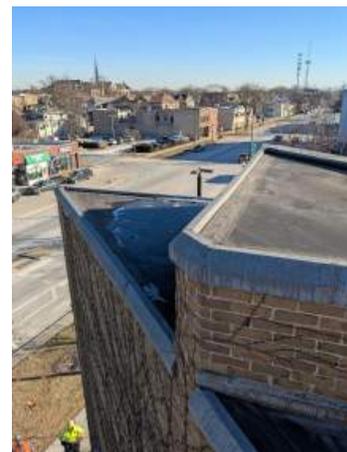
Figure 3 - Ponding Water at North Corner of Council Chamber.

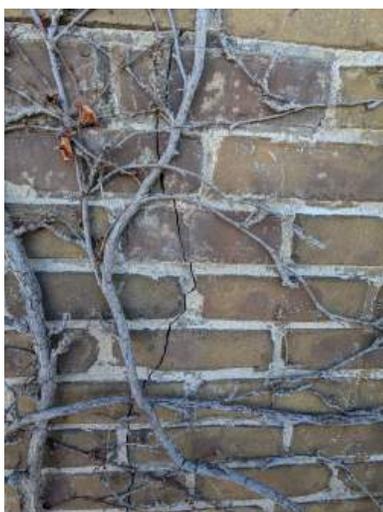
Figure 4 - Crack at Chimney.

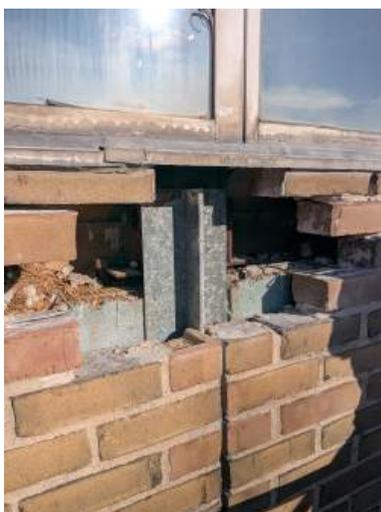
Investigative probes at the exterior walls confirmed the wall assembly is 6-inch nominal concrete block, 1-inch rigid EXP insulation, 1-inch air gap, and 3-3/8-inch brick veneer. Veneer both had corrugated anchors and wire ties. The brick is made by Claycraft in Ohio, is not through-colored and has a variety of clay body colors, which has resulted in the varying colors throughout the building. There were significant gaps and no seals around structural penetrations and varying anchorage conditions of roof structural elements bearing on the masonry wall. See the Structural Assessment for more information.

Figure 5 - South Wall Probe.

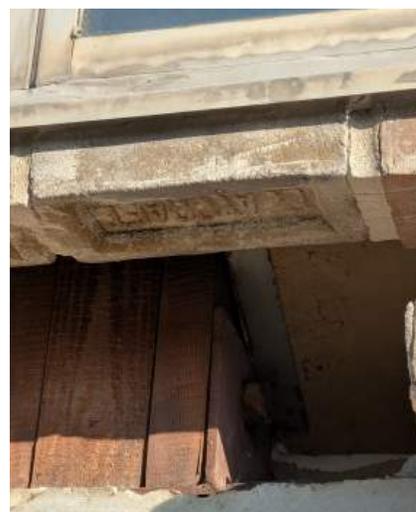
Figure 5 - West Wall Probe - Claycraft brick label.

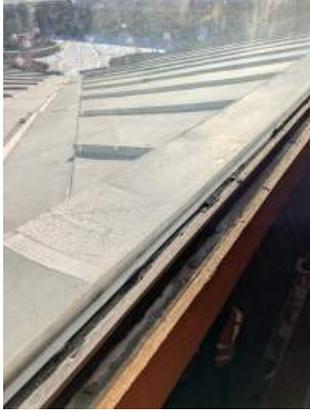
The upper clerestory windows on both the street and courtyard sides of the building have insulated glass. The street-facing clerestory windows have mirrored glass on the exterior side. On the courtyard side, gaps were observed where the windows meet the glulam roof girders.

**Figure 6** - Insulated Glass at Clerestory in Courtyard.

All glazing should be replaced with new insulated, low-E glazing. New aluminum window frames should be thermally broken; however, frames should match the existing in dimensions and profiles as closely as possible. New windows at the clerestories should be mirrored to match the existing. Considerations for high performance glazing systems should be reviewed and considered given sustainability goals.

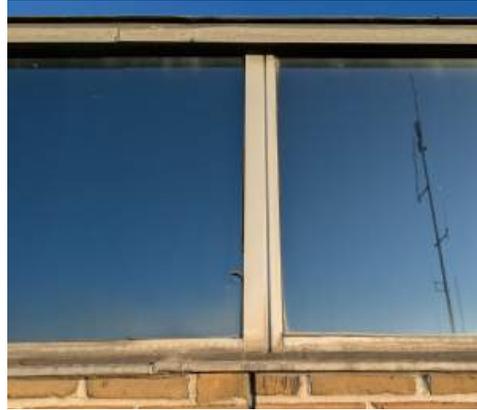
**Figure 7** - Typical Mirrored Glass at Exterior Perimeter Clerestory with areas of sealant failure.

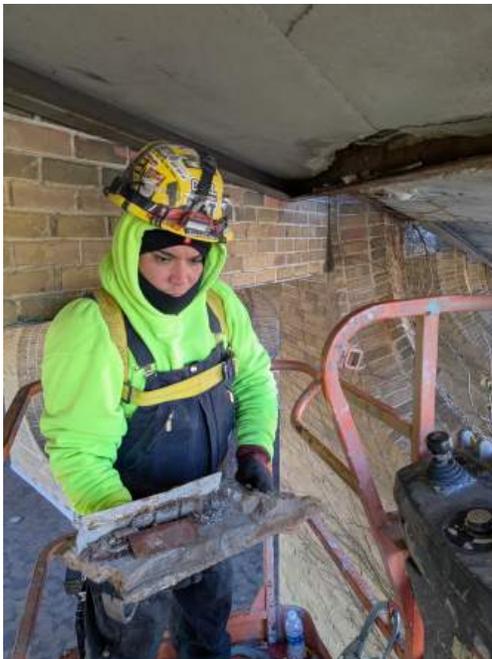
The reinforced concrete ramp that leads to the entrance to the council chamber is in poor condition. During the investigation, a large concrete spall was removed from the underside of the ramp. Several cracks were also found on the underside of the ramp. Because of this, the underside of the ramp was temporarily protected with plywood and 2x wood framing. In addition to the spalls and cracking, the steel connections to the exterior wall of the council chamber are corroded. The ramp also does not comply with ADA standards.

**Figure 8** - Large Spall at underside of Council Chamber Ramp.

The reinforced concrete ramp should be replaced in-kind. Given the ramp is a character defining feature, reconstructing it will require additional design studies to balance accessibility needs with the original design intent.

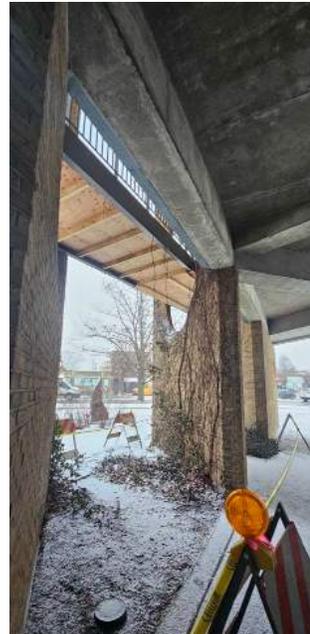
Upon review from lift, a large spall and cracking was observed along the Council Chambers exterior ramp. As directed by TyLin, the spall was removed and temporary protection at the underside of the slab was installed.

**Figure 9** - Temporary Repair at Ramp.

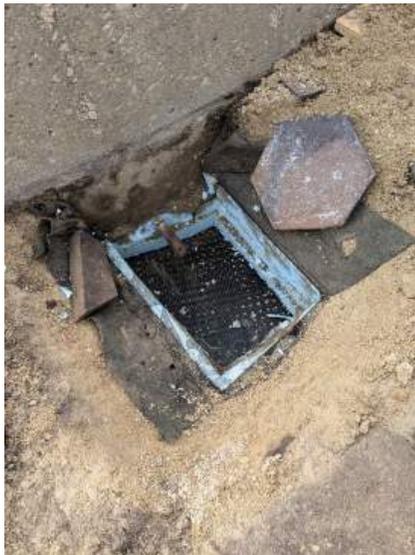
The courtyard pavers are in poor condition. The pavers are heaving and displaced in several locations. A probe at the courtyard paving revealed a waterproofing membrane above the concrete deck, drainage board, 3 layers of 2-inch of insulation, filter fabric, 6-inches of sand with a setting bed below the brick pavers.

**Figure 10** - Probe at Courtyard. Tool inserted to show the concrete planter sits above concrete deck.

All the pavers should be carefully removed and salvaged for reinstallation on a level surface. Select areas where there is known leaking below should be excavated down to the existing concrete deck and the waterproofing membrane should be replaced. Future work at the courtyard is dependent on the use requirements for the spaces below.

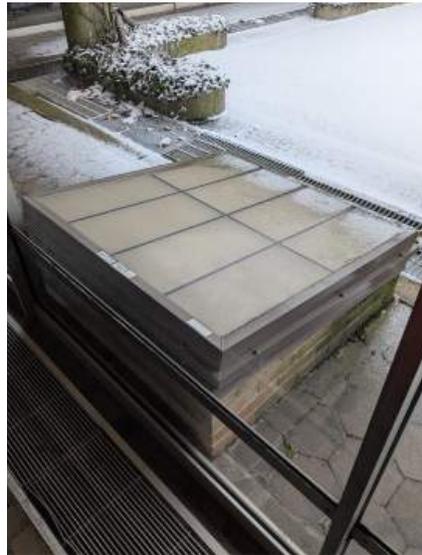
There are skylights at the perimeter of the courtyard that provide natural light to spaces in the basement below. These skylights are currently a safety hazard since there is no protection to prevent someone from falling through them.

**Figure 11** - Courtyard Skylight to Lower Level.

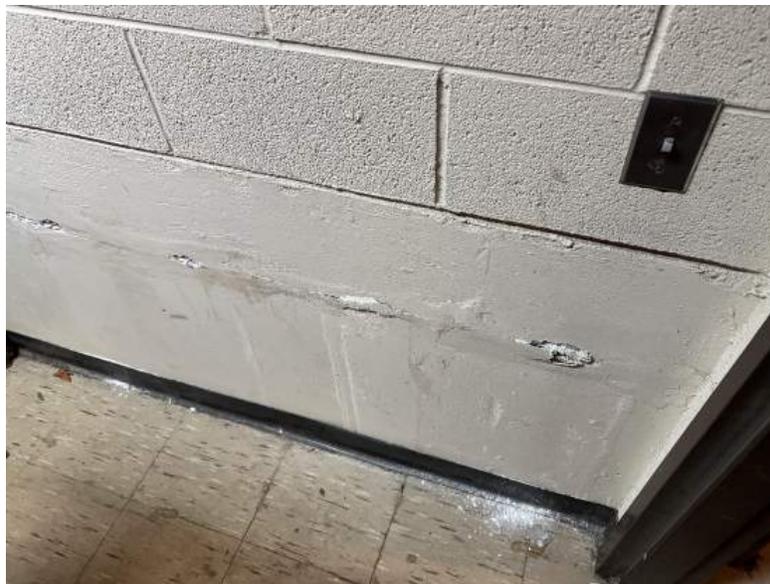
Localized areas of concrete deterioration were noted and are most likely due to moisture ingress. Along one elevation of the lower basement slab, there is excessive efflorescence at the control joint between the basement slab on grade and the foundation wall (see Figure 1). This is most likely due to lack of waterproofing on the exterior face of the building and moisture finding its way through the soil below the slab on grade to the joint. It could also be indicative of some abandoned or damaged utilities in this area so review of underground utilities in this space should be completed. A total of 29 ft, of the cold joint, should be raked out and repointed.

Figure 1 - Efflorescence at control joint at basement

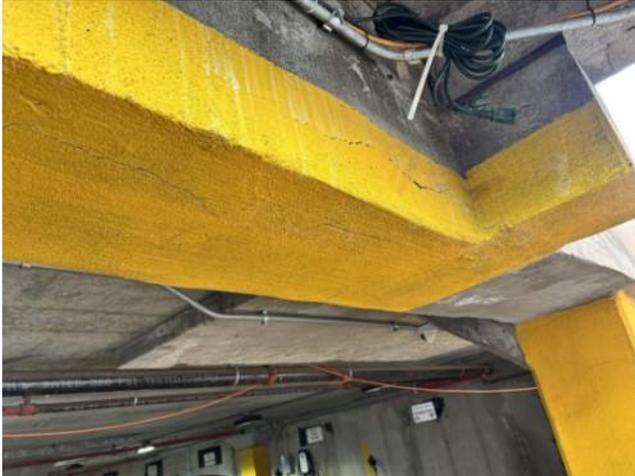
The bridge that pedestrians use to access the main entrance of the building was showing concrete cracks at the south end support. There were also areas showing concrete spalling and cracking. These conditions are most likely due to exposure to the elements and water finding its way to the control joints at either end of the bridge. As the water gets into the control joints, it can damage the perimeter framing elements (see Figure 2, Figure 3 and Figure 4). This amounts to approximately 30 SF of concrete patching for areas of spalling and cracking.

**Figure 2** - Loose concrete and cracking at Beam supporting South end of Bridge

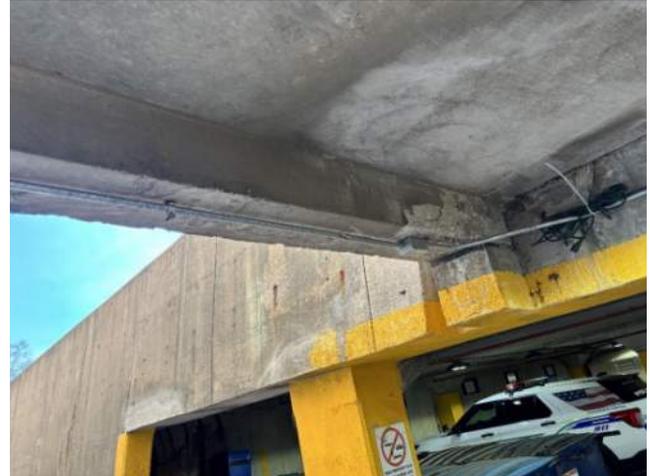
**Figure 3** - Concrete Cracking and Spalling at South end of Bridge

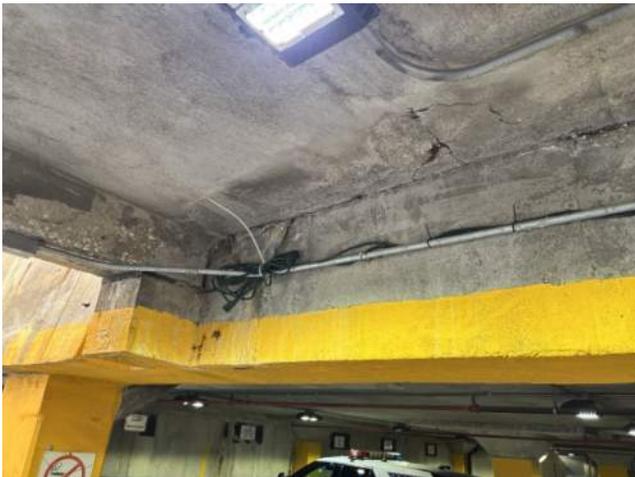
**Figure 4** - Loose Concrete and Spalling at Underside of Bridge

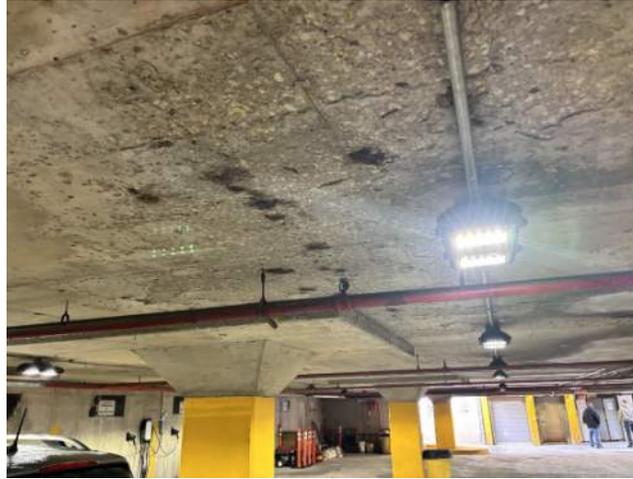
The slab underside of the underground parking garage also had cracking, spalling and loose concrete (See Figure 5). Many of these areas also showed exposed concrete aggregate. Previous repairs of the concrete were noticed, and approximately 160 SF of additional concrete repairs would be required. The entire underside should be sounded, the loose concrete removed, rebar cleaned and prepped and new concrete placed.

**Figure 5** - Loose Concrete and Spalling at Parking Garage

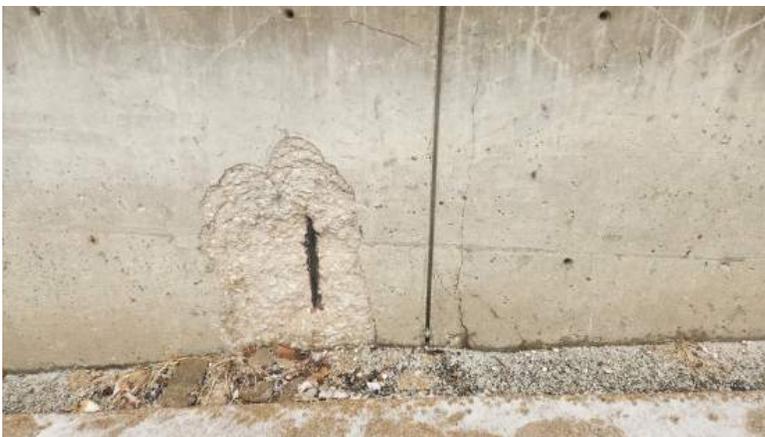
The ramp walls that lead down to the underground parking also had areas of spalling concrete and exposed rebar, both on the walls that abut the building (see Figure 6), and the retaining walls that abut the parking garage (see Figure 7). Similar to the bridge, the cracking and spalling in the walls are most likely due to exposure to the elements and water finding its way to the control joints. For both walls in total, approximately 60 SF of concrete repairs will be required, and 200 LF of cracks would need repair.

**Figure 6** - Concrete Spalling with Exposed Rebar at Wall Abutting Building

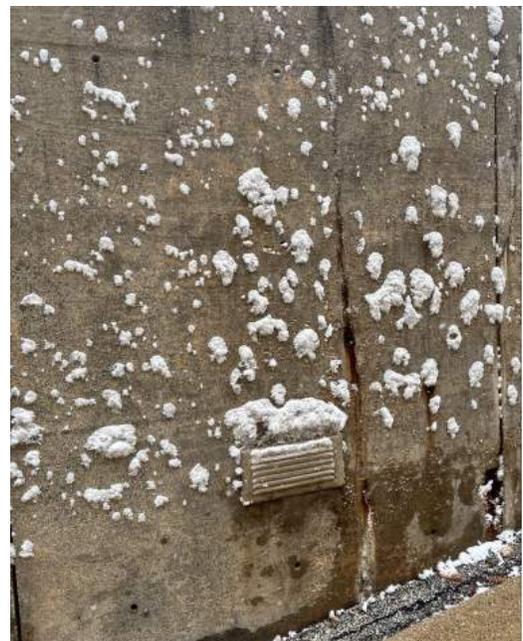
**Figure 7** - Concrete Cracking at Retaining Wall Abutting Parking Garage

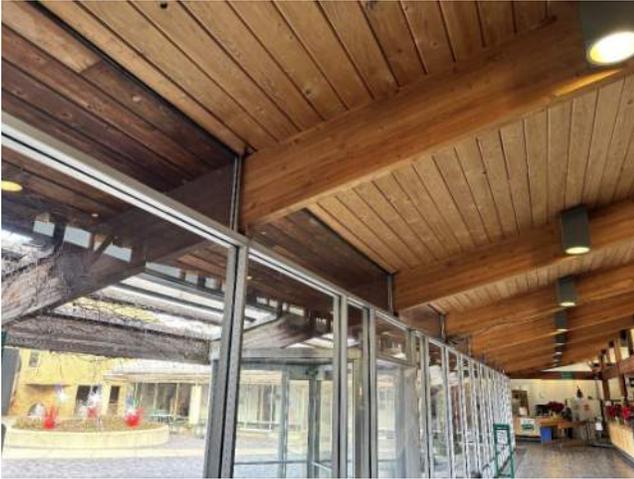
The superstructure for the building appears to be in fair to good condition. One area to note is the sloping glulam roof girders that continue past the glazing envelope and are exposed on the outside (See Figure 8). There is visible discoloration, checking, and other signs of deterioration where the glulams are unroofed beyond the interior courtyard's canopy (see Figure 9). In addition, the hips beams appear to have areas that have dried or have stained close to the envelope transition between interior and exterior (See Figure 10). The perimeter framing around the courtyard that is unroofed is in poor condition with many 4x4 purlins that have fallen or shifted off their intended location and/or rotted (see Figure 11).

Figure 8 - Glulam beams extending past glazing envelope

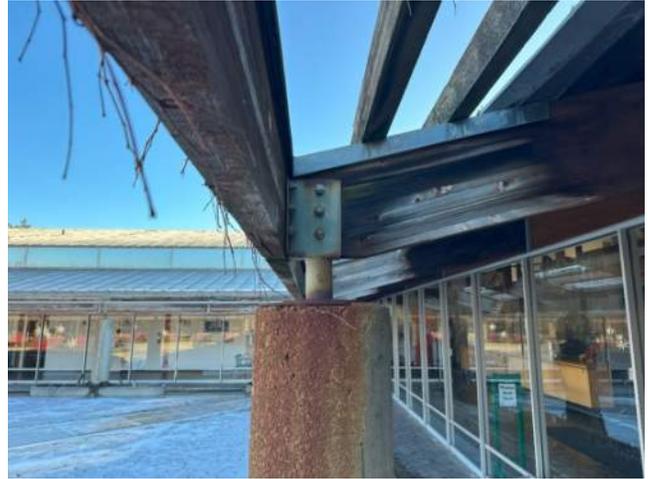
Figure 9 - Discoloration on Exterior Sloped Glulam Beams

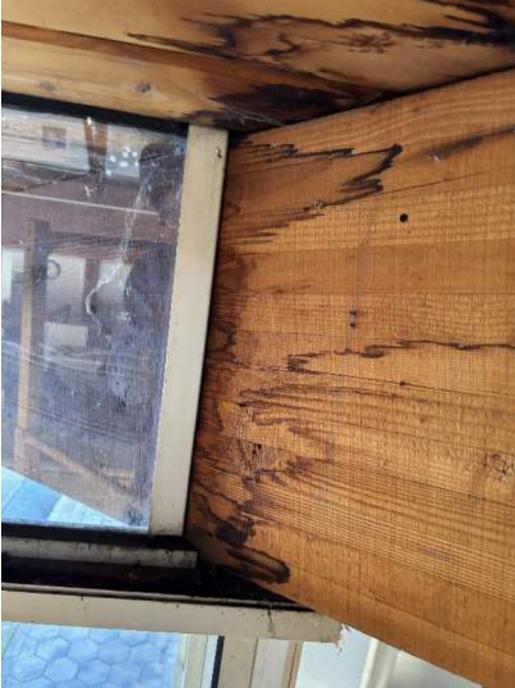
Figure 10 - Dried and Staining of Hip Beam

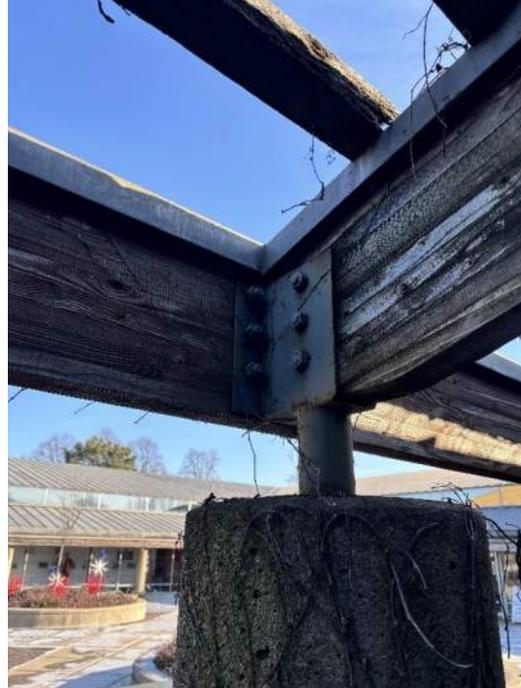
Figure 11 - Rotted Purlin at courtyard roof

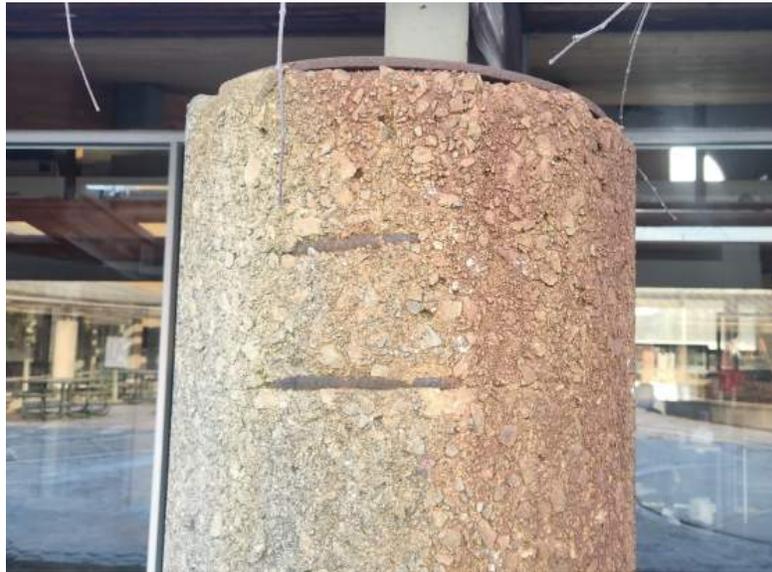
The exterior concrete columns, supporting the beams at the courtyard, had exposed rebar and concrete spalling (see Figure 12). Some columns also had exposed aggregate and reinforcement. There are a total of 13 columns in the courtyard and approximately 8 SF of concrete repair will be required.

**Figure 12** - Exposed Rebar on Courtyard Concrete Column

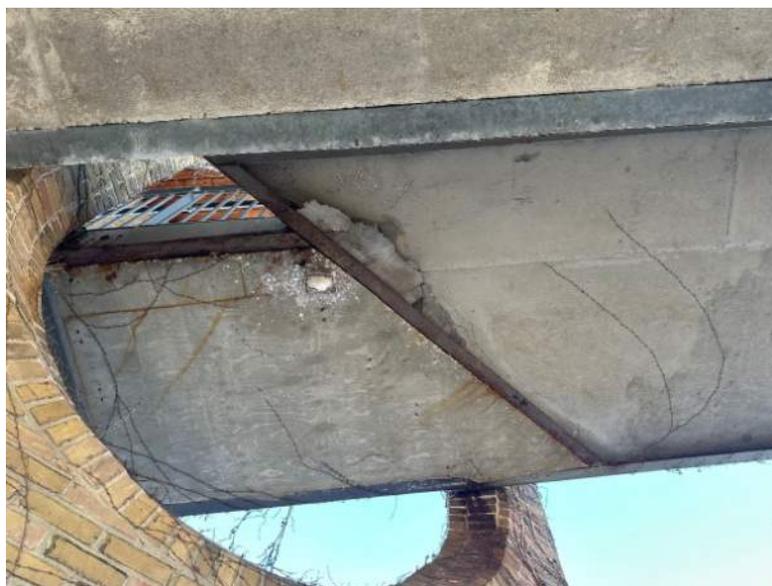
The ramp leading from the council chamber down to the interior courtyard has a moderate amount of concrete spalling and cracking, mostly at the doorway transition above (see Figure 13). There are other areas under the triangular corner of the council chamber with cracking, spalls and exposed rebar. This area has been temporarily shored but for full repairs, the concrete should be sounded, loose concrete removed, exposed rebar be cleaned and prepped, and the slab repatched. In addition, the steel framing elements, including the anchorage of the steel beams back to the masonry piers, should be cleaned, assessed and possibly retrofitted/repared and coated. This is approximately 80 SF of concrete repair, 35 LF of steel beam repair and 4 connection repairs.

**Figure 13** - Concrete Spalling on Underside of Ramp

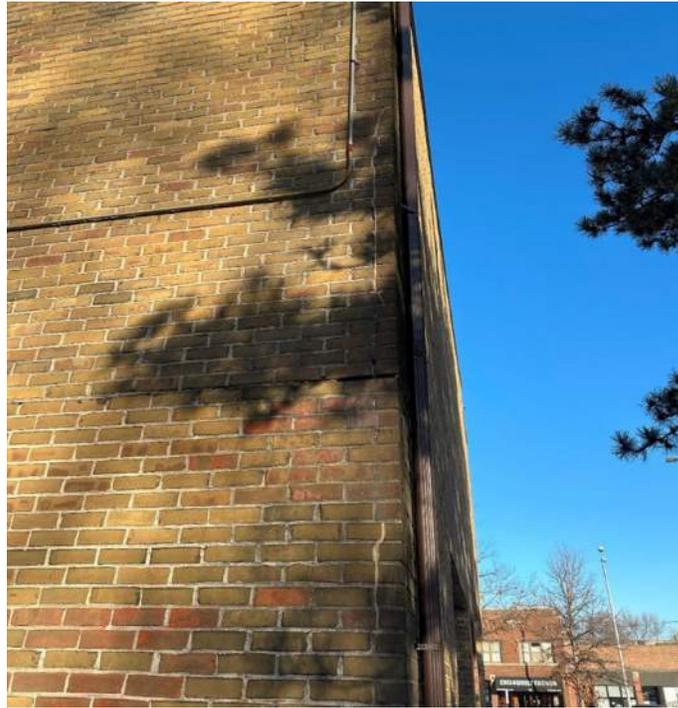
There are areas of brick veneer cracking around the building, mostly at corners where expansion joints in the brick are not present (see Figure 14).

**Figure 14** - Masonry Cracking at Southeast Corner of Council Chamber Building

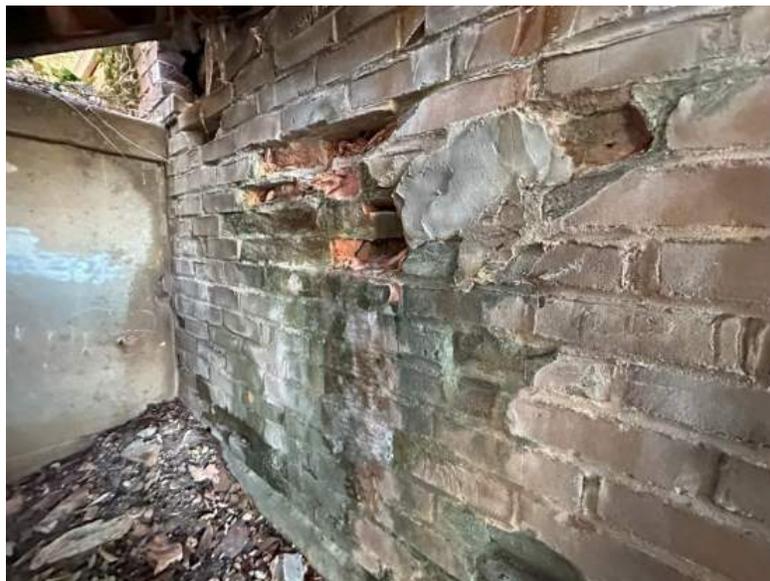
The exterior wall behind the southeast stair that leads from under the council chamber to the central courtyard is in particularly poor condition (see Figure 15). The brick is visibly damaged, with areas of broken and dislodged masonry and widescale efflorescence. Water is getting behind the veneer beneath this stair, freezing and causing internal pressure pushing the brick outward. This is the main corner where all the water from the courtyard and the building meet. Water removal must be studied to alleviate the water damage being caused at this corner. The brick will need to be removed, the concrete edge beam repatched and proper waterproofing be installed behind the brick rebuild.

**Figure 15** - Masonry Wall Damage Beneath Southeast Stair

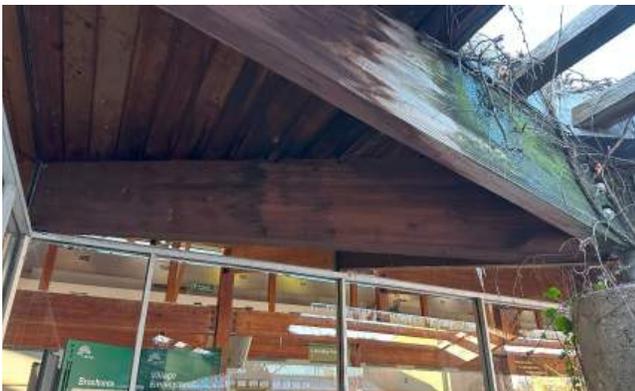
TYLin was able to review the interior wood roof framing up close via scaffolding. Particular attention was paid to the transition of the glulam roof girders from the interior of the space, through the glazing envelope and to the exterior courtyard. Up-close review showed the beams to be in fair condition despite areas of discoloration (see Figure 16). Both the interior and roofed exterior lengths of the beam were in good condition, while the portion of the beams that extend beyond the canopy roof are in fair condition (seen Figure 17). At the exterior end bearing support connections, it was observed that some beams show some sign or deterioration and splitting at the exterior end bearing support connections (see Figure 18). Also, the edge beams were observed to show signs of deterioration and splitting (see Figure 19). It is recommended that the edge beams should be removed and replaced due to their poor condition.

Figure 16 - Discoloration at Hip Beams on Exterior

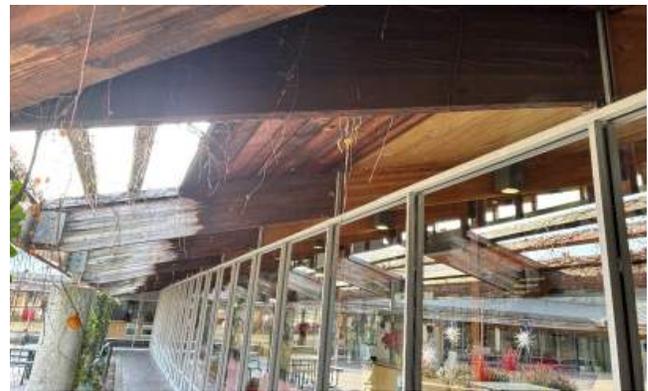
Figure 17 - Glulam Beam Conditions at Transition From Exterior (Left) to Interior (right)

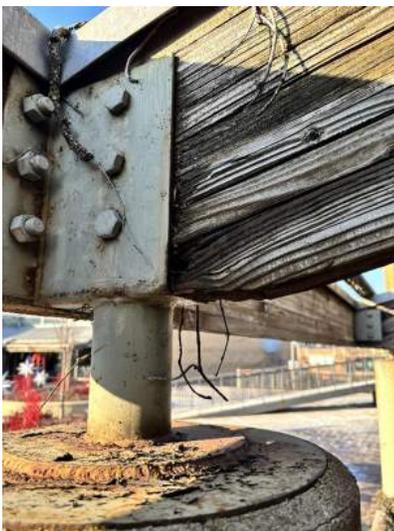
Figure 18 - Beam deterioration and splitting at exterior end supports

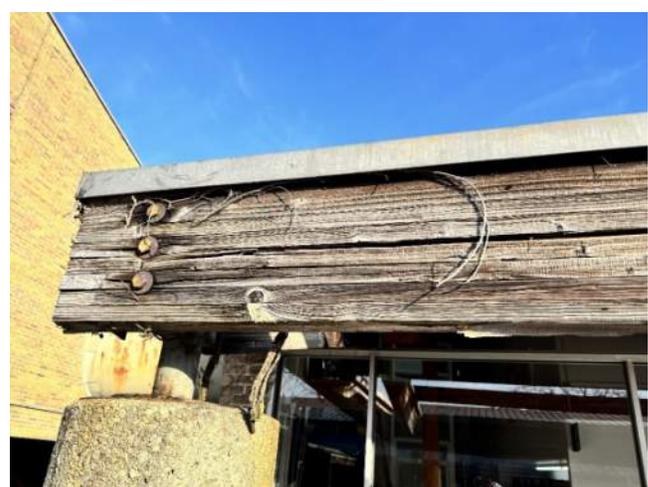
Figure 19 - Splitting of Edge beam at courtyard roof

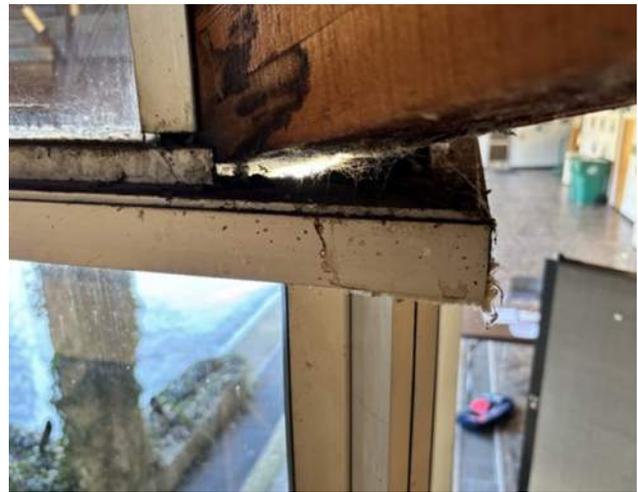
The detail for how the glulam members continues through the glazing envelope differs from what was actually installed and creates a weak point in the envelope's thermal performances. The original drawings show the glulam anchored down to the top of the glazing mullion via a steel shoe which is then filled with a neoprene gasket to create a watertight and weathertight seal. No such shoe and gasket were installed, and cold air could be felt coming through the three corners of the building where the hip beams pass across the envelope (see Figure 20). While not a structural concern, this detail needs to be re-evaluated and retrofitted to improve the thermal performance of the building envelope.

**Figure 20** - Corner Hip Beam at Glazing Envelope

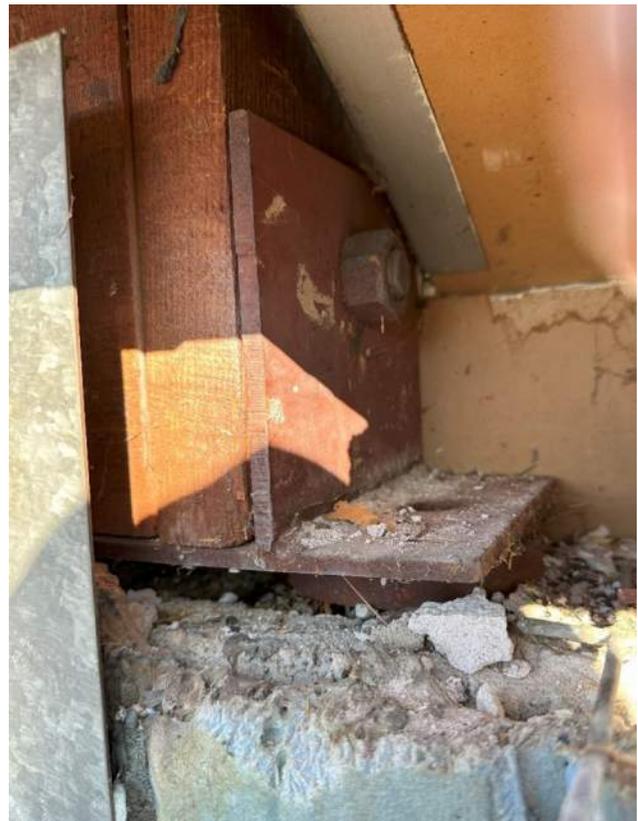
A probe was performed at the base of the clerestory along the masonry exterior to confirm the envelope construction as well as review how the roof glulams are supported on the perimeter walls. The probe revealed a 6" concrete block wall, 1" insulation, 1" air gap and 4" brick veneer wall construction in keeping with the original drawings. At the base of the clerestory, a wood glulam stub post bears on the block wall and supports the roof glulam element that frames into the post at the top of the clerestory. The first probe revealed an install that differed from the original drawings, most likely due to constructability issues. The wood post sits in a steel shoe that is supported to be anchored down to the masonry wall. The probe revealed the shoe elevated 1" above the masonry wall and shimmed down to the masonry wall with a series of metal shims and washers. The probe also revealed the absence of anchorage down to the wall and the base of the shoe hovering above the wall without any grout to provide adequate bearing (See Figure 21) The contractor has since grouted the base plate solid to provide continuous bearing for the shoe element.

**Figure 21** - Base Shoe Hovering Above Masonry Wall without Anchorage

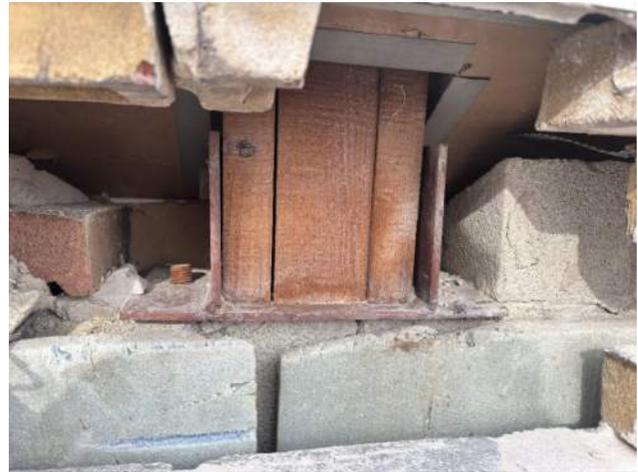
A secondary location was opened up to confirm if this was a consistent installation error. The second probe location revealed a detail more aligned with the original drawing detail: a shoe that sits consistently on the top of the masonry wall and is anchored down with bolts that continue into the masonry wall. However, one of the anchor bolts was missing and the locking nut on the installed anchor was missing, as well (see Figure 22).

**Figure 22** - Top clear story post base with missing nut on anchor bolt

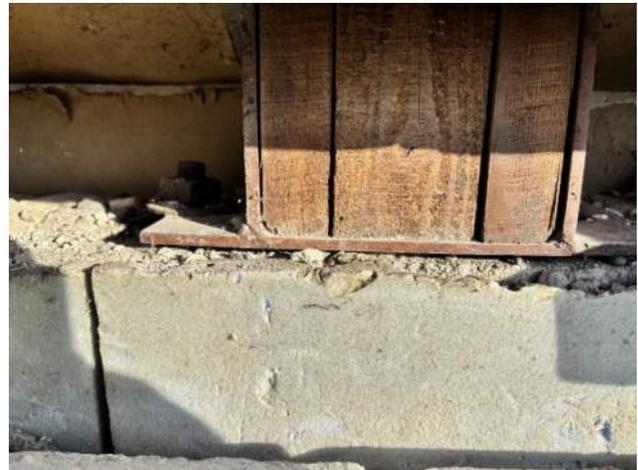
TYLIN was able to investigate a third location and confirm the installation of the post base connection. This probe revealed a similar condition as the first probe. The base connection was installed with only one anchor with a nut and washer plate, located outside the base plate. It seems like the anchor is meant to clamp down the base plate. However, the base plate was found to be bearing on the masonry wall, and no gap was noticed (see Figure 23). These connections must be exposed and repaired around the building.

**Figure 23** - Post base with missing anchor bolt and anchor bolt installed outside of base plate

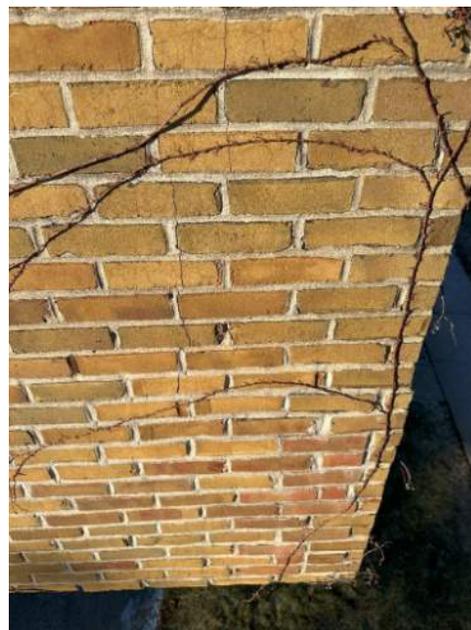
The remainder of the exterior was reviewed via a boom lift which allowed the design team to perform localized tactile review of the masonry veneer. The most brick veneer damage noted was around the chamber council façade. There is an area of brick displacement and open mortar joints over the circular window, aligned with where the roof transitions toward the northeast cantilever corner. The small lower roof at this corner was covered in ice which alludes to poor water drainage off that roof. The water may be finding its way along this wall transition back behind the brick veneer. In addition, two large vertical cracks have formed on either side of the cantilevered triangular end of the council building (see Figure 24). This is most likely due to excessive deflection (more than what was anticipated in design) at the corner of the building. These areas will require brick removal and replacement.

**Figure 24** - Vertical Cracks in Masonry on East Face of Council Chamber Triangular Cantilever

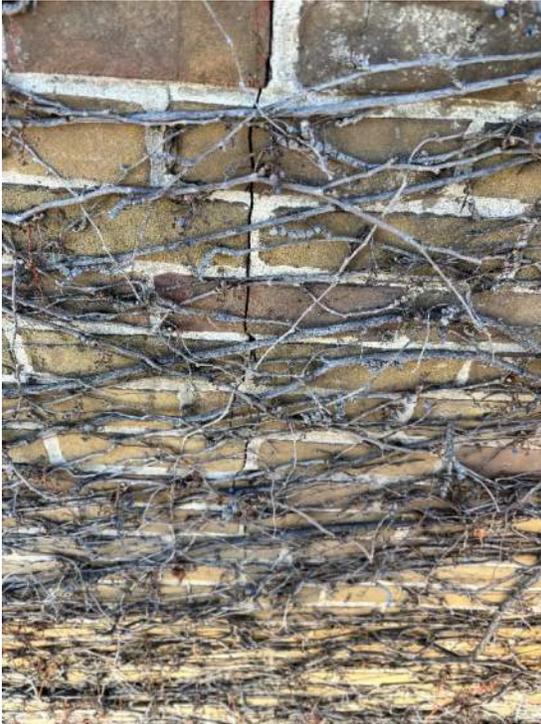
TYLIN inspected the brick veneer of the triangular shape chimney structure, located at the Northwest corner of the building, was observed to have cracks on the Southeast and Northwest face of the chimney, and larger cracks and brick bulging outward on the Southeast face of the chimney (see Figure 25, Figure 26 and Figure 27).

**Figure 25** - Brick veneer cracking at Northwest face of chimney structure

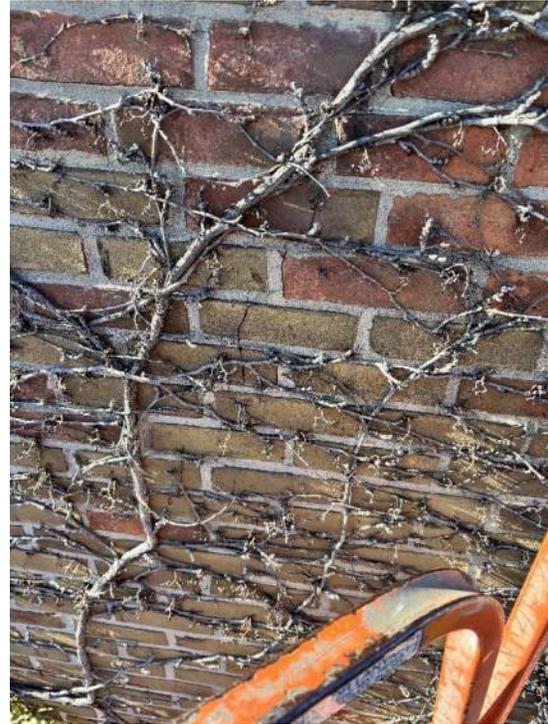
**Figure 26** - Brick veneer cracking at Southeast face of chimney structure

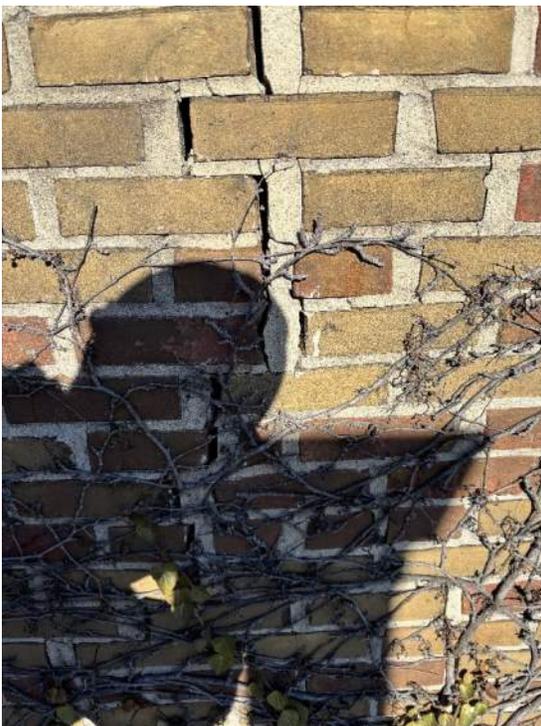
**Figure 27** - Brick veneer bulging outward and cracking at Southwest face of chimney structure
