## THE VILLAGE OF OAK PARK PARKING STRUCTURES

OAK PARK, ILLINOIS

WRC PROJECT NO. 31-8130.00  
MAY 2017

## CONDITION ASSESSMENT OF THREE PARKING STRUCTURES

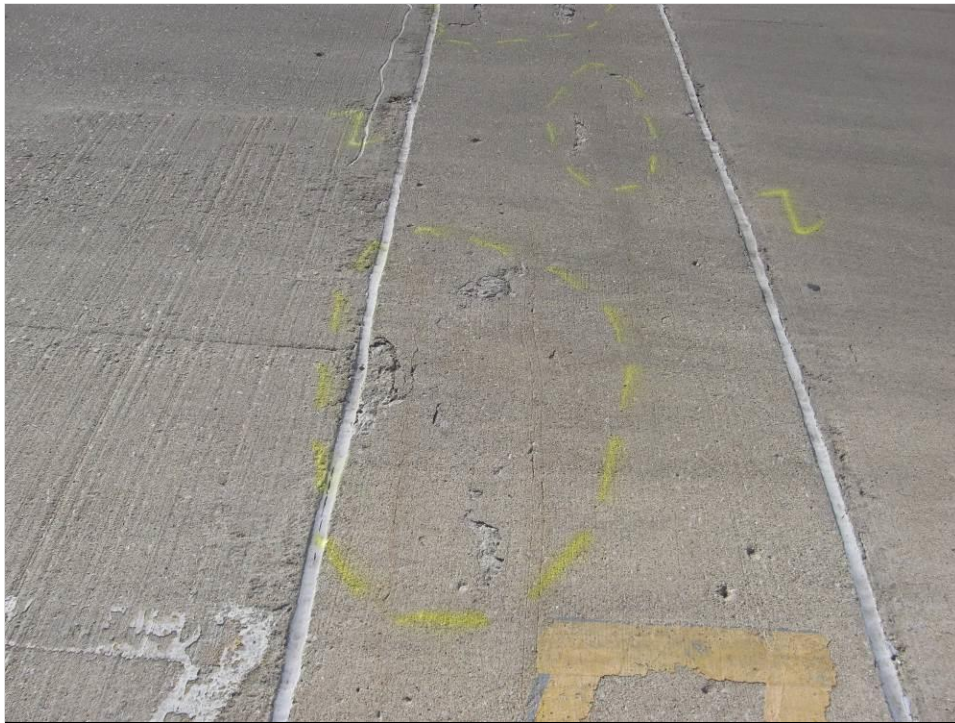
Photo 1 – Typical concrete delamination and cracking in floor slabs at pour strips.

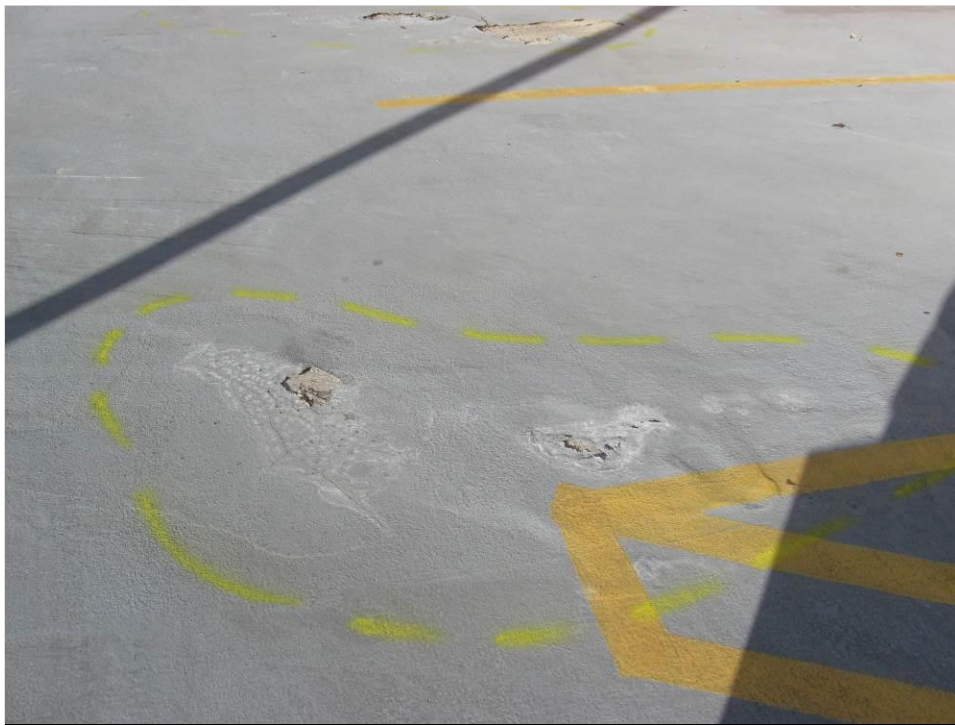
Photo 2 – Concrete deterioration in floor slab under traffic topping.

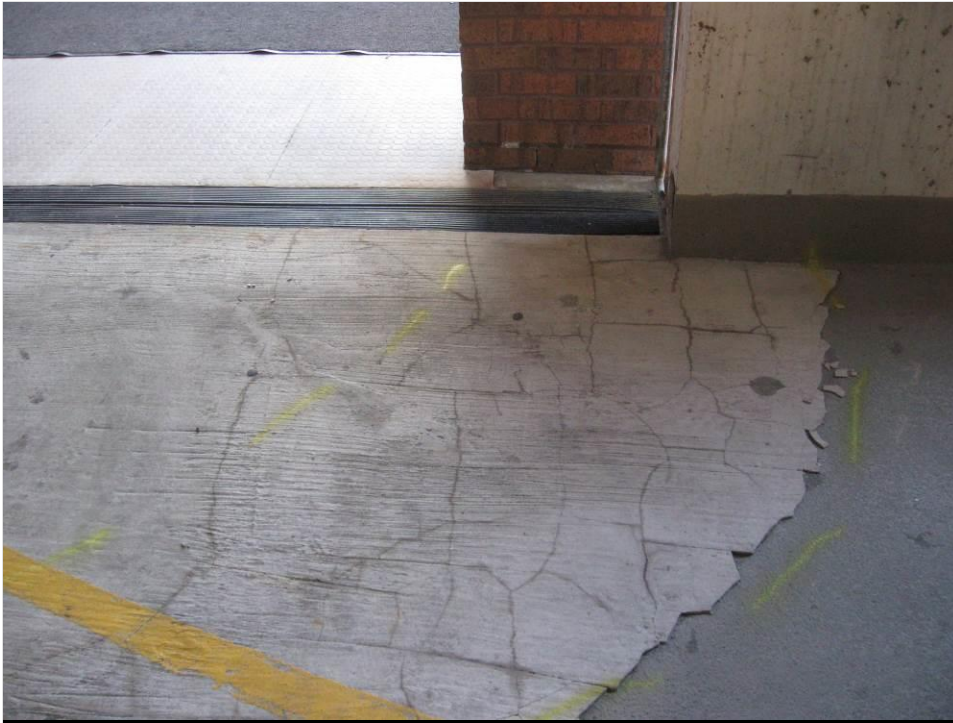
Photo 3 – Floor slab deterioration at entrance to elevator tower.

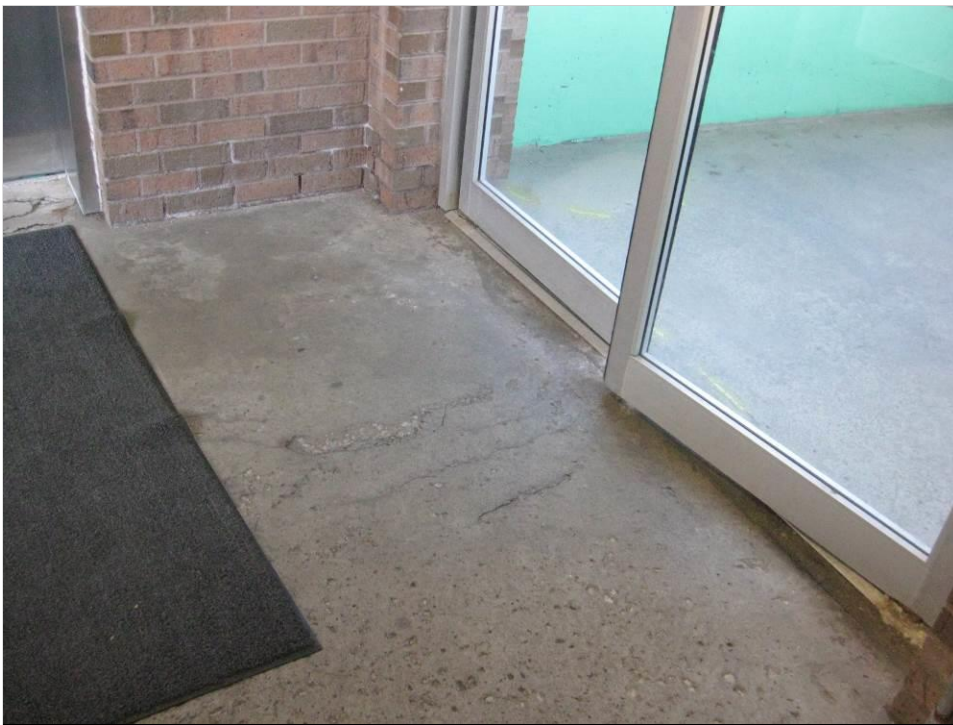
Photo 4 – Floor slab deterioration within stair/elevator tower.

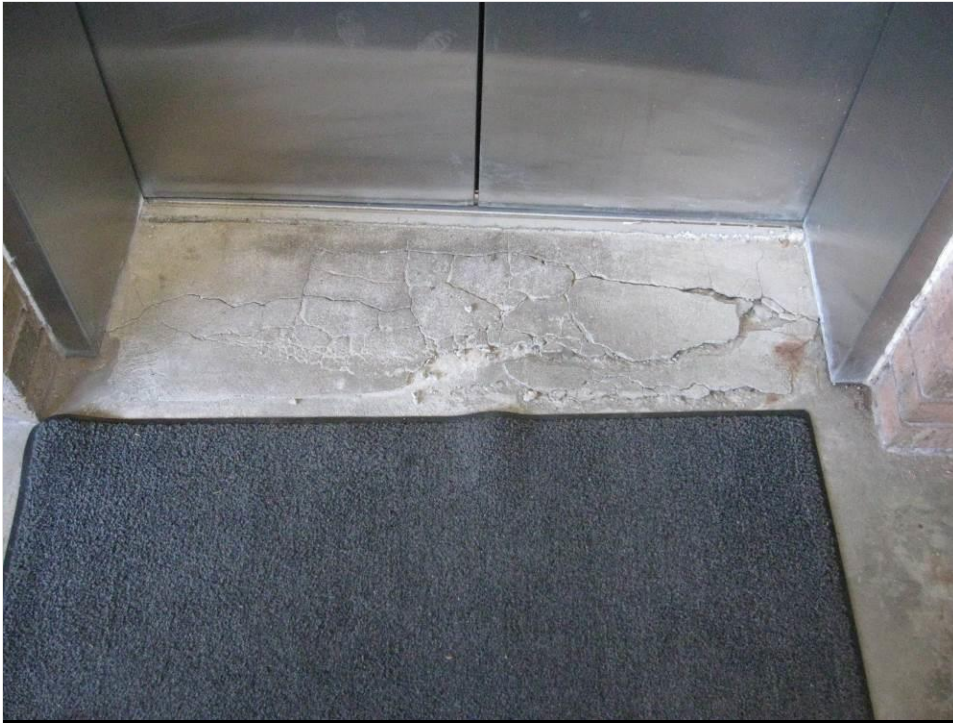
Photo 5 – Floor slab deterioration at elevator landing.

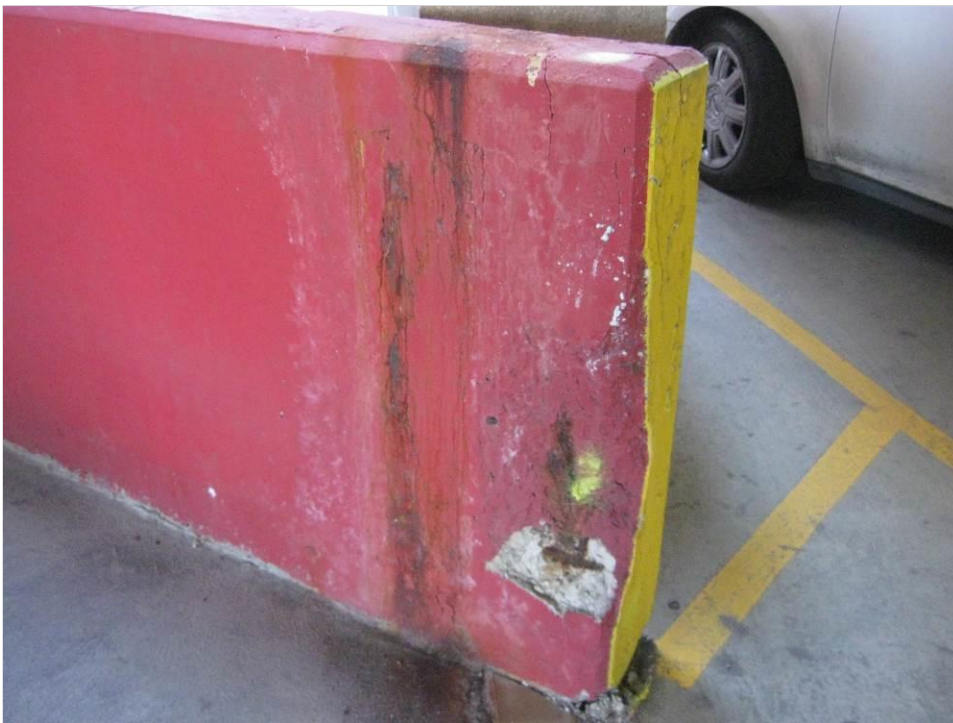
Photo 6 – Typical wall deterioration.

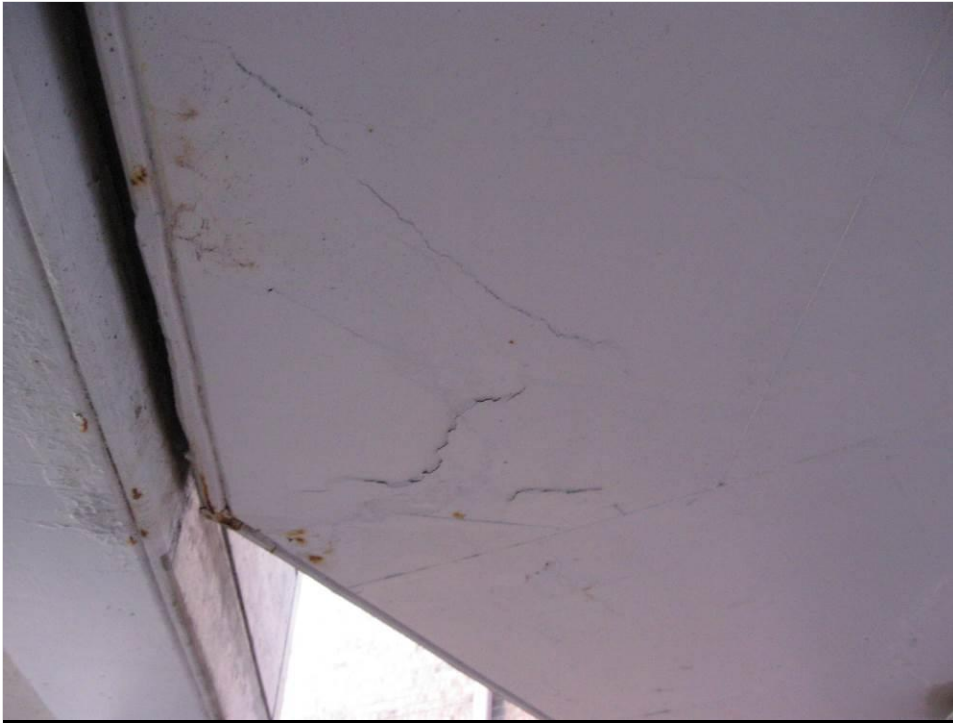
Photo 7 – Typical ceiling delamination.

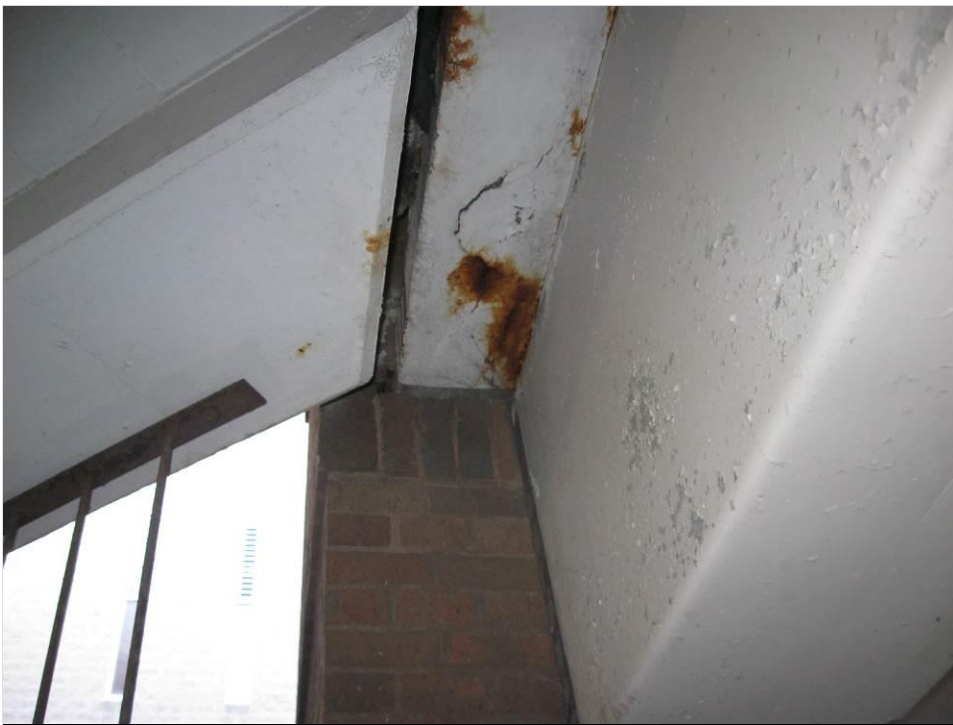
Photo 8 – Typical delaminated beam at stair tower.

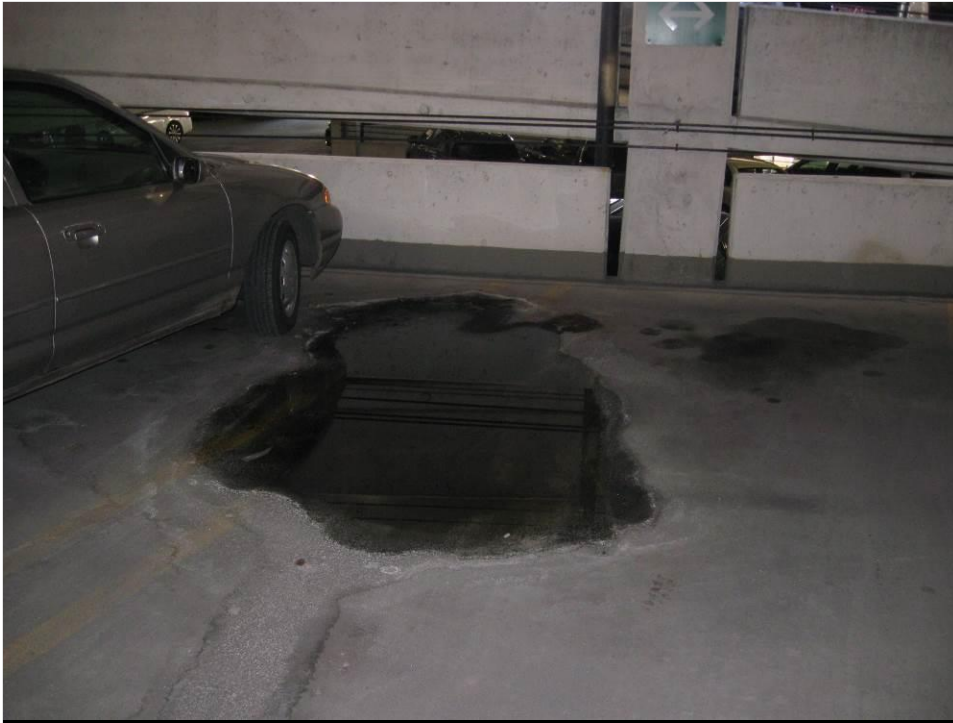
Photo 11 – Area of ponding water of supported slab.

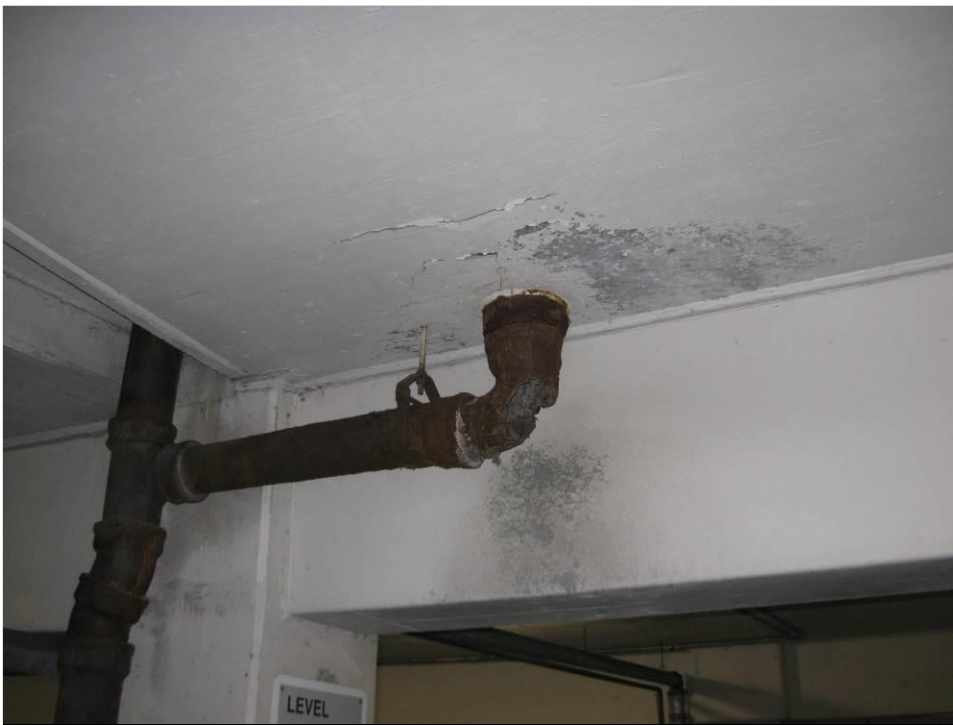
Photo 12 – Broken elbow on floor drain.

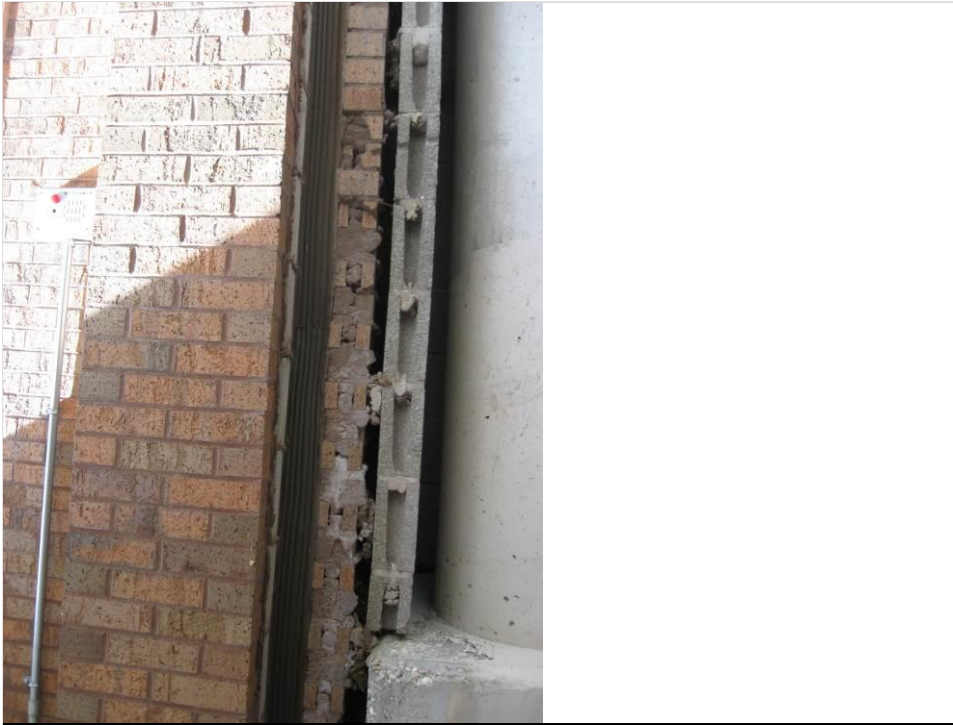
Photo 13 – Open joint at elevator tower.

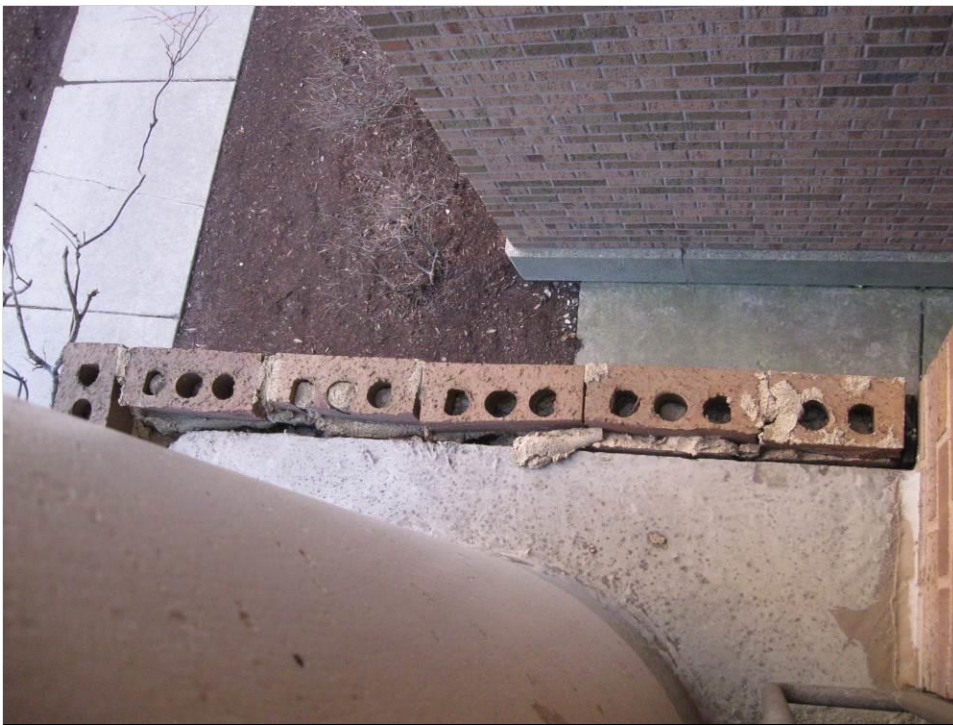
Photo 14 – Masonry wall without any cap stones.

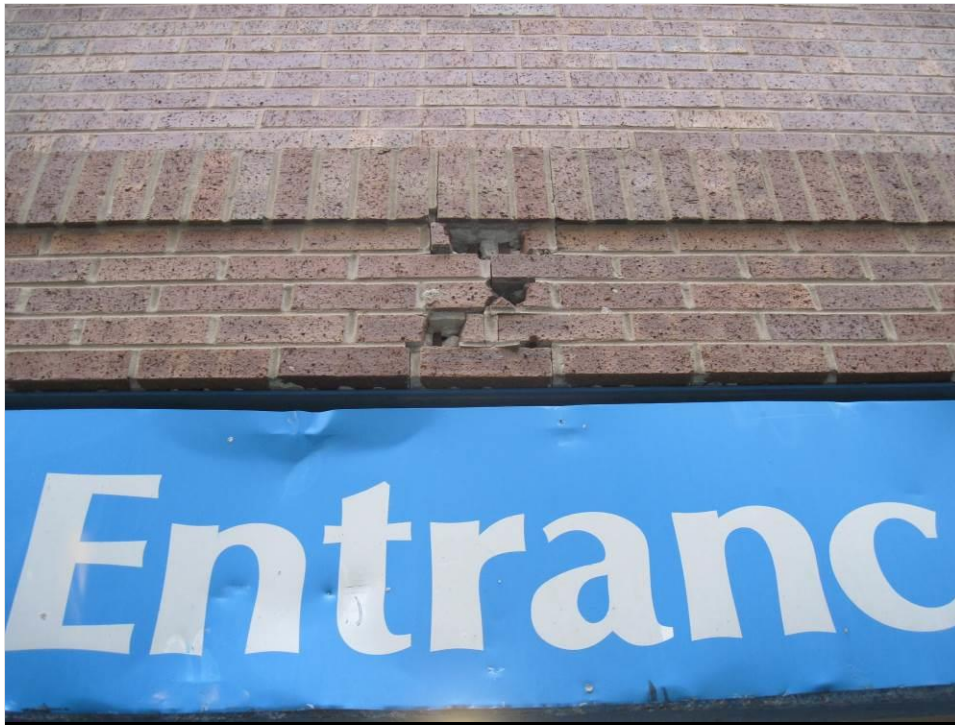
Photo 15 – Damaged masonry façade at entrance.

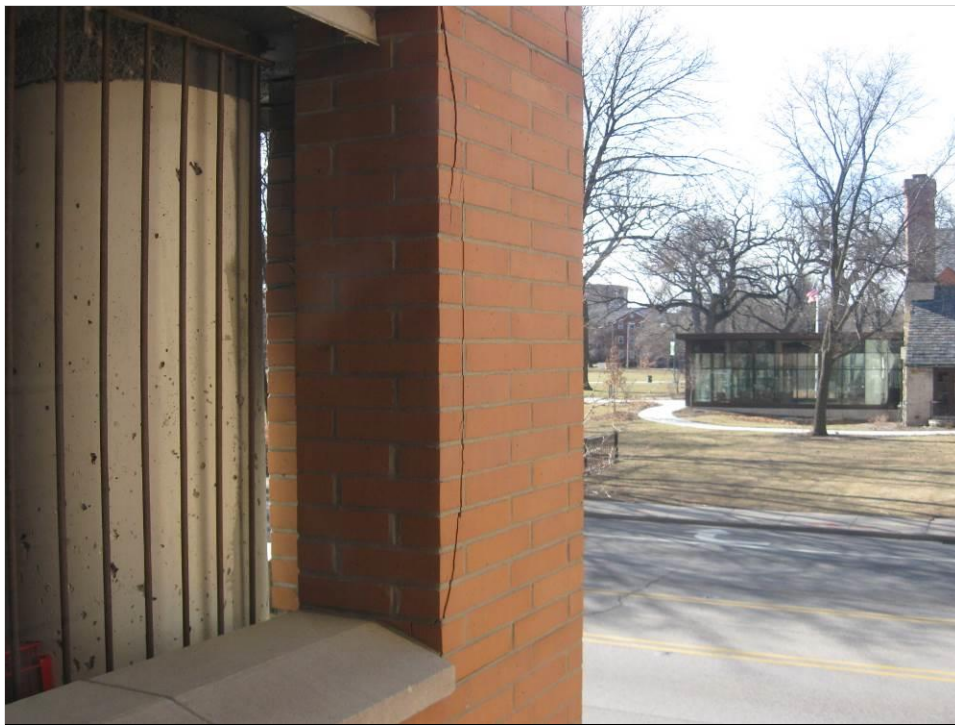
Photo 16 – Crack in masonry façade.

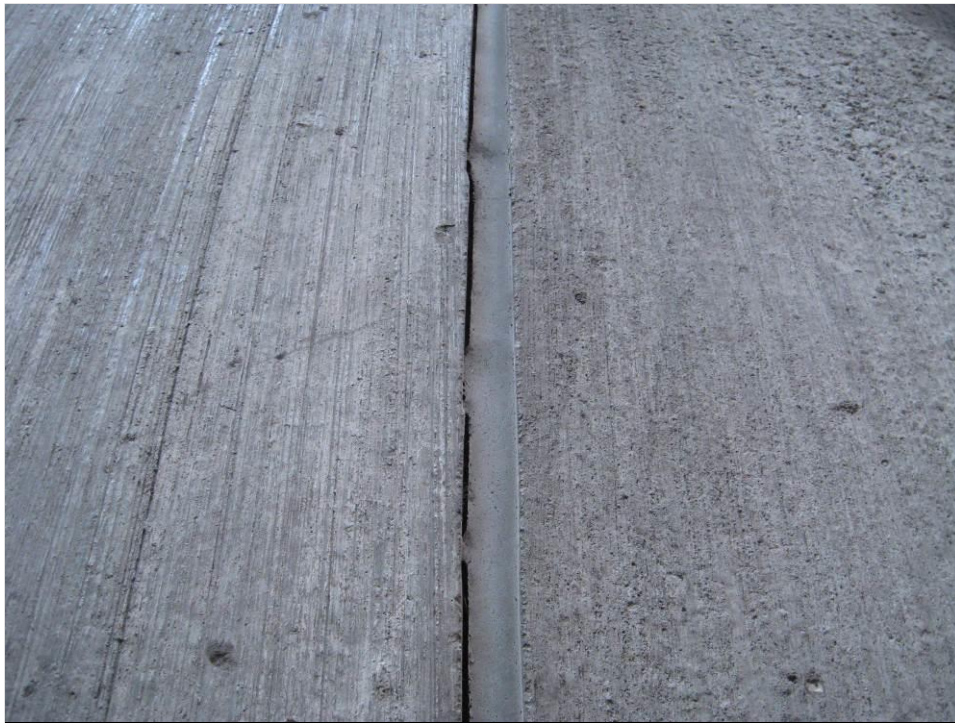
Photo 1 – Adhesion failure of tee-to-tee joint sealant.

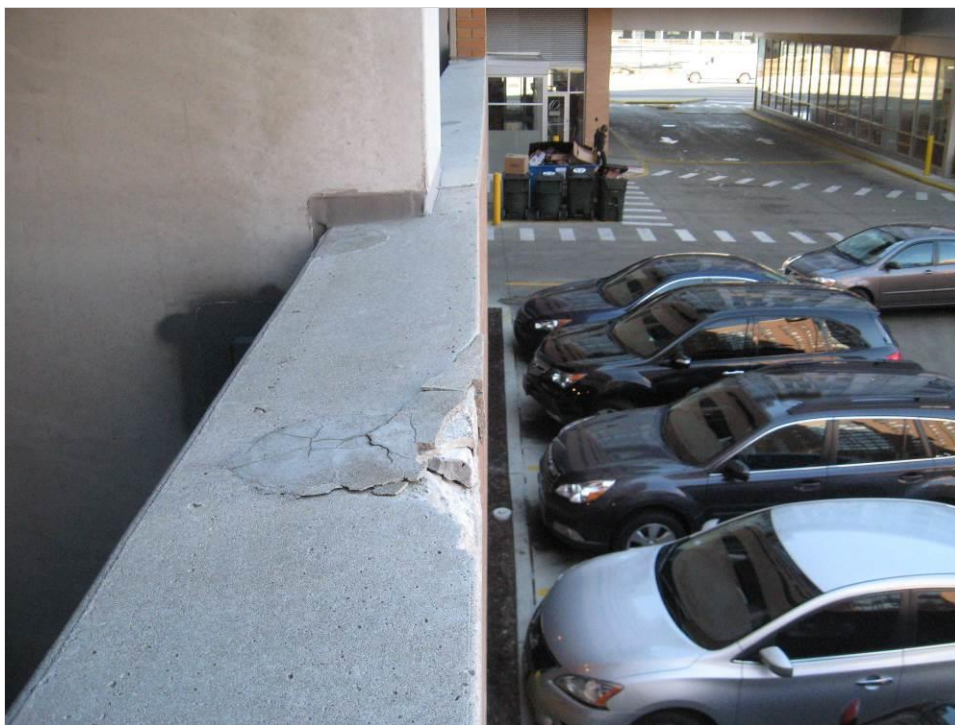
Photo 2 – Minor deterioration on façade wall.

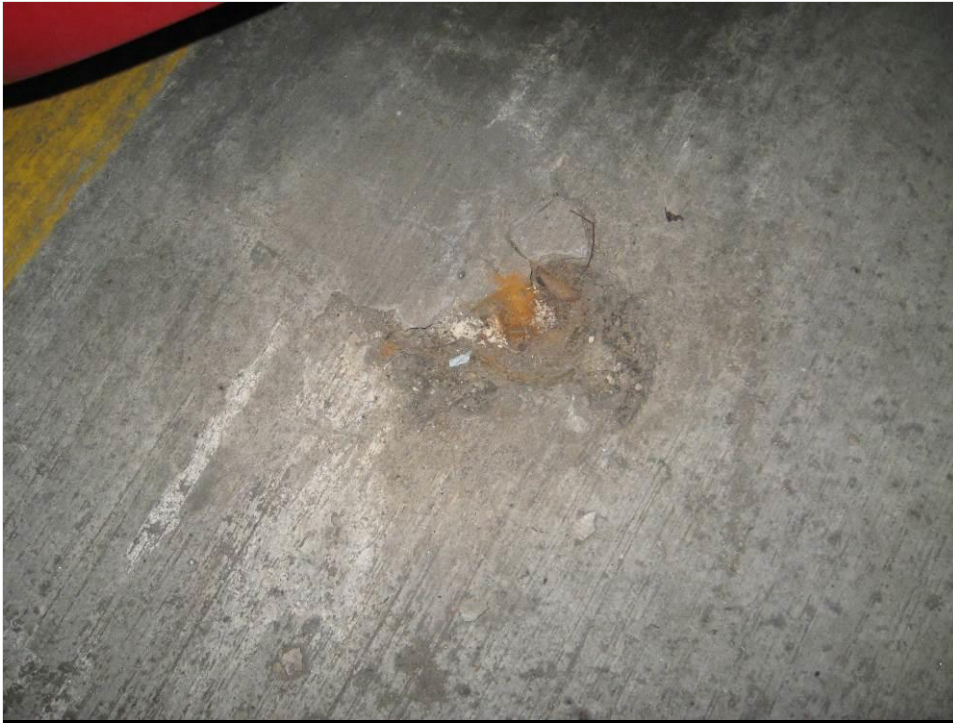
Photo 3 – Minor floor spall of precast tee.

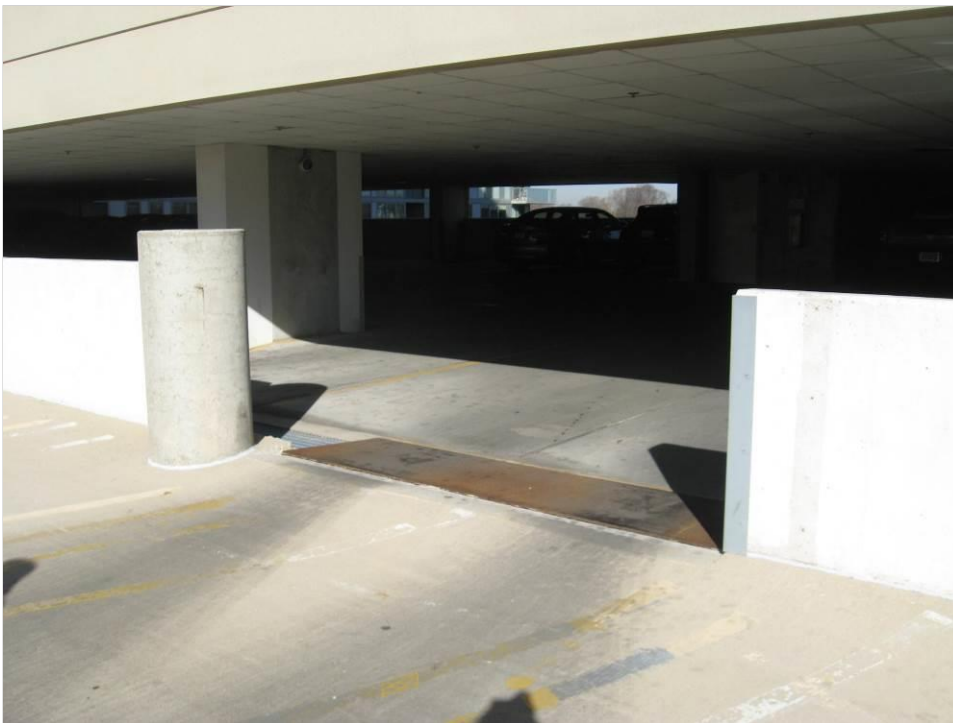
Photo 4 – Open gap area between both structures.

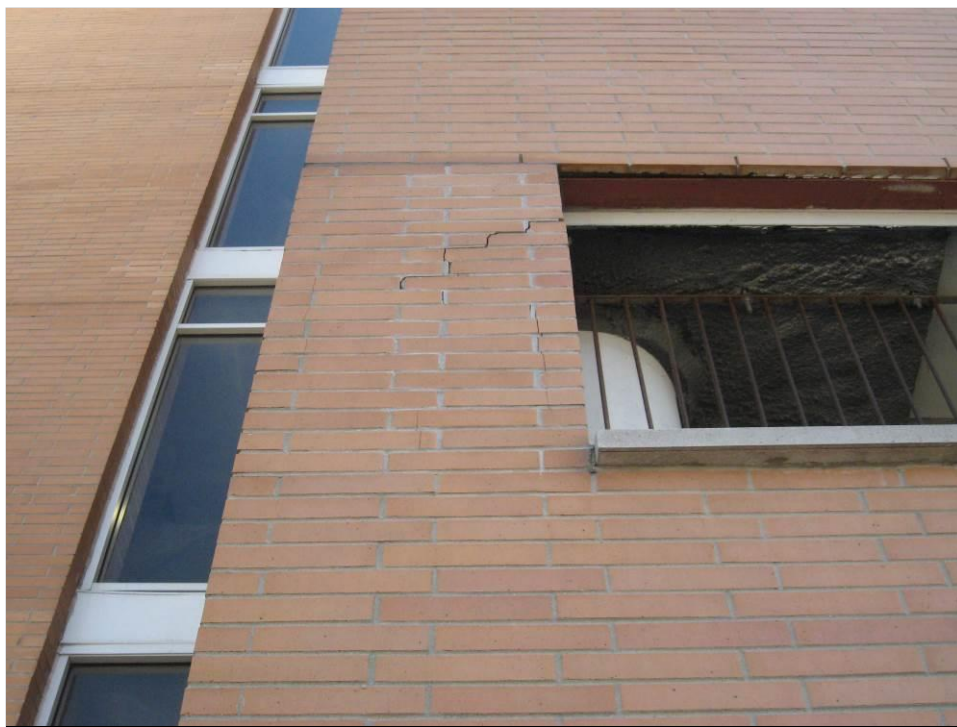
Photo 5 – Crack in masonry on façade.

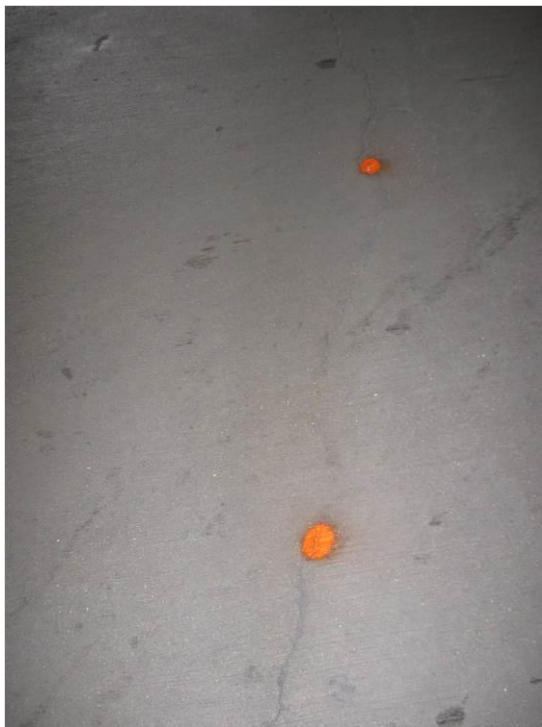
Photo 2 – Typical random floor crack in floor slab.

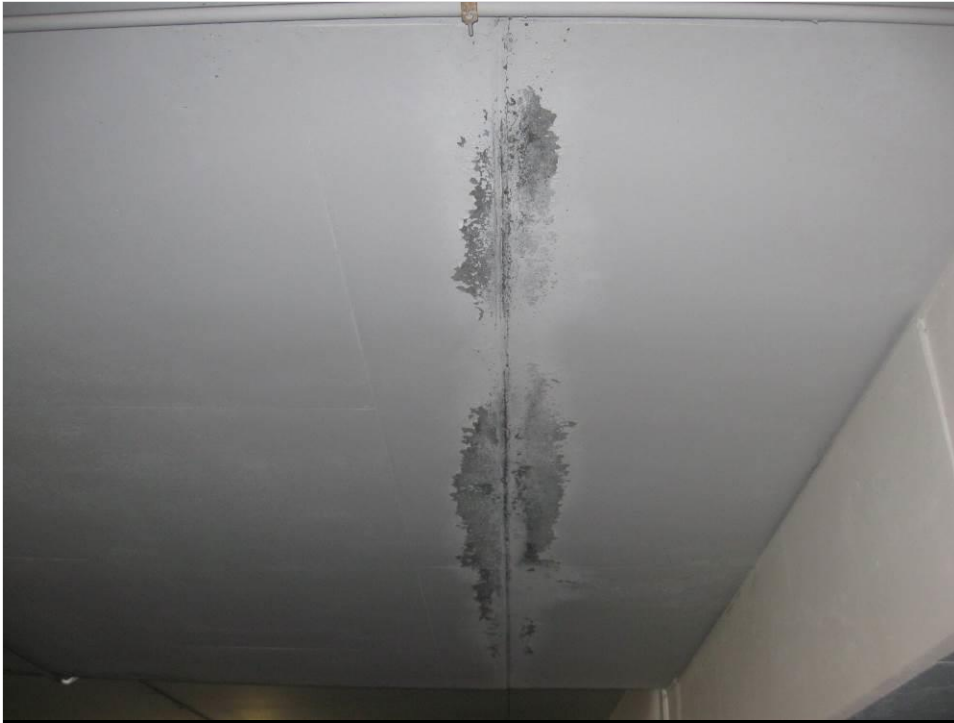
Photo 3 – Active leaking construction joint seen from below slab.

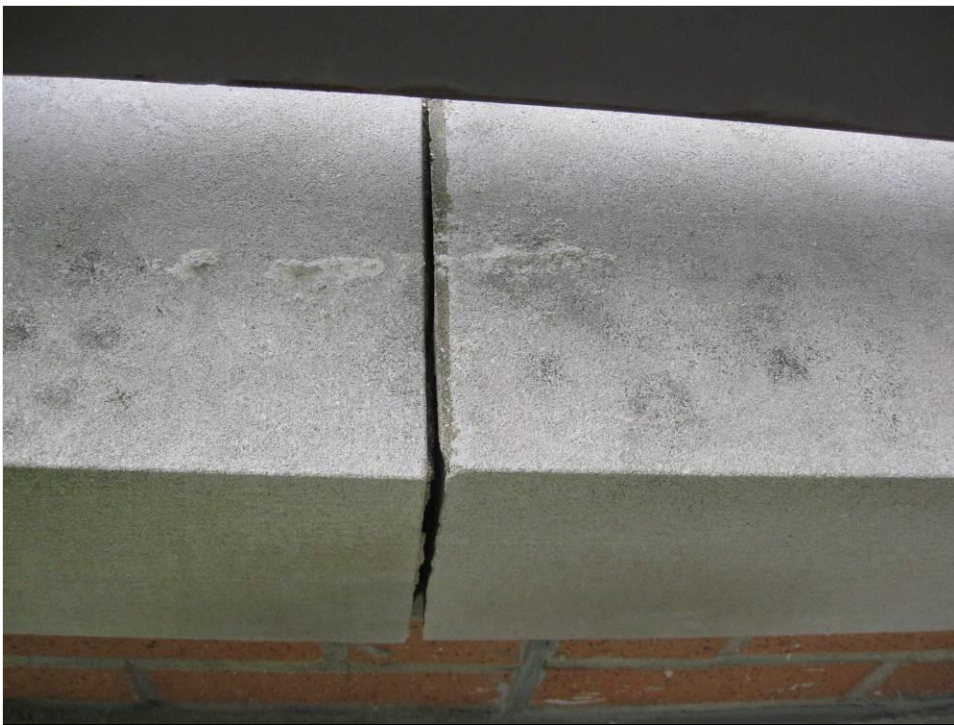
Photo 4 – Typical severely deteriorated mortar joint on cap stone.

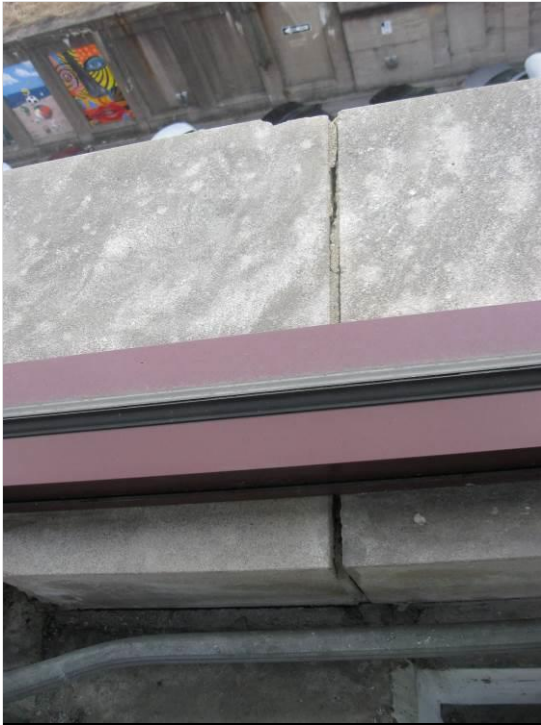
Photo 5 – Severely deteriorated mortar joint under window mullion on stair tower.

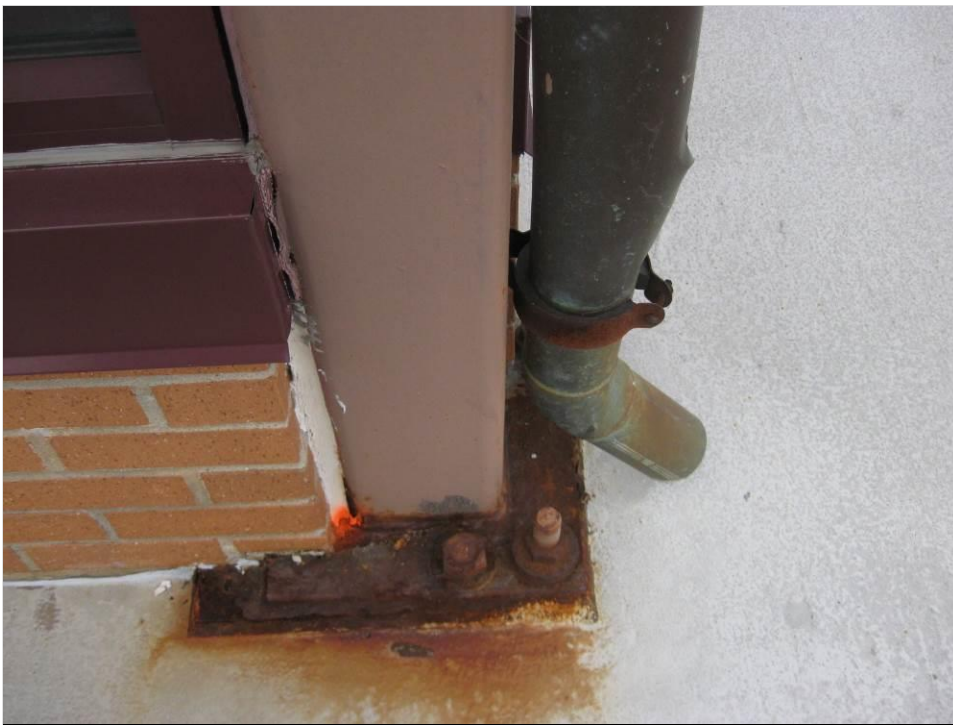
Photo 6 – Severely deteriorated vertical joint sealant on stair/elevator tower.

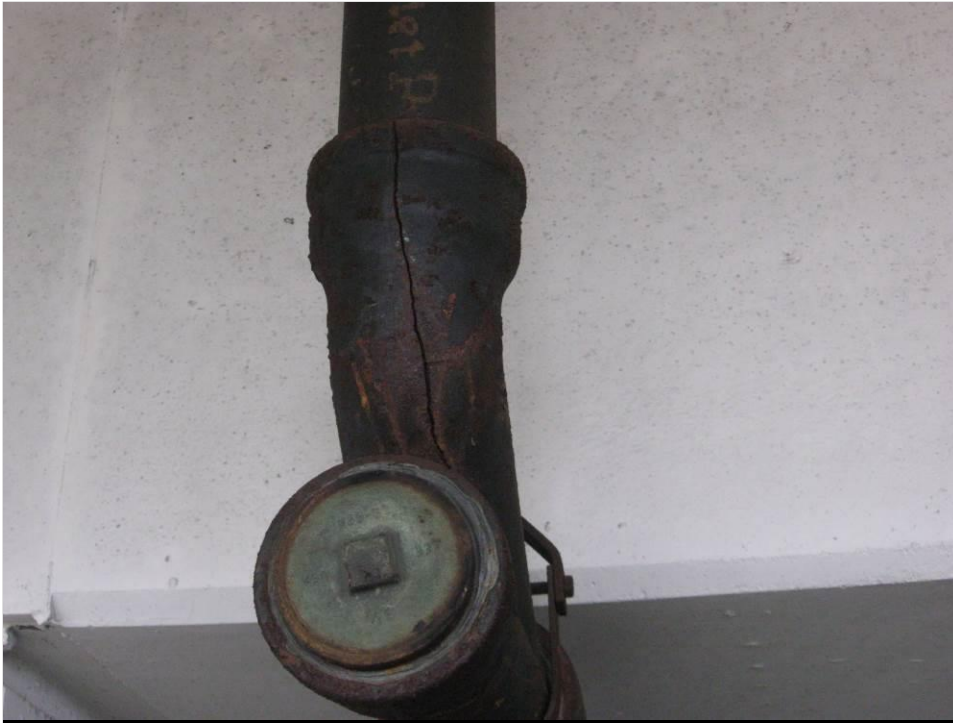
Photo 9 – Crack in drain pipe.

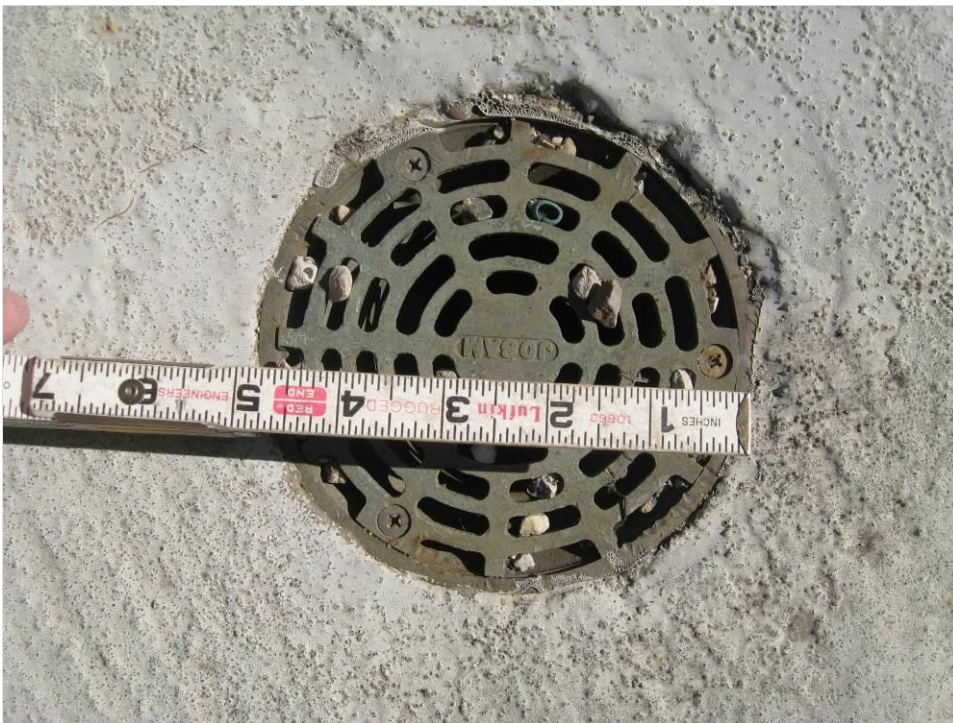
Photo 10 – typical inadequate size floor drain.

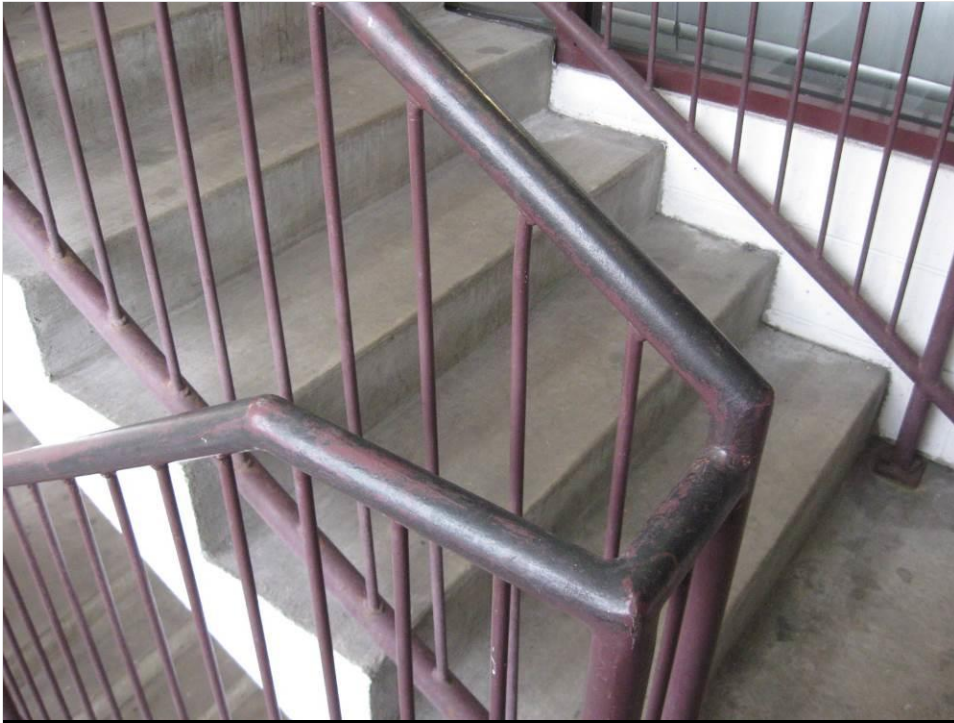
Photo 11 – Worn off paint on stair tower handrails.

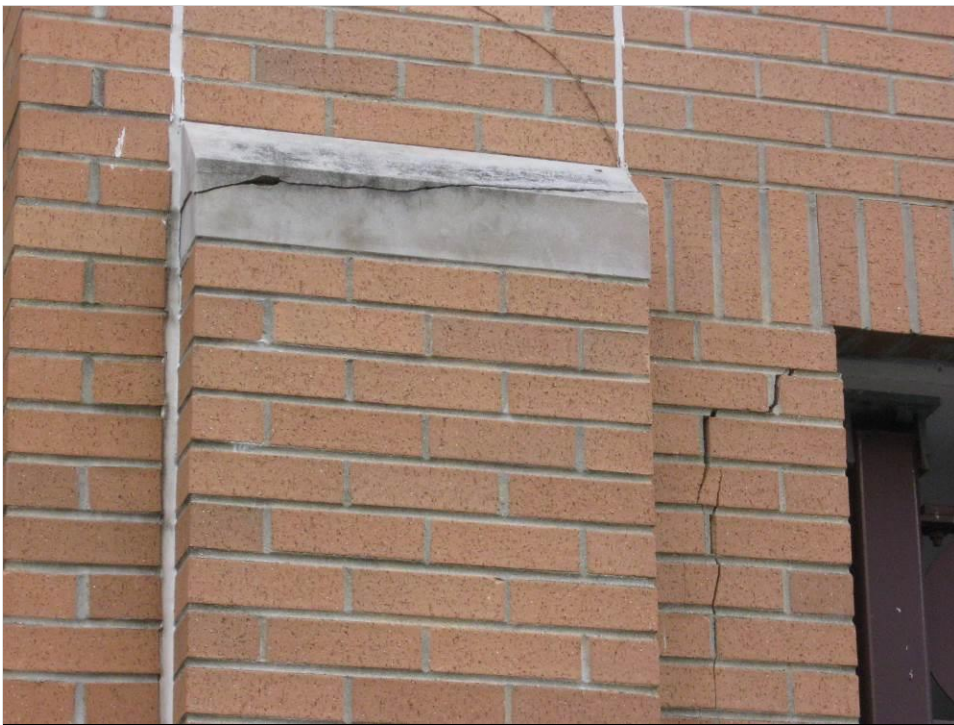
Photo 12 – Broken cap stone and cracked masonry.

We did note a condition that we recommend that should be addressing immediately. The two capstones that are cracked and broken cap stones, on south façade elevation along North Avenue, should be removed until repairs can be done. Refer to photographs 12 and 13 for Avenue Parking Structure in Appendix A.

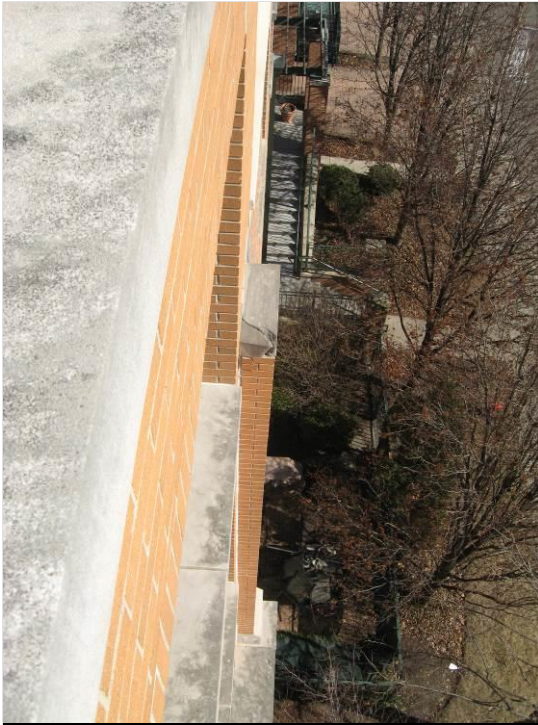
Photo 13 – Broken cap stone with the potential to fall off, south elevation.

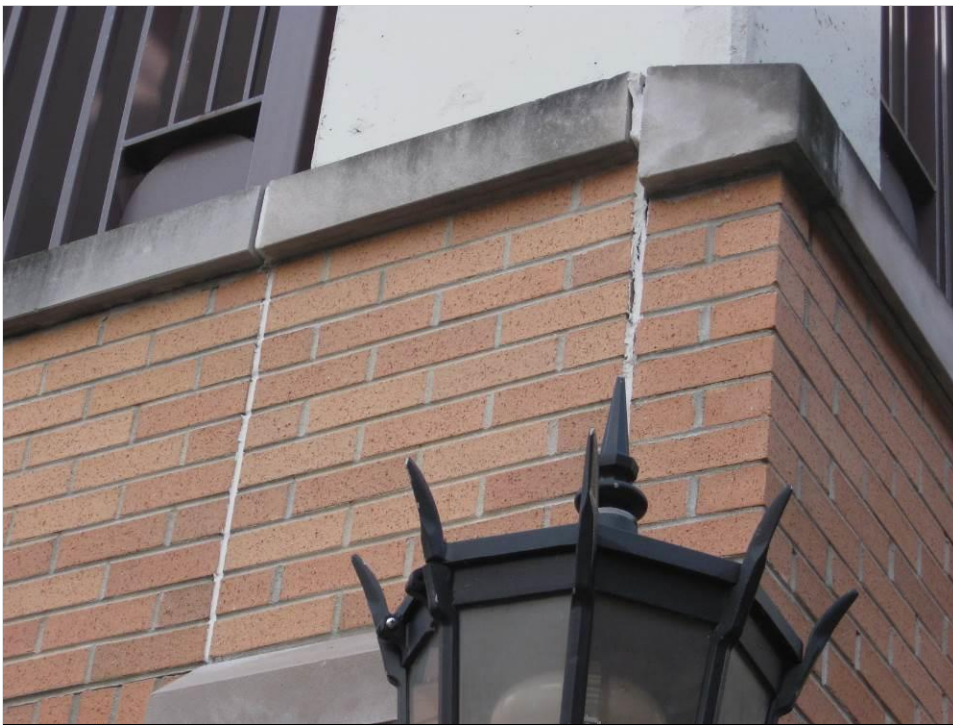
Photo 14 – Severely deteriorated vertical joint sealant on exterior masonry wall.

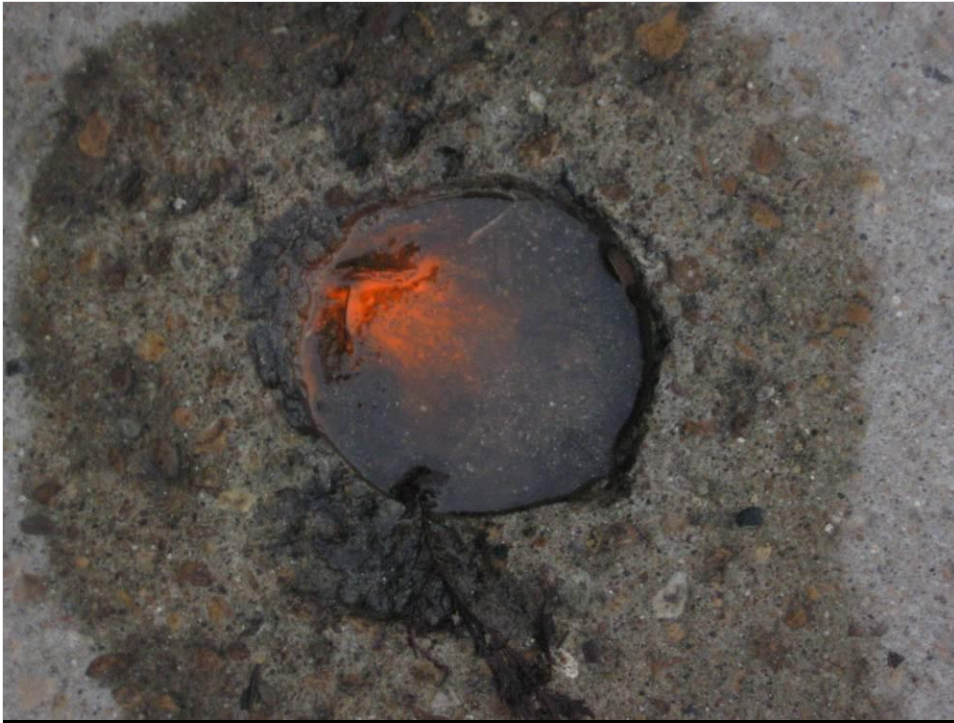
Photo 3 – Floor delamination over lifting loop.

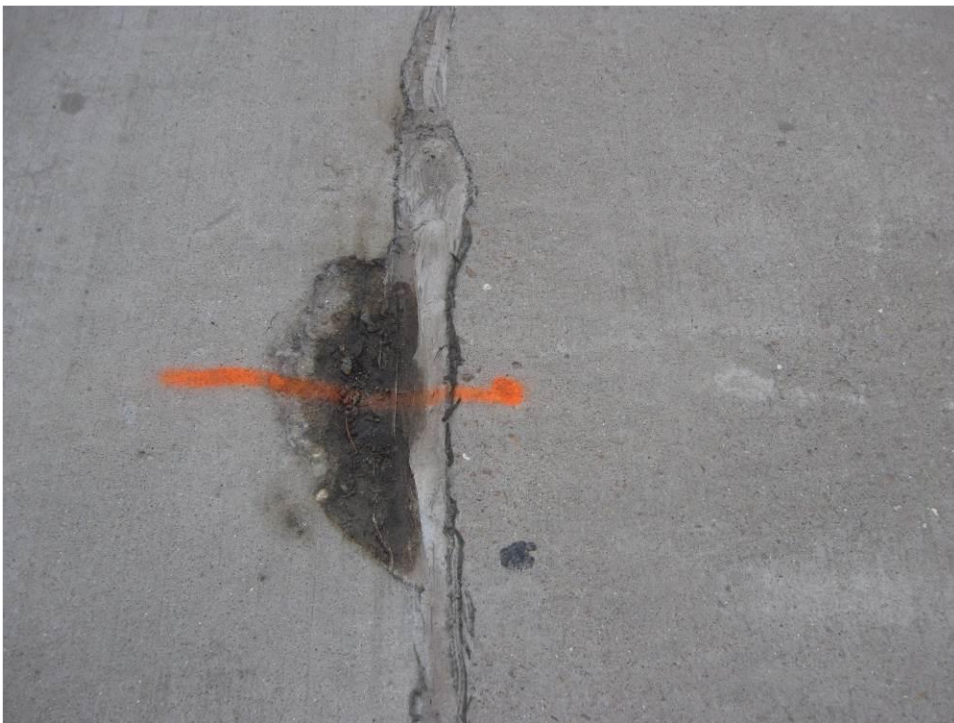
Photo 4 – typical floor spall over shear connector.

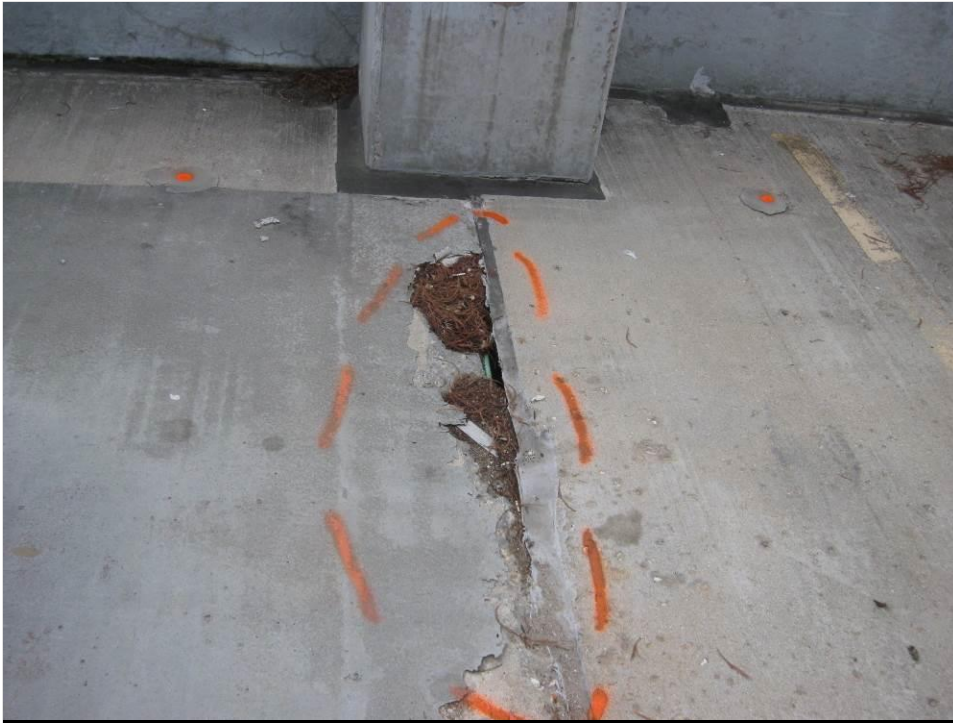
Photo 5 – Hole in the flange.

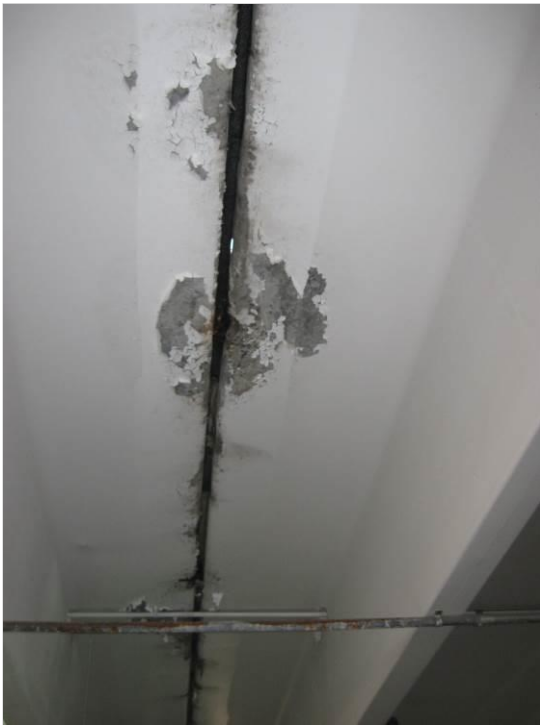
Photo 6 – Concrete spall at underside of precast tee flange.

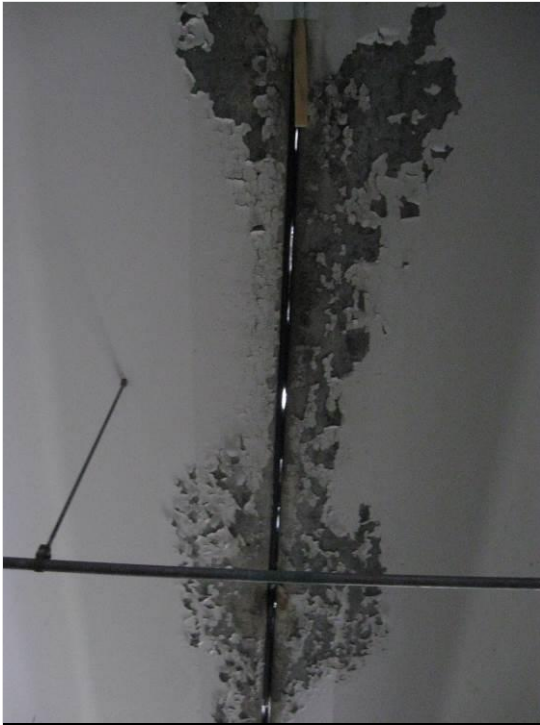
Photo 7 – Corroding tee-flange-to-tee-flange shear connectors at joint with severely deteriorated sealant.
