## THE VILLAGE OF OAK PARK PARKING STRUCTURES

OAK PARK, ILLINOIS

WRC PROJECT NO. 31-8130.00  
MAY 2017

## CONDITION ASSESSMENT OF THREE PARKING STRUCTURES

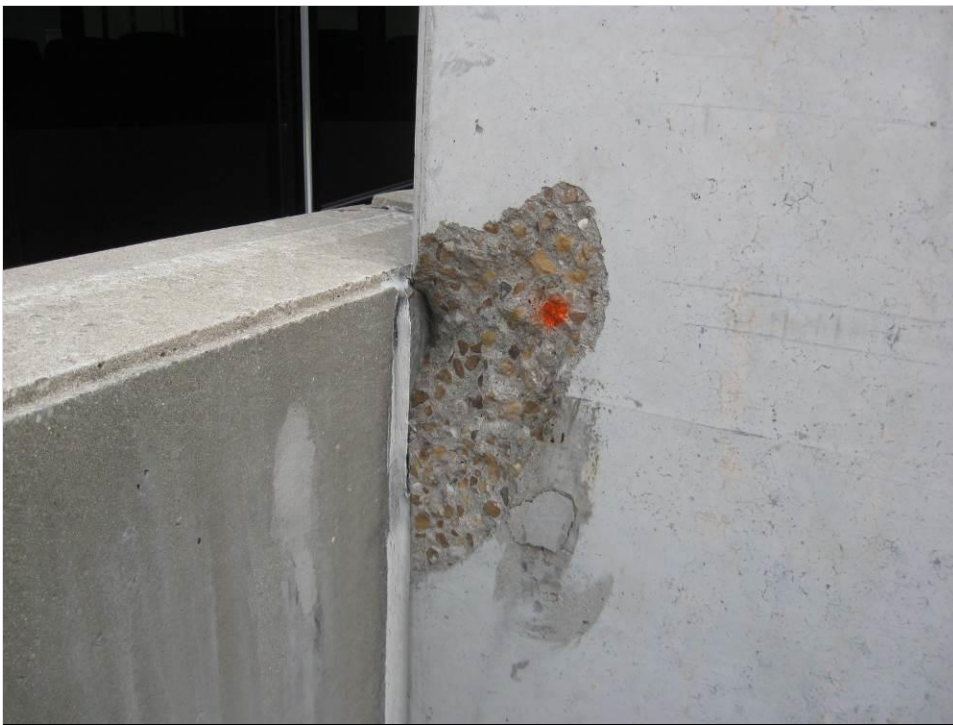
Photo 8 – Spall on the side of a column.

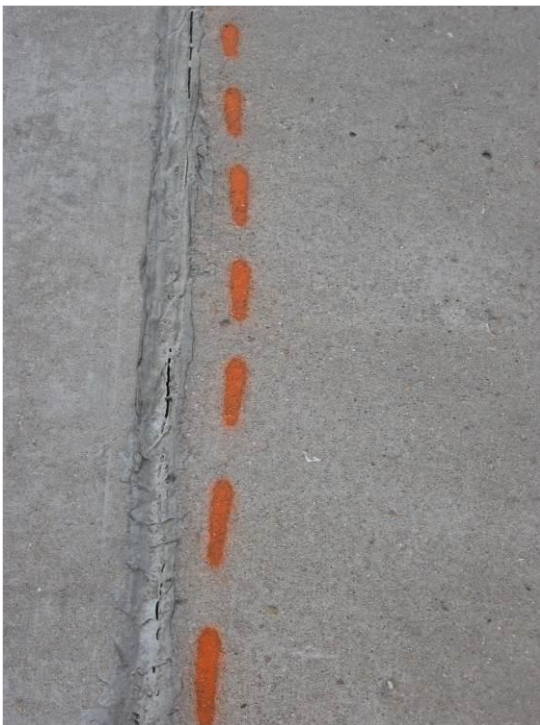
Photo 10 – Typical severely deteriorated tee-to-tee flange joint sealant.

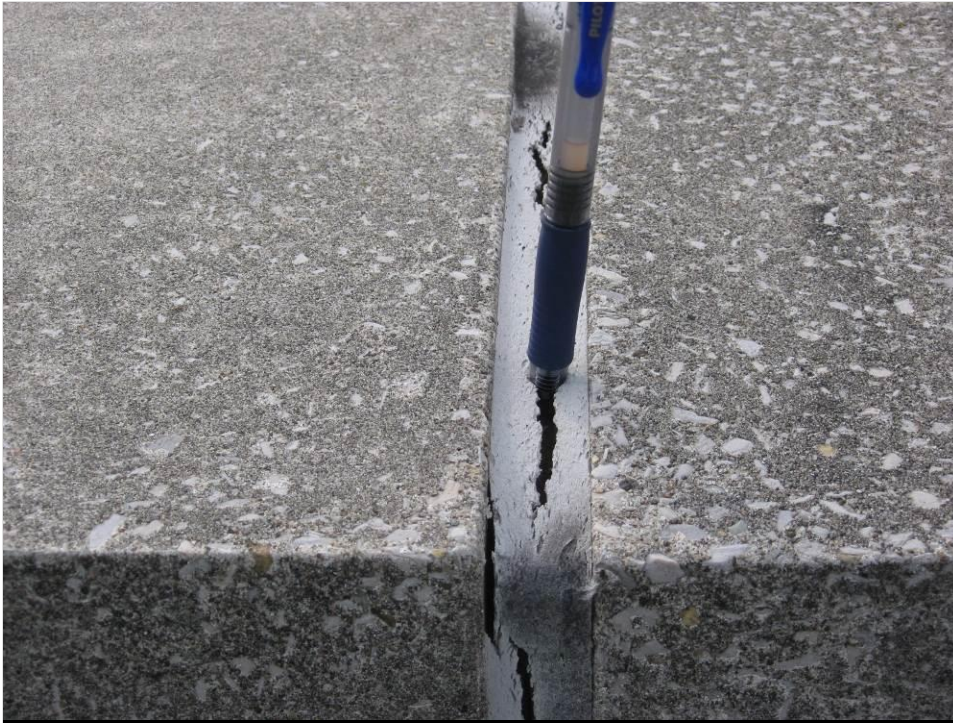
Photo 13 – Typical severely deteriorated cap stone joint sealant.

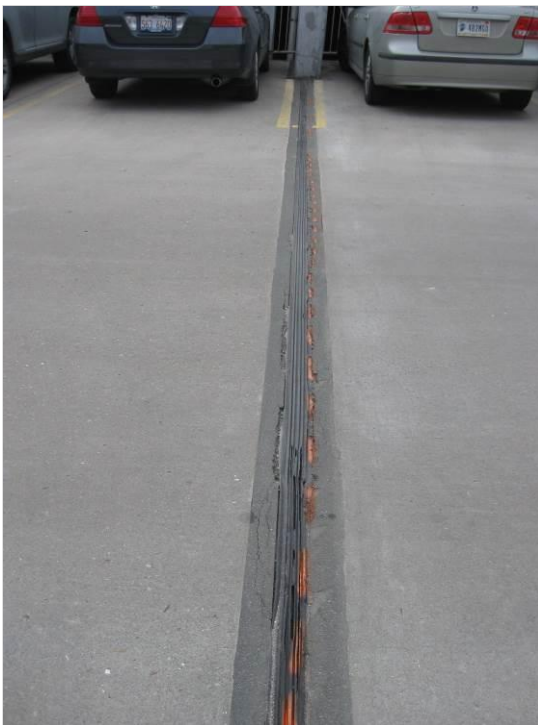
Photo 14 – Severely deteriorated expansion joint at grade slab.

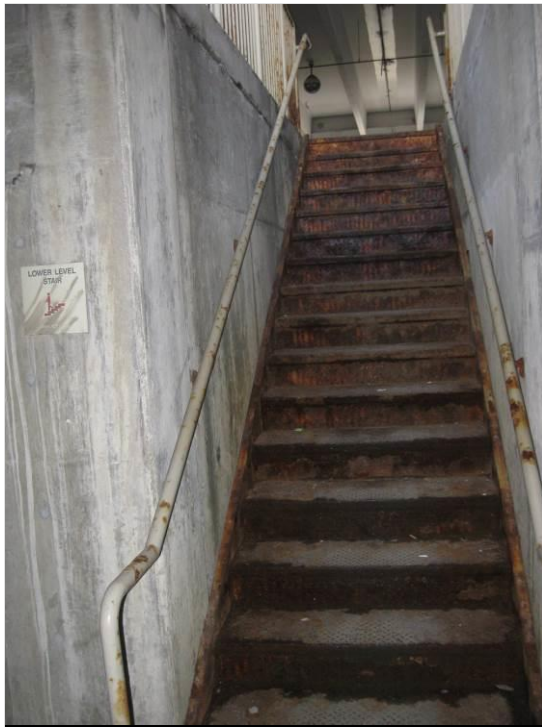
Photo 1 – Severely corroded stairs from Lower Level to First Level.

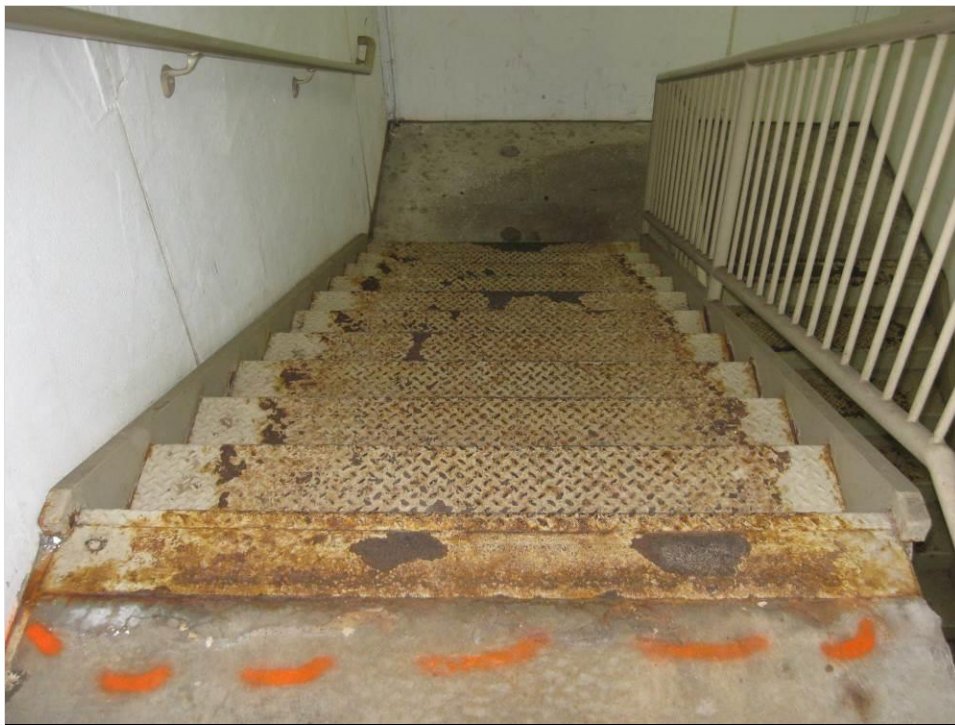
Photo 2 – Corroding stairs within stair tower.

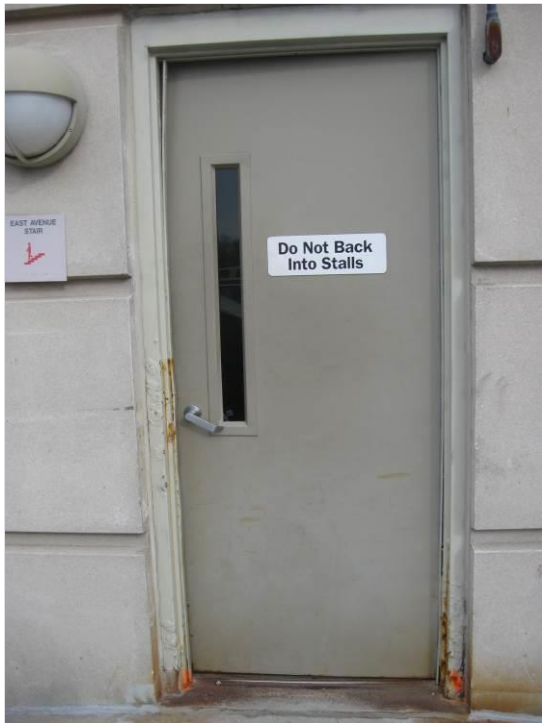
Photo 3 – Severely corroded door and frame.

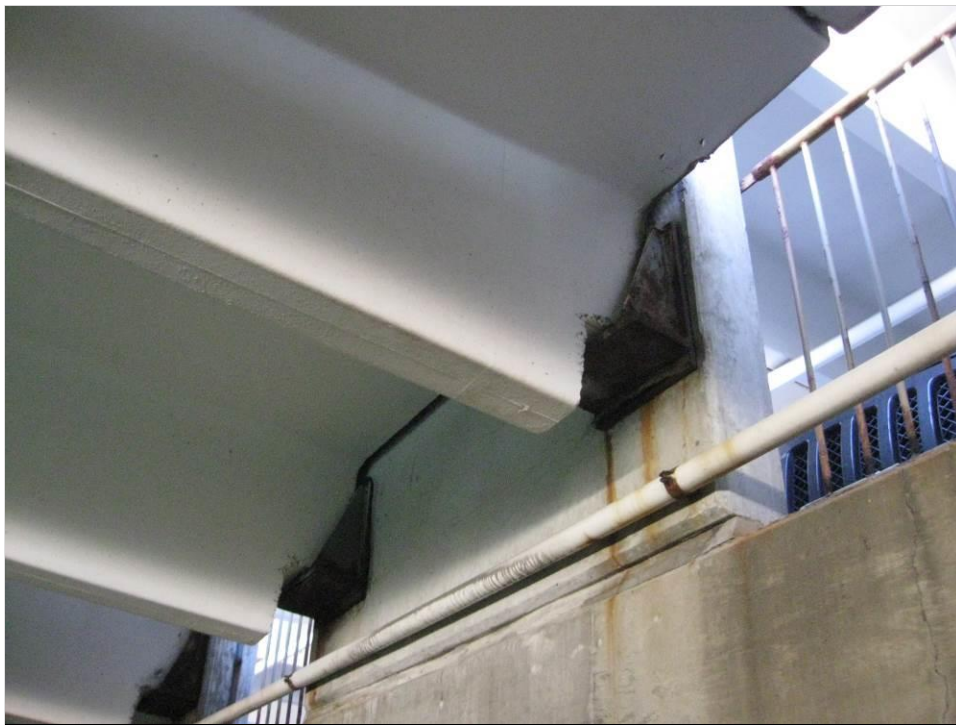
Photo 4 – Corroded tee stem support angles.

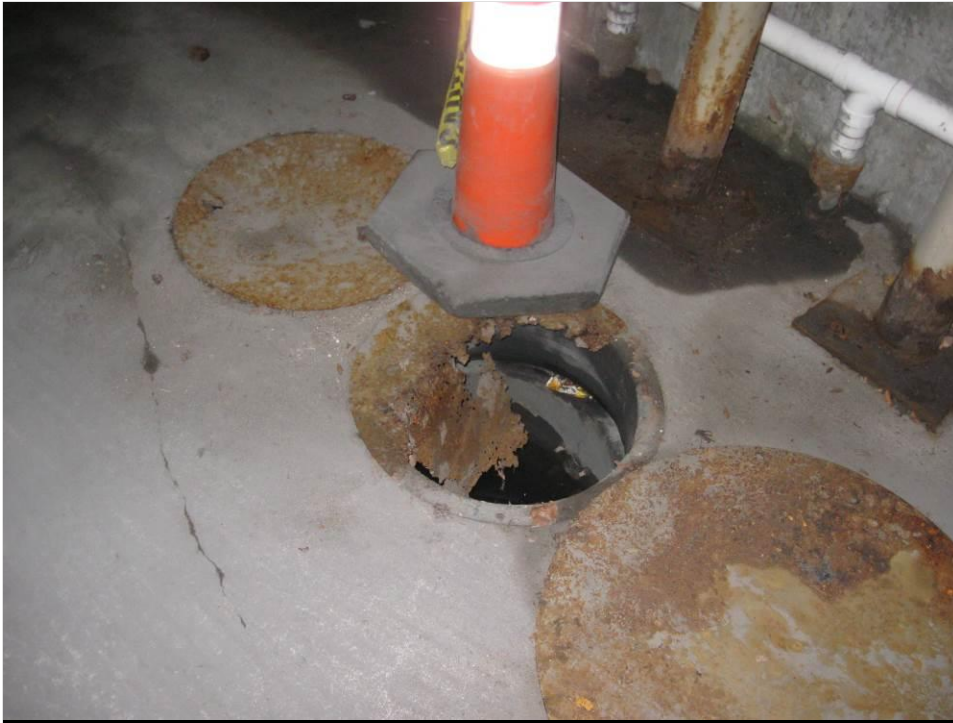
Photo 5 – Corroded cover on triple basin.

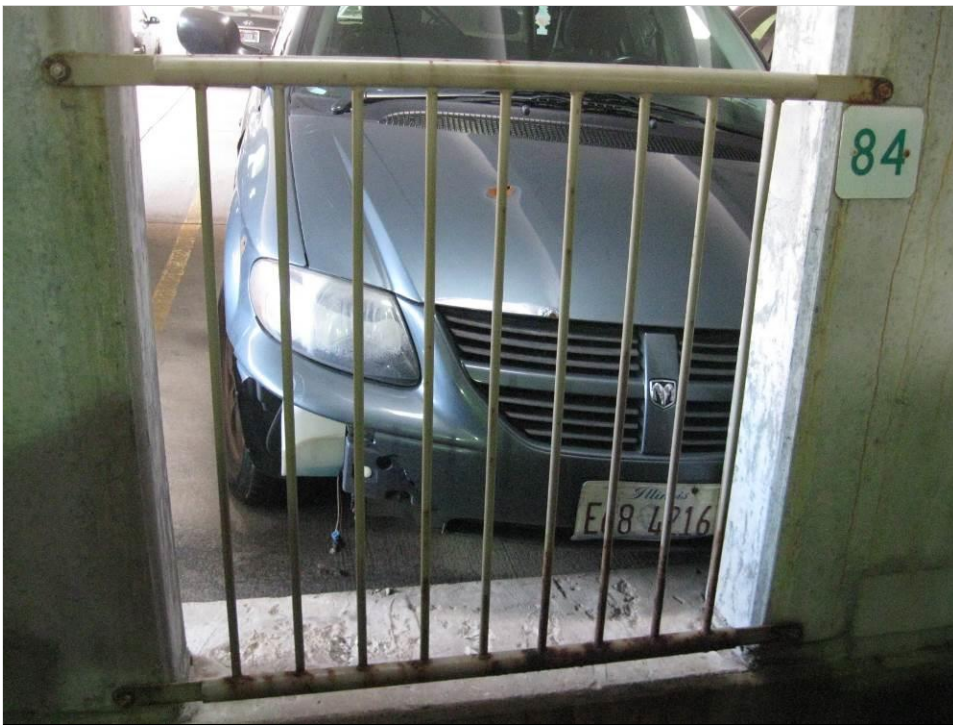
Photo 6 – Typical corroding guard rail on light wall.

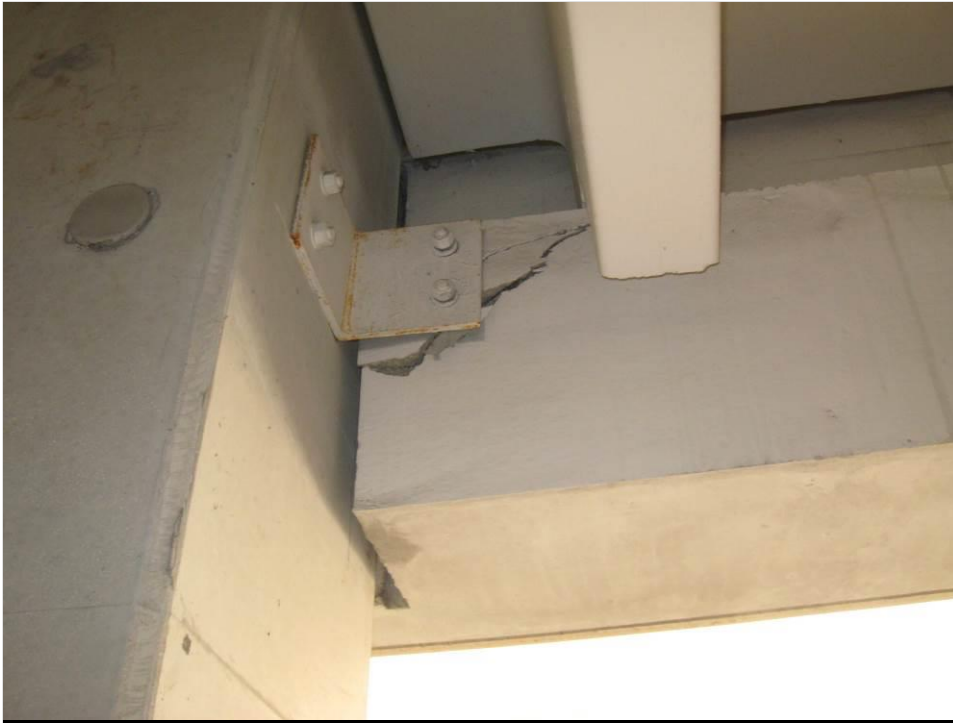
Photo 7 – Broken connection on façade panel.

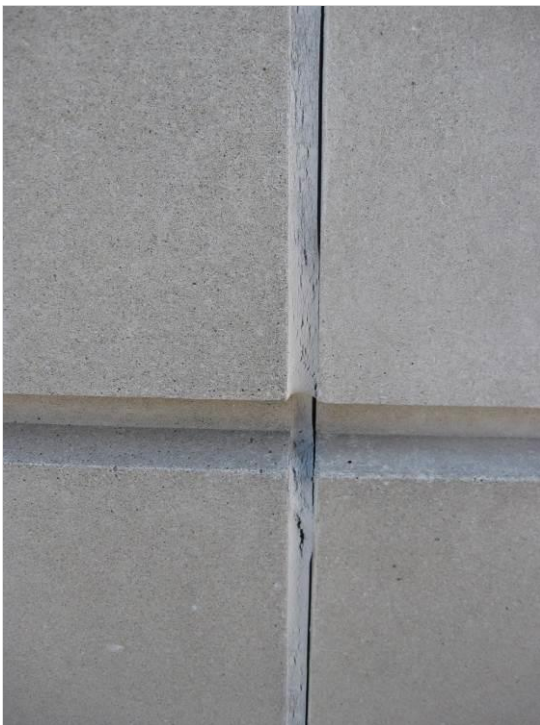
Photo 8 – Severely deteriorated vertical joint sealant on façade panel.
