# 5-Year Plan for Bridges Over I-290

August 2022

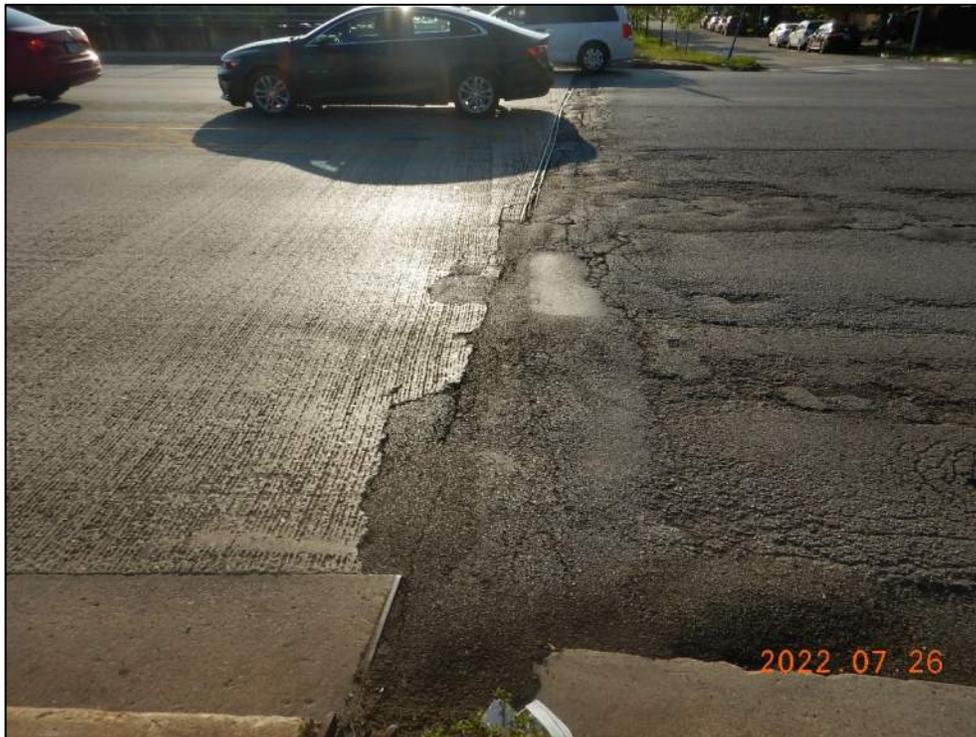
- The expansion joint at the south abutment of the southern bridge has been overlaid with HMA (Photo B1).
- No protective shielding is provided for the bridge.
- Debris has accumulated on the bridge expansion joints.
- Full width transverse cracks were located approximately every 7'-0" (Photo B3).
- Spalls were observed on the top side of the deck (Photo B2).
- Rebar is exposed in the concrete curb (Photo B6).
- Handrail bolts have failed resulting in a loose handrail (Photo B4).

Photo B1: Overlaid Expansion Joint at the South Abutment of the Southern Bridge (Looking East).

- **Hot-Mix Asphalt Surface Removal, 2" (44000157)**  
The expansion joint at the south abutment of the southern bridge has been partially overlaid with Hot-Mix Asphalt – obstructing an inspector's view and preventing any assessment of the joint. It is recommended that the overlaid HMA pavement is removed within 2 years so the condition of the joint can be assessed, and the appropriate repair action can be taken if necessary. This work shall be performed in accordance with Section 440 of the IDOT Standard Specifications for Road and Bridge Construction (SSRBC) and shall consist of removing the top 2" of HMA pavement that covers the bridge's expansion joint.

- **Expansion Joint Repair (Z0021900)**  
 The expansion joint at the south abutment of the southern bridge has been overlaid with HMA. Until the condition of the joint can be fully assessed, it is recommended that the joint be repaired within the next 2 years. The repair, if any, shall be determined after the condition of the joint has been fully assessed.

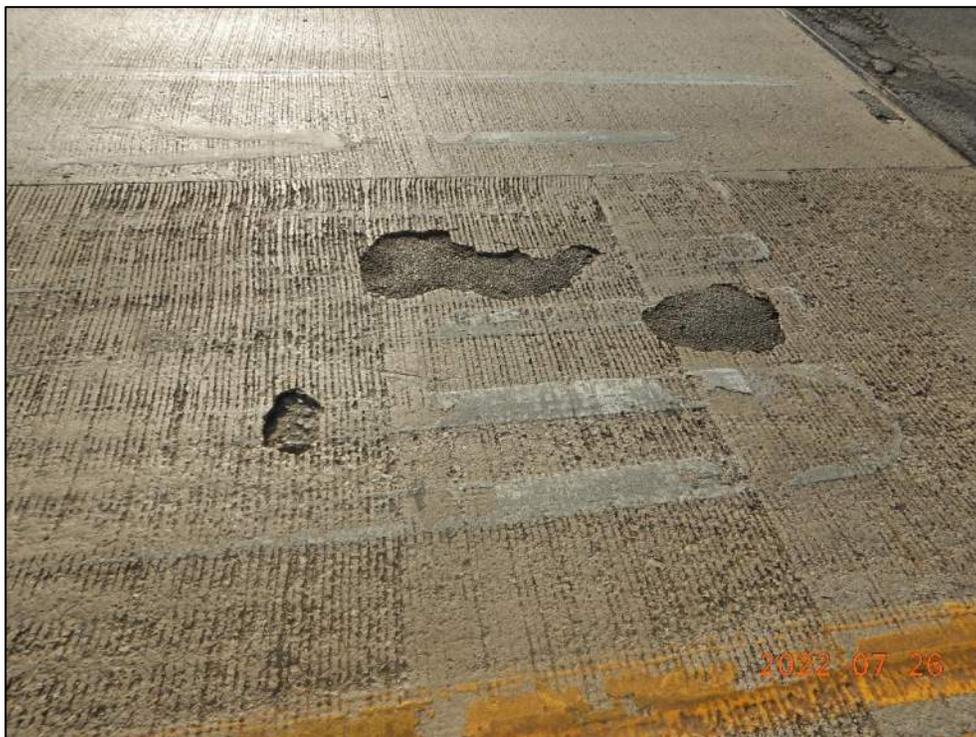
Photo B2: HMA Patches near Bridge Centerline (Looking East).

- **Class D Patches, Type I, 4 Inch (44201690)**  
 Several small patches lined the west side of Austin Boulevard. It is recommended that all HMA patch work be completed within the next 5 years. This work shall be performed in accordance with Section 442 of the IDOT SSRBC and shall consist of removing the existing pavement and replacing it with HMA pavement.

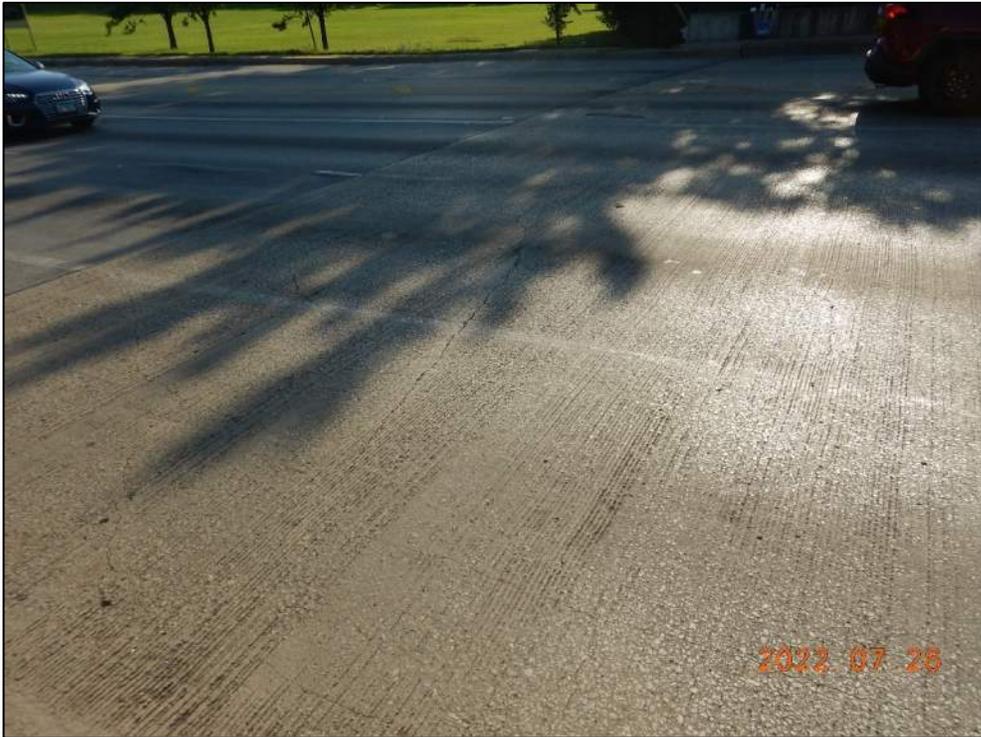
Photo B3: Transverse Cracking (Looking East).

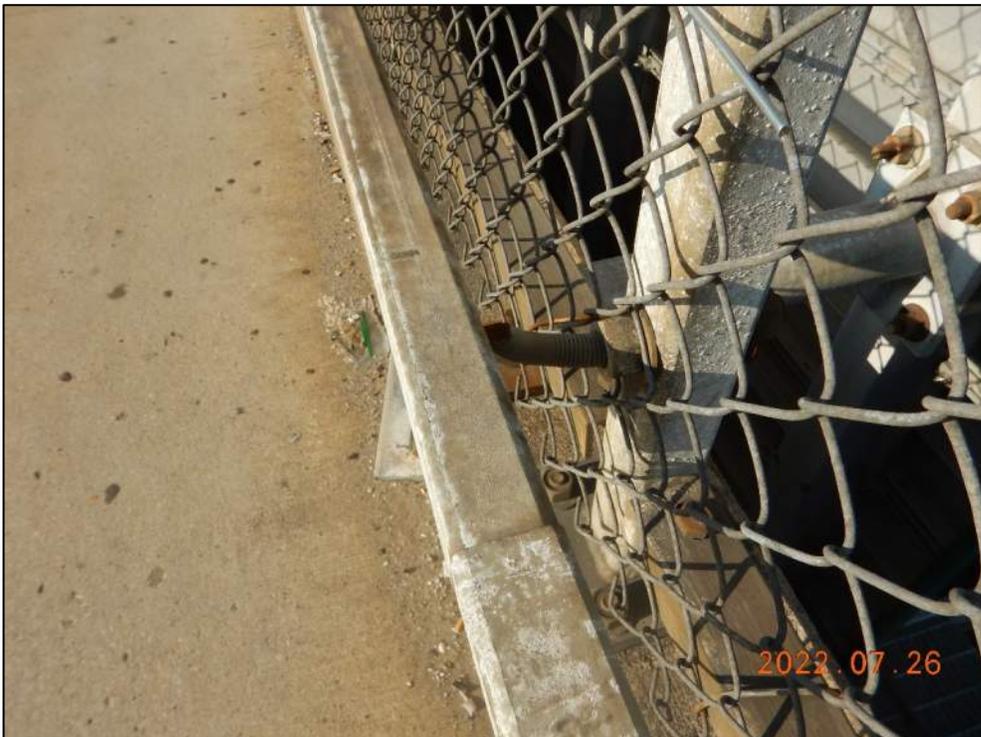
Photo B4: Failed Handrail Bolt.

- **Handrail Repairs (Z0029603)**  
 A few of the handrail bolts have failed resulting in a loose handrail. It is recommended that the bolts be replaced within the next 5 years. This work shall consist of replacing the failed handrail bolts.

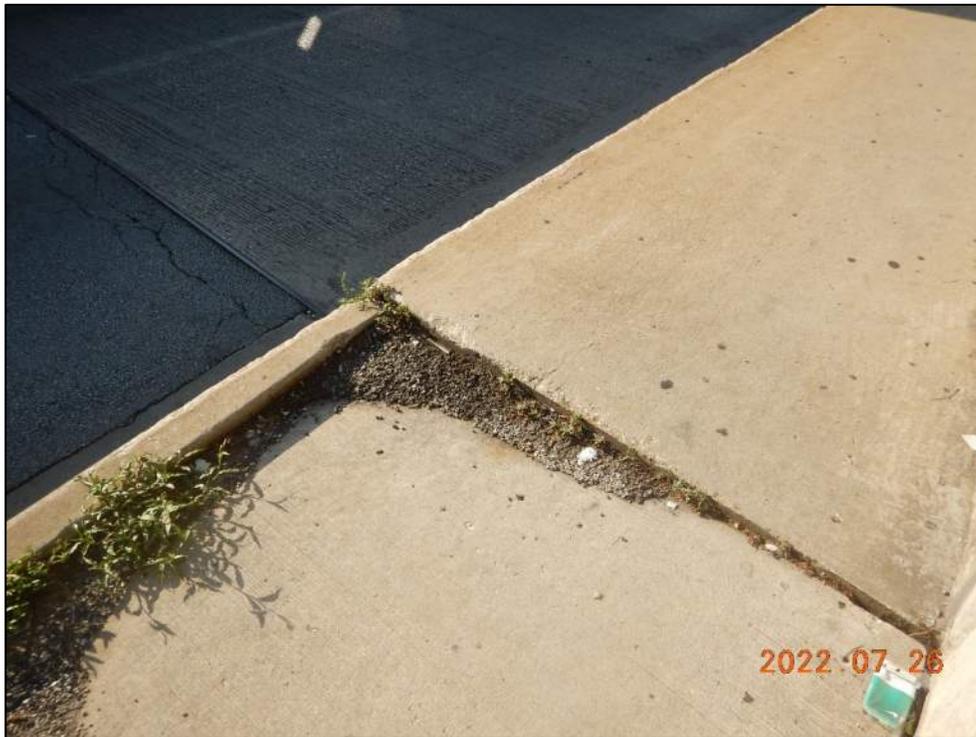
Photo B5: Sidewalk Settlement. Trip Hazard in Northwest Corner of Northern Bridge (Looking South).

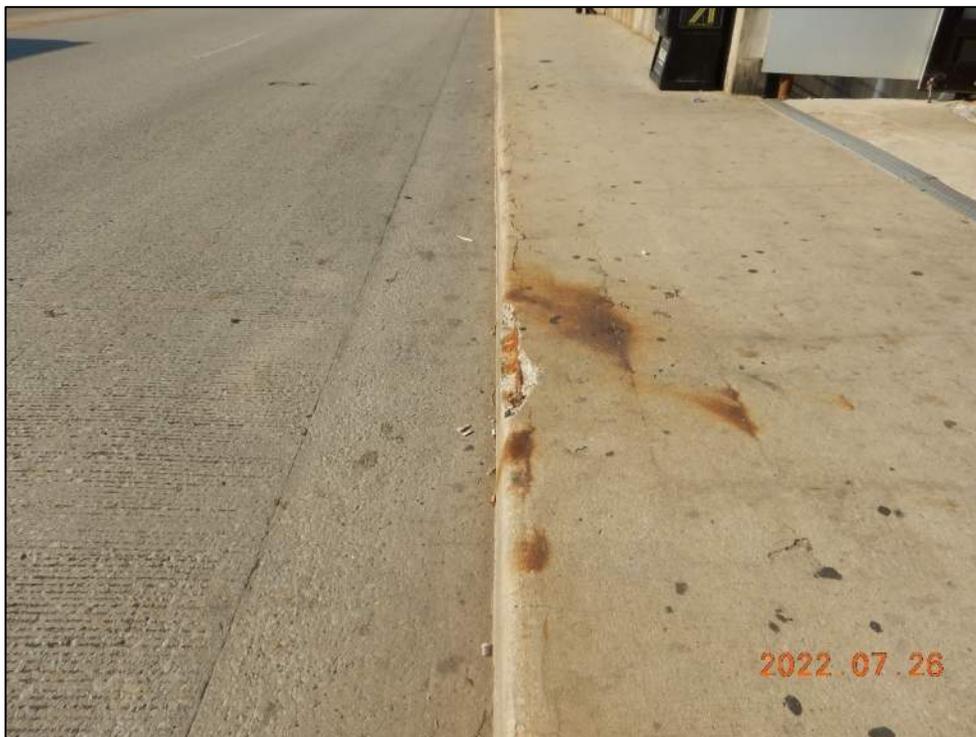
Photo B6: Exposed Curb Rebar (Looking South).

- **Concrete Curb Repair (Z0012500)**  
 A small portion of the Austin Boulevard curb is experiencing section loss and rebar is exposed. It is recommended that the curb be repaired within 5 years to prevent further damage. This work shall consist of applying a concrete repair material to the damaged curb area.

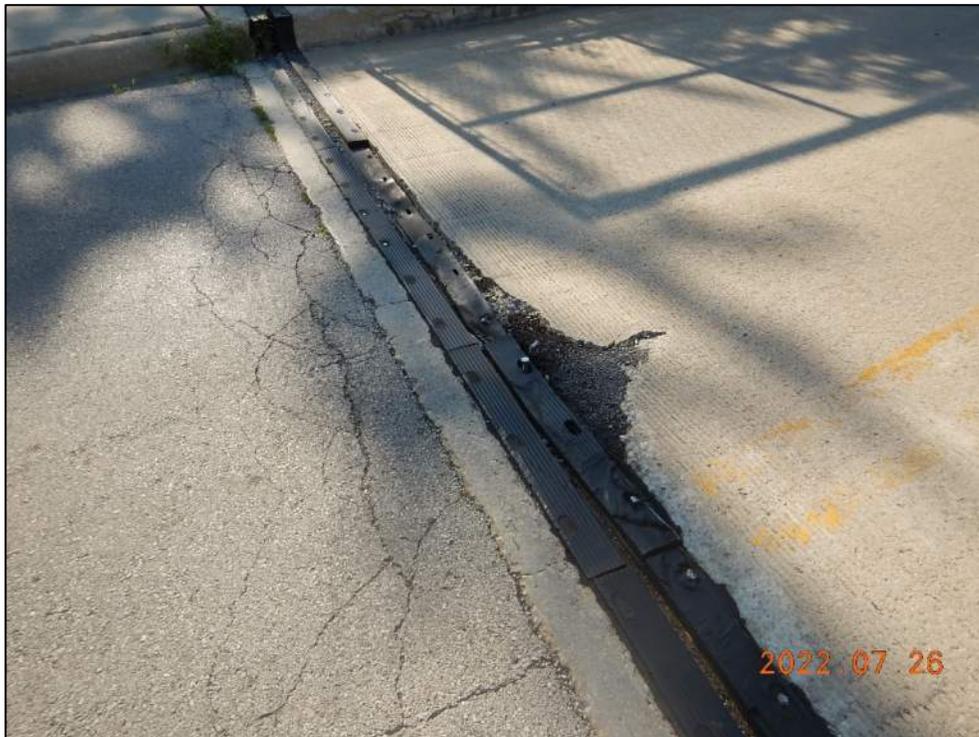
Photo C2: Missing blocks in Expansion Joint at North Abutment (Looking East).

- **Expansion Joint Repair (Z0021900)**  
The expansion joint covers on the Lombard Avenue bridge are missing blocks to secure the covers. It is recommended that damaged blocks be replaced within the next 2 years. This work shall consist of removing and replacing damaged blocks.

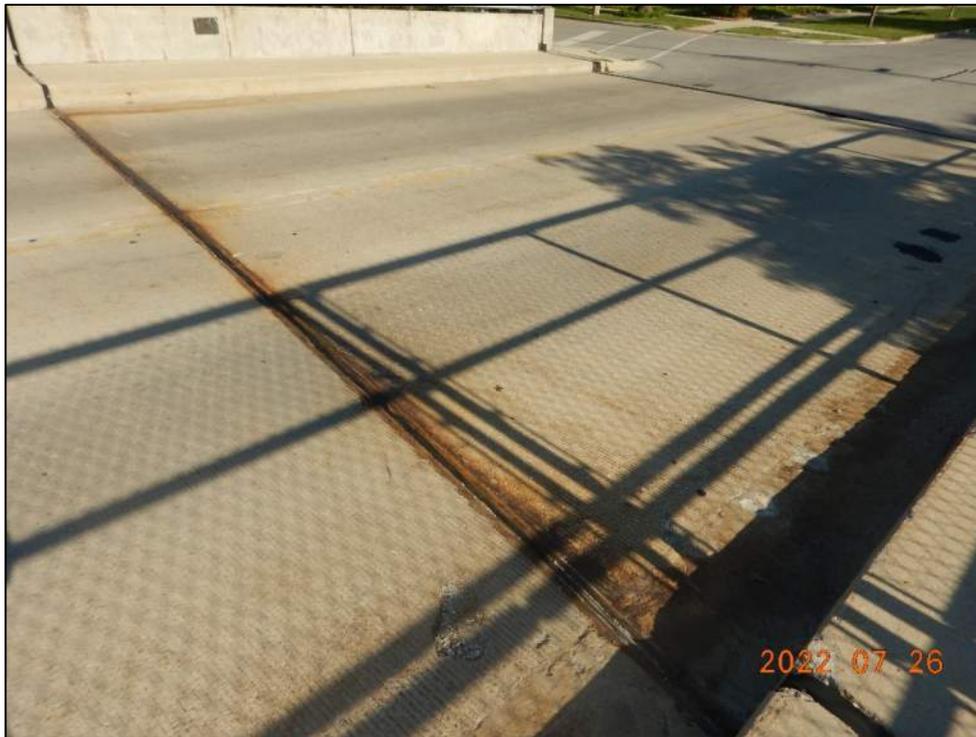
Photo C3: Expansion Joint at Pier 1 (Looking Northwest).

- **Blast Cleaning Bridge Joint Steel (X0325217)**  
It is recommended that the expansion joints be blast cleaned within 2 years to help assess any additional repair locations and remove any debris that may impact the joints' performance. This work shall consist of either dry abrasive blast cleaning, wet abrasive blast cleaning, or water jetting with abrasive injection the surface to be cleaned so that the surface is free of all visible oil, grease, dirt, dust, mill scale, rust, paint, oxides, corrosion products, and other foreign matter, except for staining.

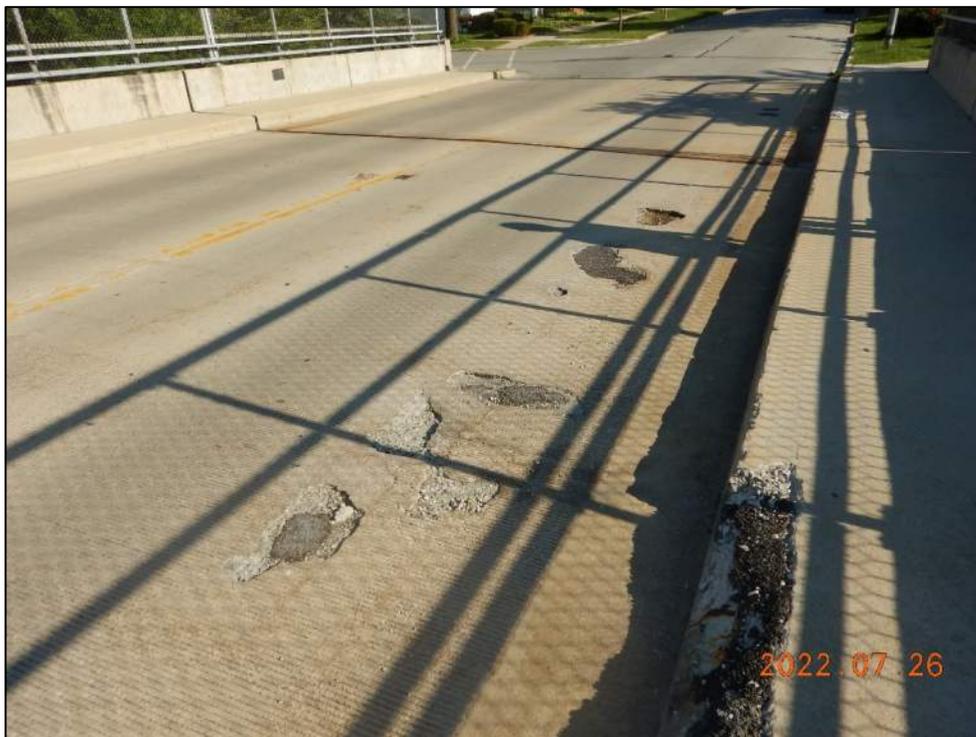
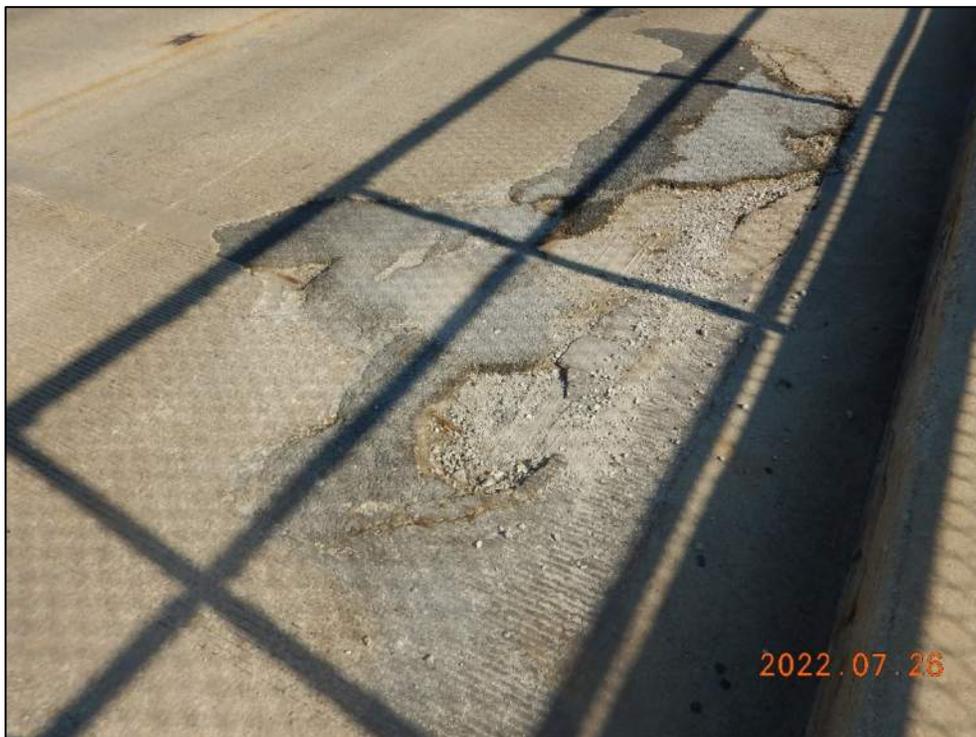
- Large spalls were observed on the top side of the deck - especially in the northbound travel lane (Photos C4 and C8).
- No protective shielding is provided for the bridge.
- Debris has accumulated on the bridge expansion joints (Photo C3).
- Longitudinal cracks were observed on the top side of the deck.
- The concrete curb is damaged, and portions of the curb have exposed rebar (Photos C4 and C6).
- The expansion joint at the north abutment is missing blocks (Photo C2).
- Reflectors have been removed but not replaced (Photo C5).

Photo C4: Deck Spalls and HMA Patches (Looking Northwest).

Photo C8: Deck Spalls with Exposed Main Reinforcement and HMA Patches (Looking Northwest).

- **Deck Slab Repair (Full Depth) Type I and Type II (Z0016001 and Z0016002)**  
Several potholes and spalls line Lombard Avenue. Potholes are located in the line of vehicular travel. A full depth deck slab repair is recommended within 1 year to help provide users with a smoother ride and prevent concrete from falling onto the expressway below. This work shall consist of removing the full depth of the concrete deck, disposing of the concrete removed, and replacing the removed portion with new concrete to the original concrete deck surface.

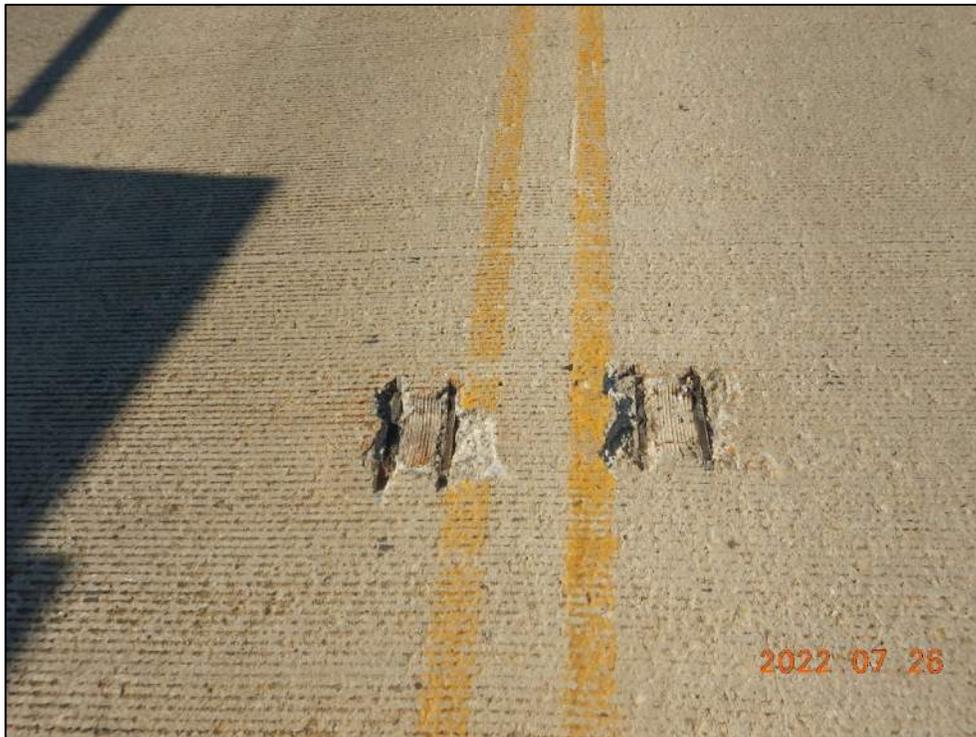
Photo C5: Missing Reflectors.

- **Replacement Reflector (78100300)**  
It appears that each of the 14 pavement reflectors have been removed on the Lombard Avenue bridge. Some of the holes have been filled with HMA whereas others have not. If The Village of Oak Park sees fit, new reflectors may be installed within the next 5 years. This work shall be performed in accordance with Section 781 of the IDOT SSRBC and shall consist of placing new reflectors into saw cut and epoxy filled holes in the deck.

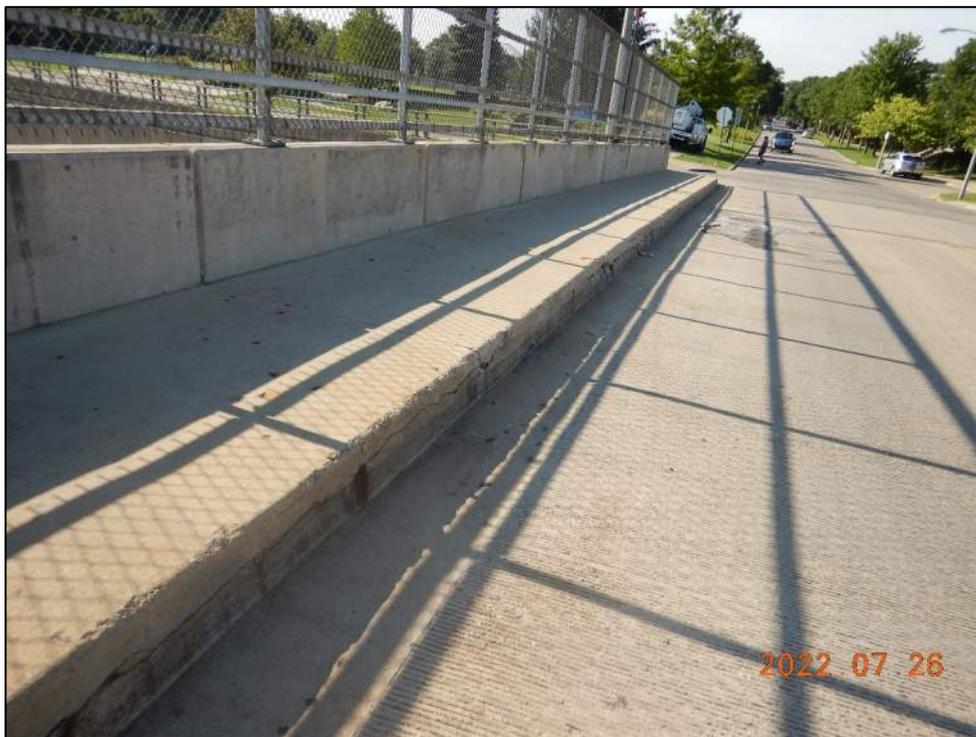
Photo C6: Sidewalk Curb Damage (Looking South).

- **Concrete Curb Repair (Z0012500)**  
A portion of the curb along the Lombard Avenue bridge has experienced section loss and rebar is exposed. It appears that an HMA patch repair was attempted but the patch has deteriorated since. It is recommended that the HMA patch be fully removed and replaced with a concrete repair material within the next 2 years. This work shall consist of removing the existing HMA patch and applying a concrete repair material to the damaged curb area.

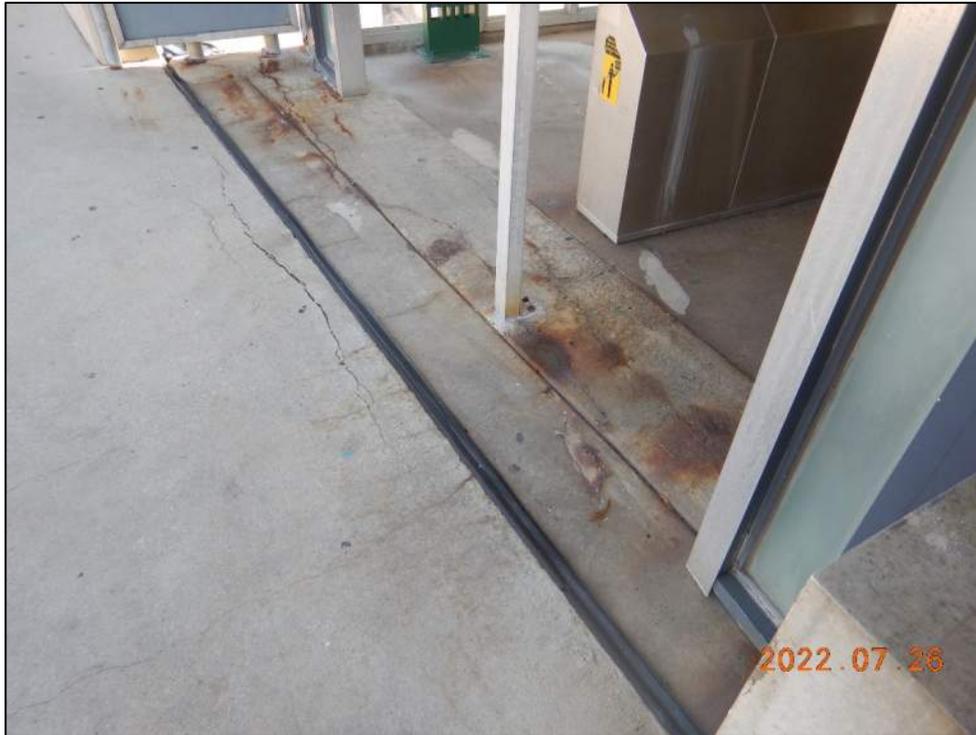
Photo C7: Joint Near CTA Station (Looking East).

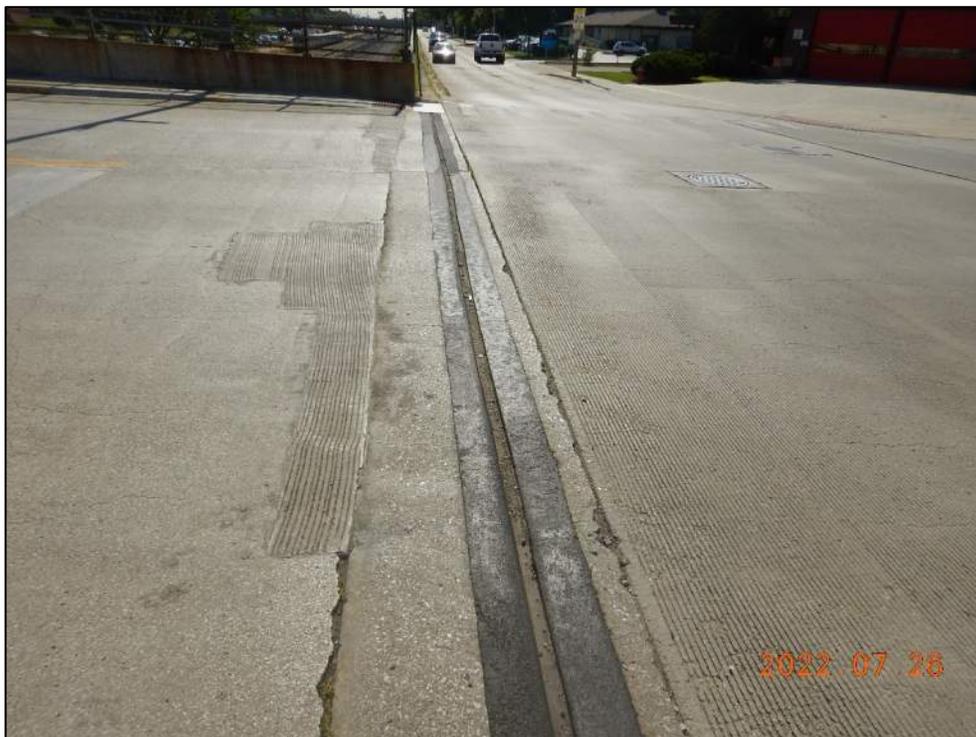
Photo D2: Dirty Expansion Joint at South Abutment (Looking East).

It is recommended that the expansion joints be blast cleaned within 2 years to help assess any additional repair locations and remove any debris that may impact the joints' performance. This work shall consist of either dry abrasive blast cleaning, wet abrasive blast cleaning, or water jetting with abrasive injection the surface to be cleaned so that the surface is free of all visible oil, grease, dirt, dust, mill scale, rust, paint, oxides, corrosion products, and other foreign matter, except for staining.

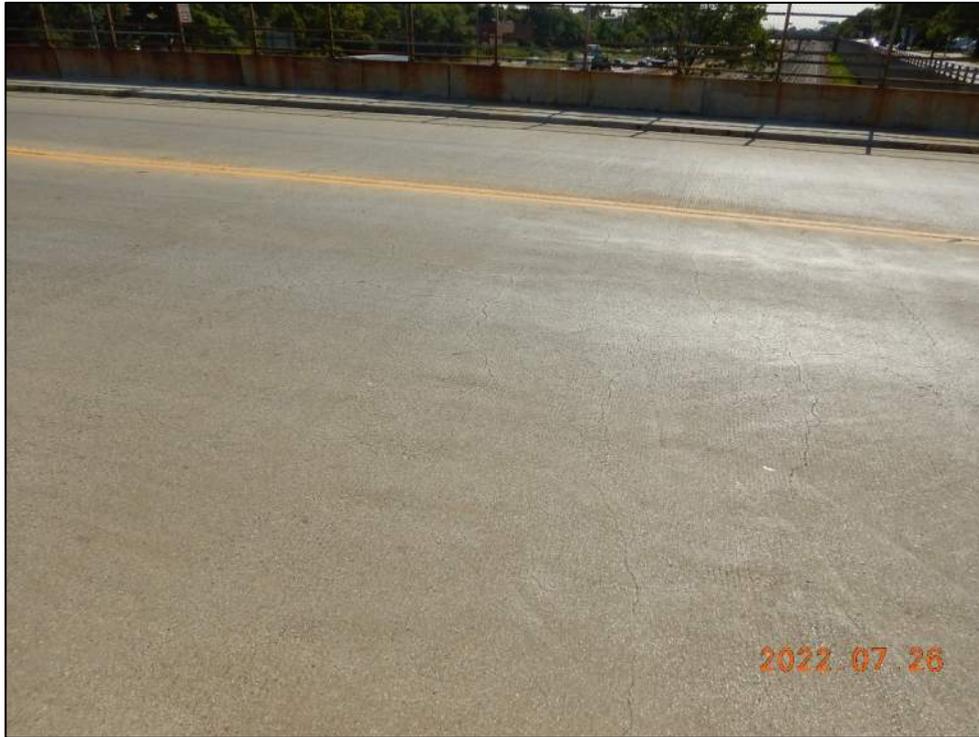
Photo D3: Map Cracking (Looking East).

A concrete sealer is recommended within 5 years to prevent further delamination in the deck. This work shall consist of applying a concrete sealer or protective coat upon the entire top surface of the deck.

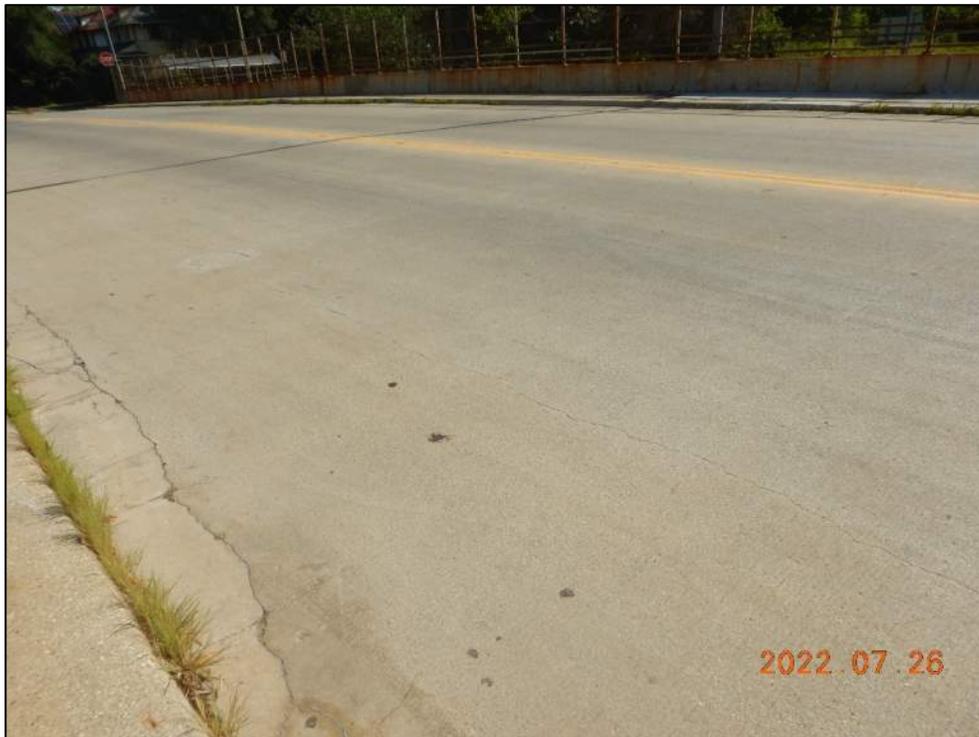
Photo D4: Longitudinal Cracking (Looking North).

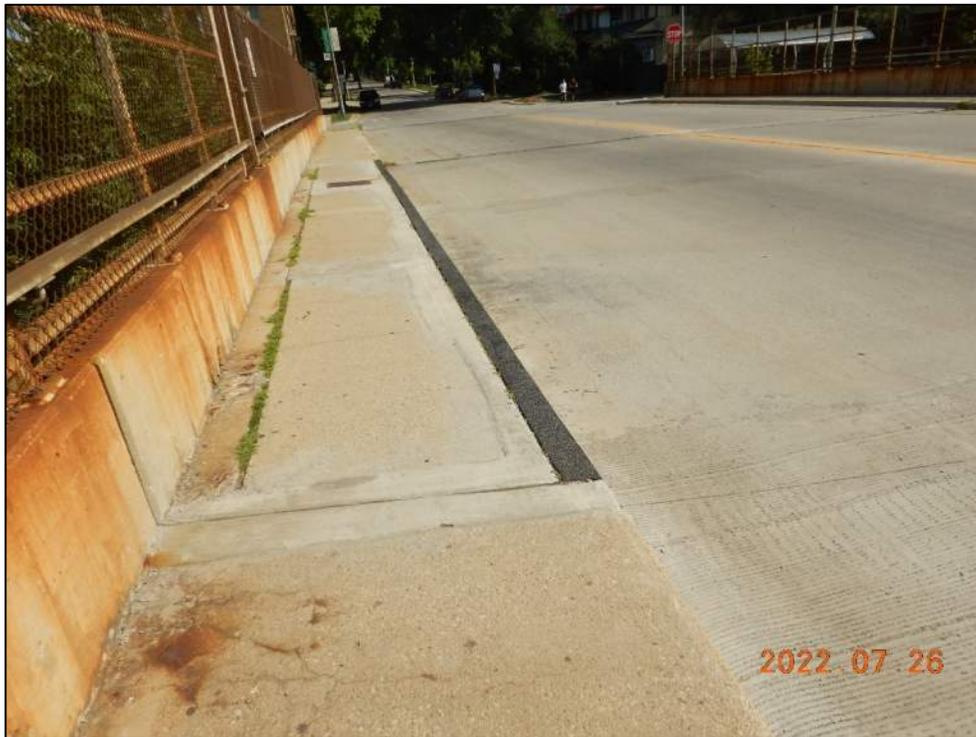
Photo D5: Curb Repair (Looking North).

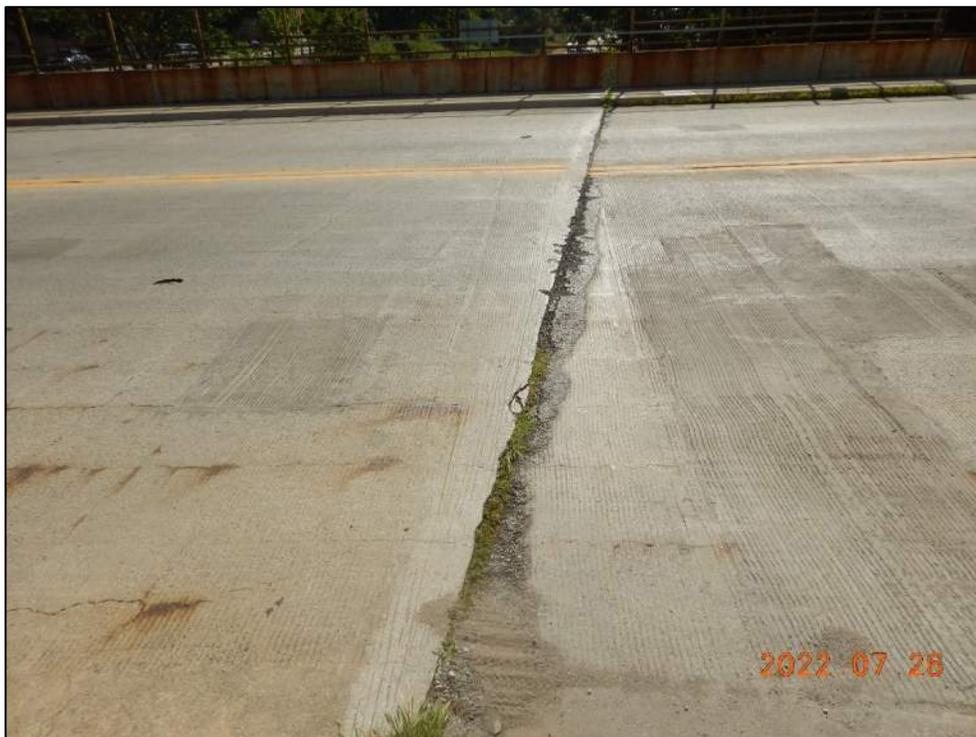
Photo D6: Overlaid Interior Joint Near Old Ramp (Looking East).

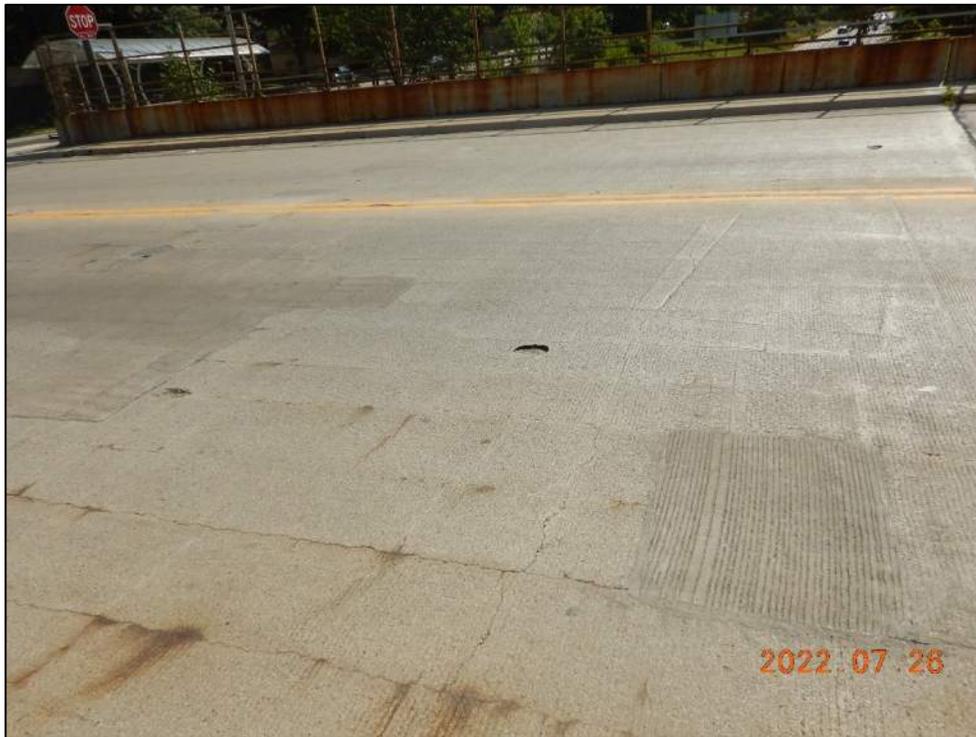
- Debris has accumulated on the bridge expansion joints (Photo D2).
- Spalls were observed on the top side of the deck (Photo D7).
- Map cracks, full width transverse cracks, and longitudinal cracks were observed (Photos D3, D4, D7, and D8).
- Protective shielding is provided in all bays over I-290 and in the west exterior bays over any rail.

Photo D7: Deck Spalls, Longitudinal Cracking, and Transverse Cracking (Looking East).

Most of the potholes on the East Avenue bridge have been repaired but there are a few new locations that should be patched. It is recommended that all HMA patch work be completed within the next 5 years. This work shall be performed in accordance with Section 442 of the IDOT SSRBC and shall consist of removing the existing pavement and replacing it with HMA pavement.

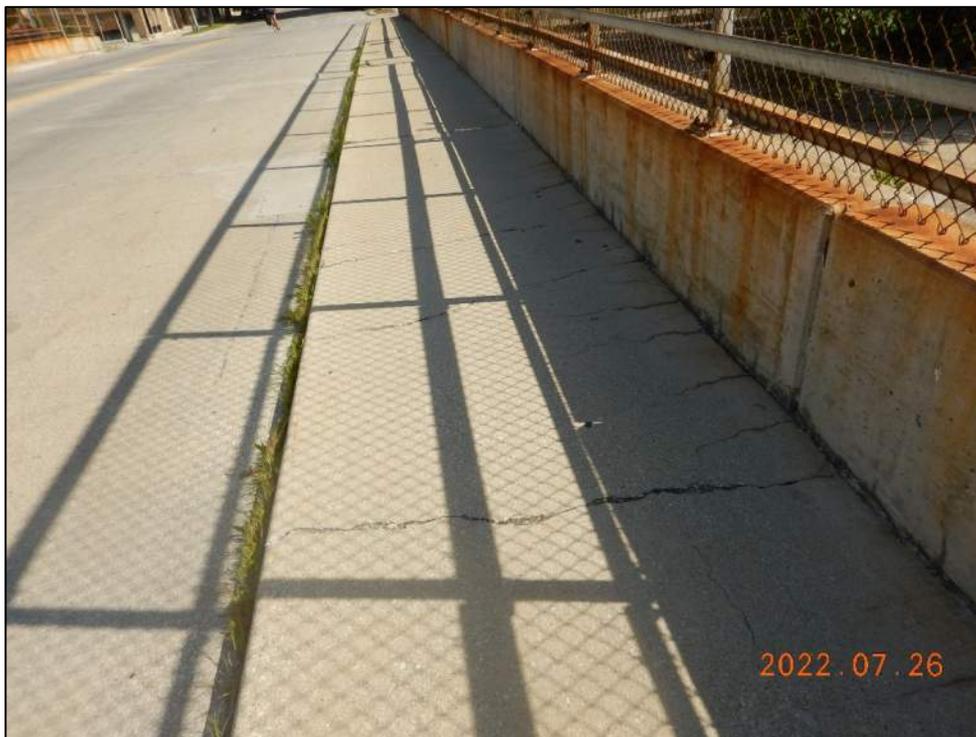
Photo D8: Sidewalk Transverse Cracking (Looking North).

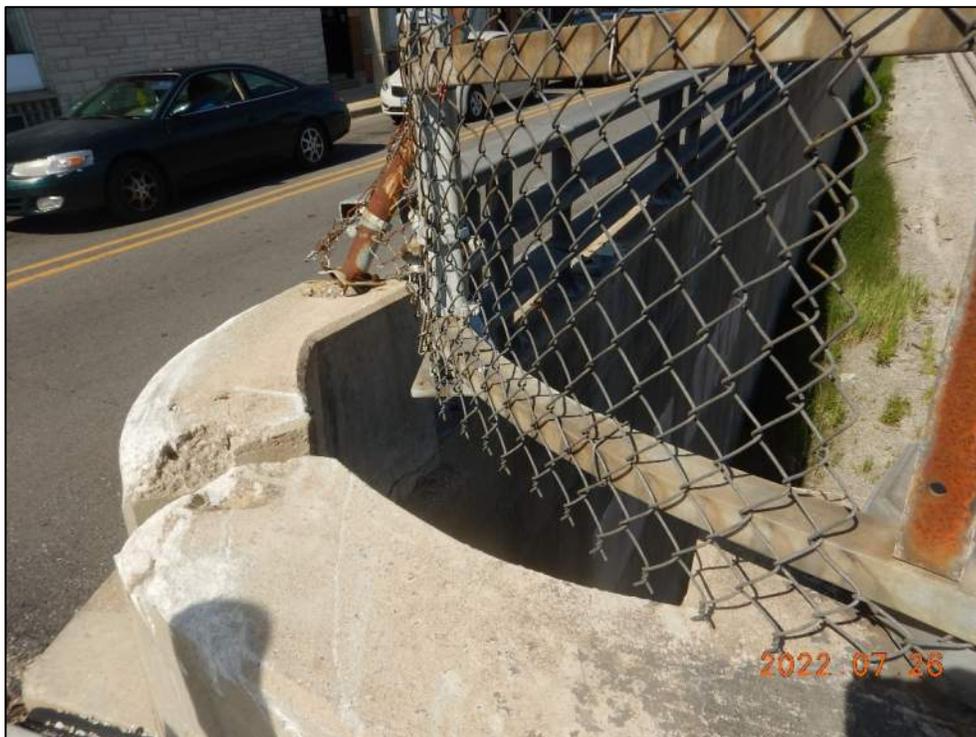
The base plate anchor bolts for two posts have all failed in shear on the Oak Park Avenue bridge. The posts are still connected to the bridge because of their connections to the chain link fence but one post is hanging in open air behind the parapet. The failed portion of the fence should be removed, and a new fence and new posts should be installed within 1 year to avoid the fence falling onto CSX property below. This work shall consist of removing and replacing the damaged portion of the fence to the nearest post in satisfactory condition.
- **Handrail Repairs (Z0029603)**

Photo E2: Fence Damage (Looking Southwest).

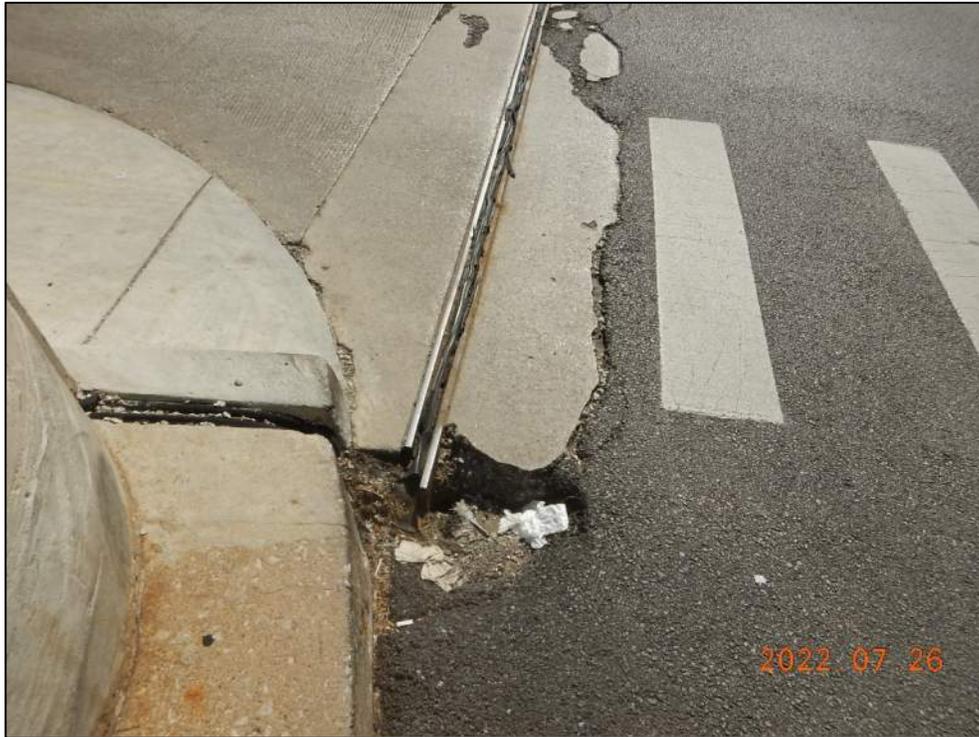
Photo E3: Southern Expansion Joints (Looking East).

It is recommended that the expansion joints be blast cleaned within 2 years to help assess any additional repair locations and remove any debris that may impact the joints' performance. This work shall consist of either dry abrasive blast cleaning, wet abrasive blast cleaning, or water jetting with abrasive injection the surface to be cleaned so that the surface is free of all visible oil, grease, dirt, dust, mill scale, rust, paint, oxides, corrosion products, and other foreign matter, except for staining.
- **Expansion Joint Repair (Z0021900)**

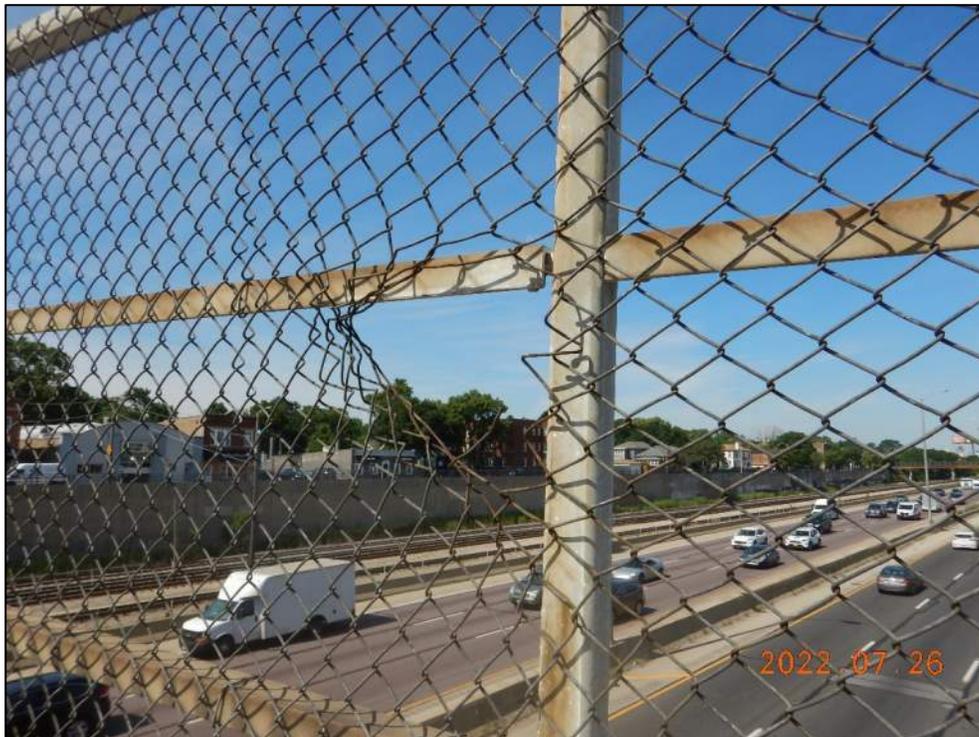
Photo E4: Hole in Fence (Looking West).

There is a hole in the Oak Park Avenue bridge chain link fence. It is recommended that the damaged portion of the Oak Park Avenue fence is replaced within 1 year. This work shall consist of removing and replacing the damaged portion of the fence.
- **Protective Shield (50157300)**

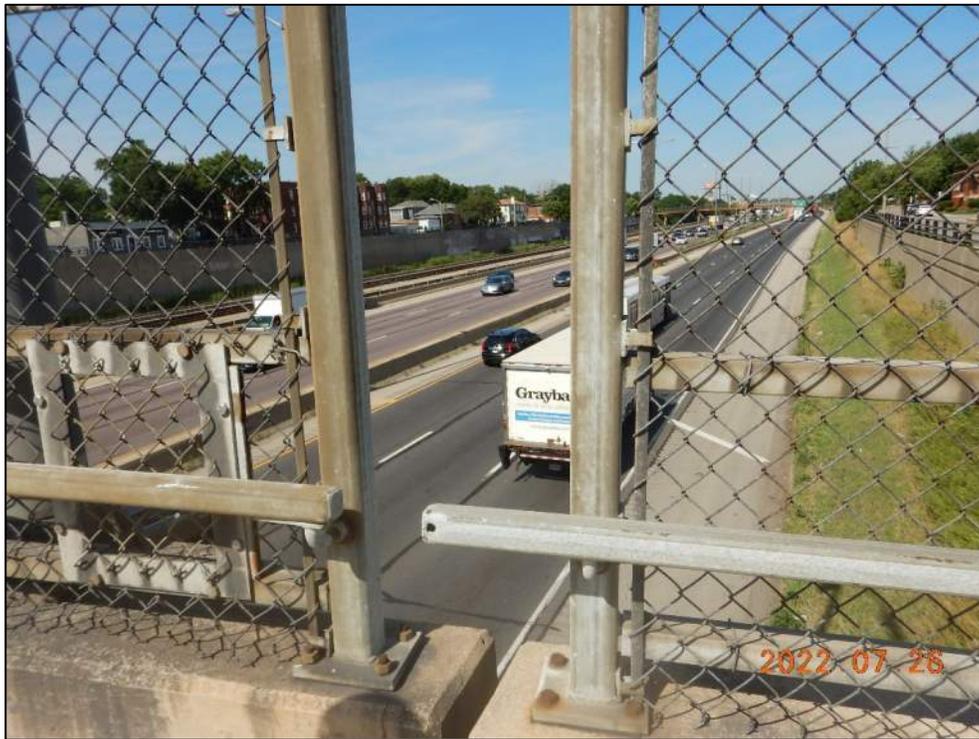
Photo E5: Human Size Fence Post Gap (Looking West).

There are two human sized gaps between fence posts on the northern end of the Oak Park Avenue bridge. It is recommended that a steel plate is welded to one of the posts at each location within 1 year to serve as a barrier. This work shall consist of welding a steel plate to one of the posts at each location.
- **Woven Wire Fence Repair (X6650204)**

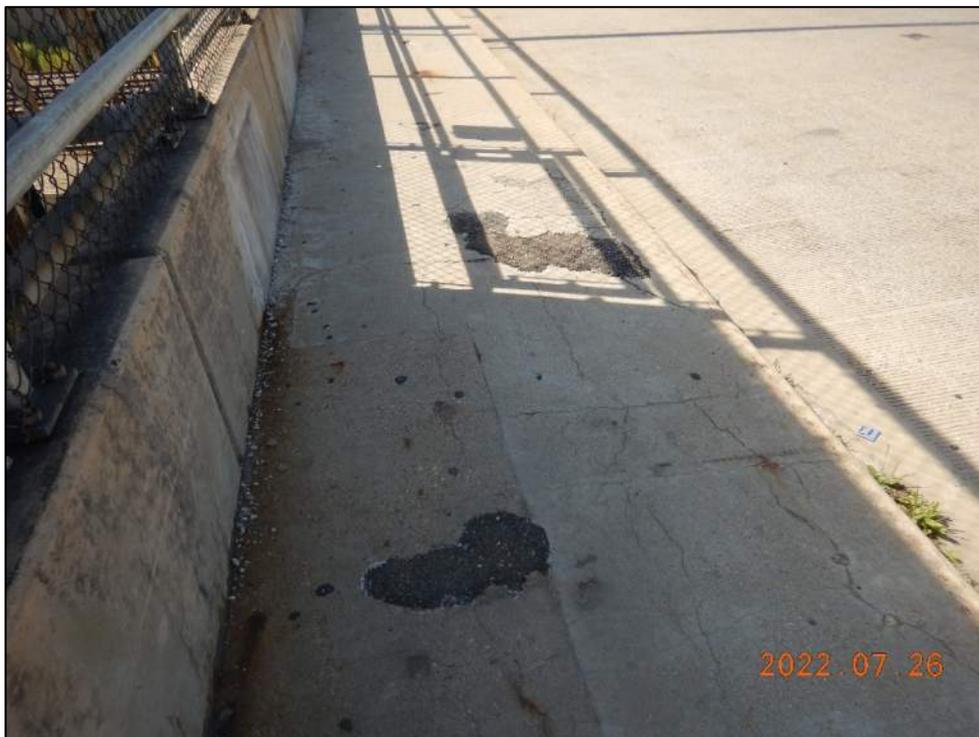
Photo E6: Sidewalk HMA Patches (Looking South).

Only a handful of potholes on the Oak Park Avenue bridge were observed. It is recommended that all HMA patch work be completed within the next 5 years. This work shall be performed in accordance with Section 442 of the IDOT SSRBC and shall consist of removing the existing pavement and replacing it with HMA pavement.

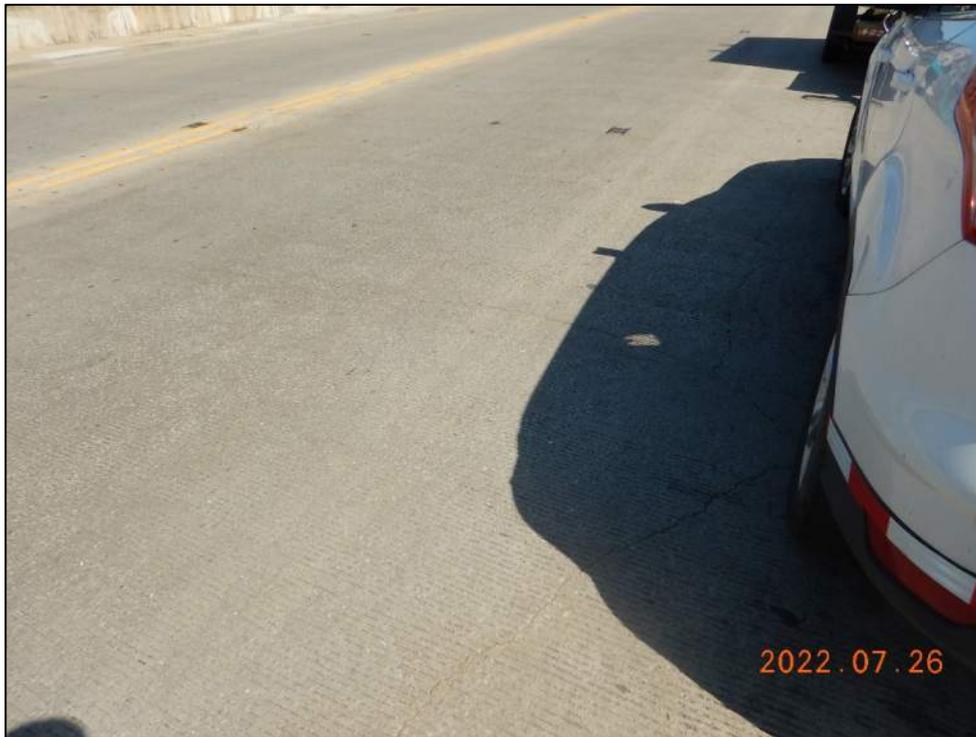
Photo E7: Map Cracking (Looking North).

A concrete sealer is recommended within 5 years to prevent further delamination in the deck. This work shall consist of applying a concrete sealer or protective coat upon the entire top surface of the deck.

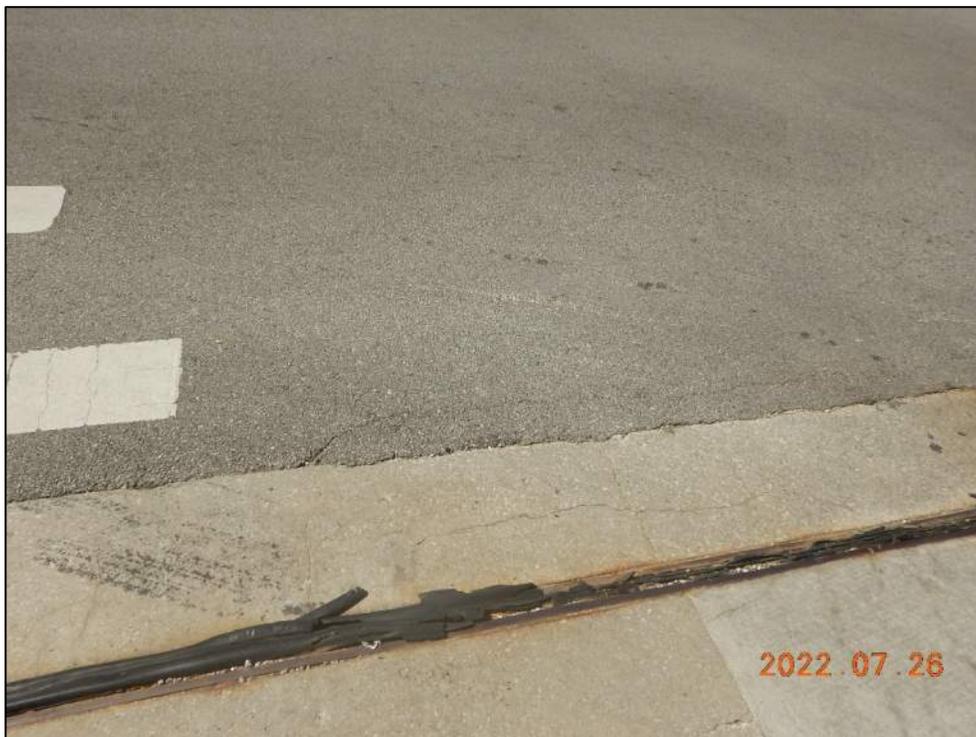
Photo E8: Damage to Expansion Joint at the South Abutment (Looking West).

The expansion joint at the south abutment has experienced serious compression and is damaged, "spilling" onto the pavement. It is recommended that the damaged portion of the expansion joint be removed and replaced within the next 2 years to prevent further damage. This work shall consist of removing and replacing the damaged portion of the expansion joint.
- **Class D Patches, Type I, 4 Inch (44201690)**
