# 5-Year Plan for Bridges Over I-290

August 2022

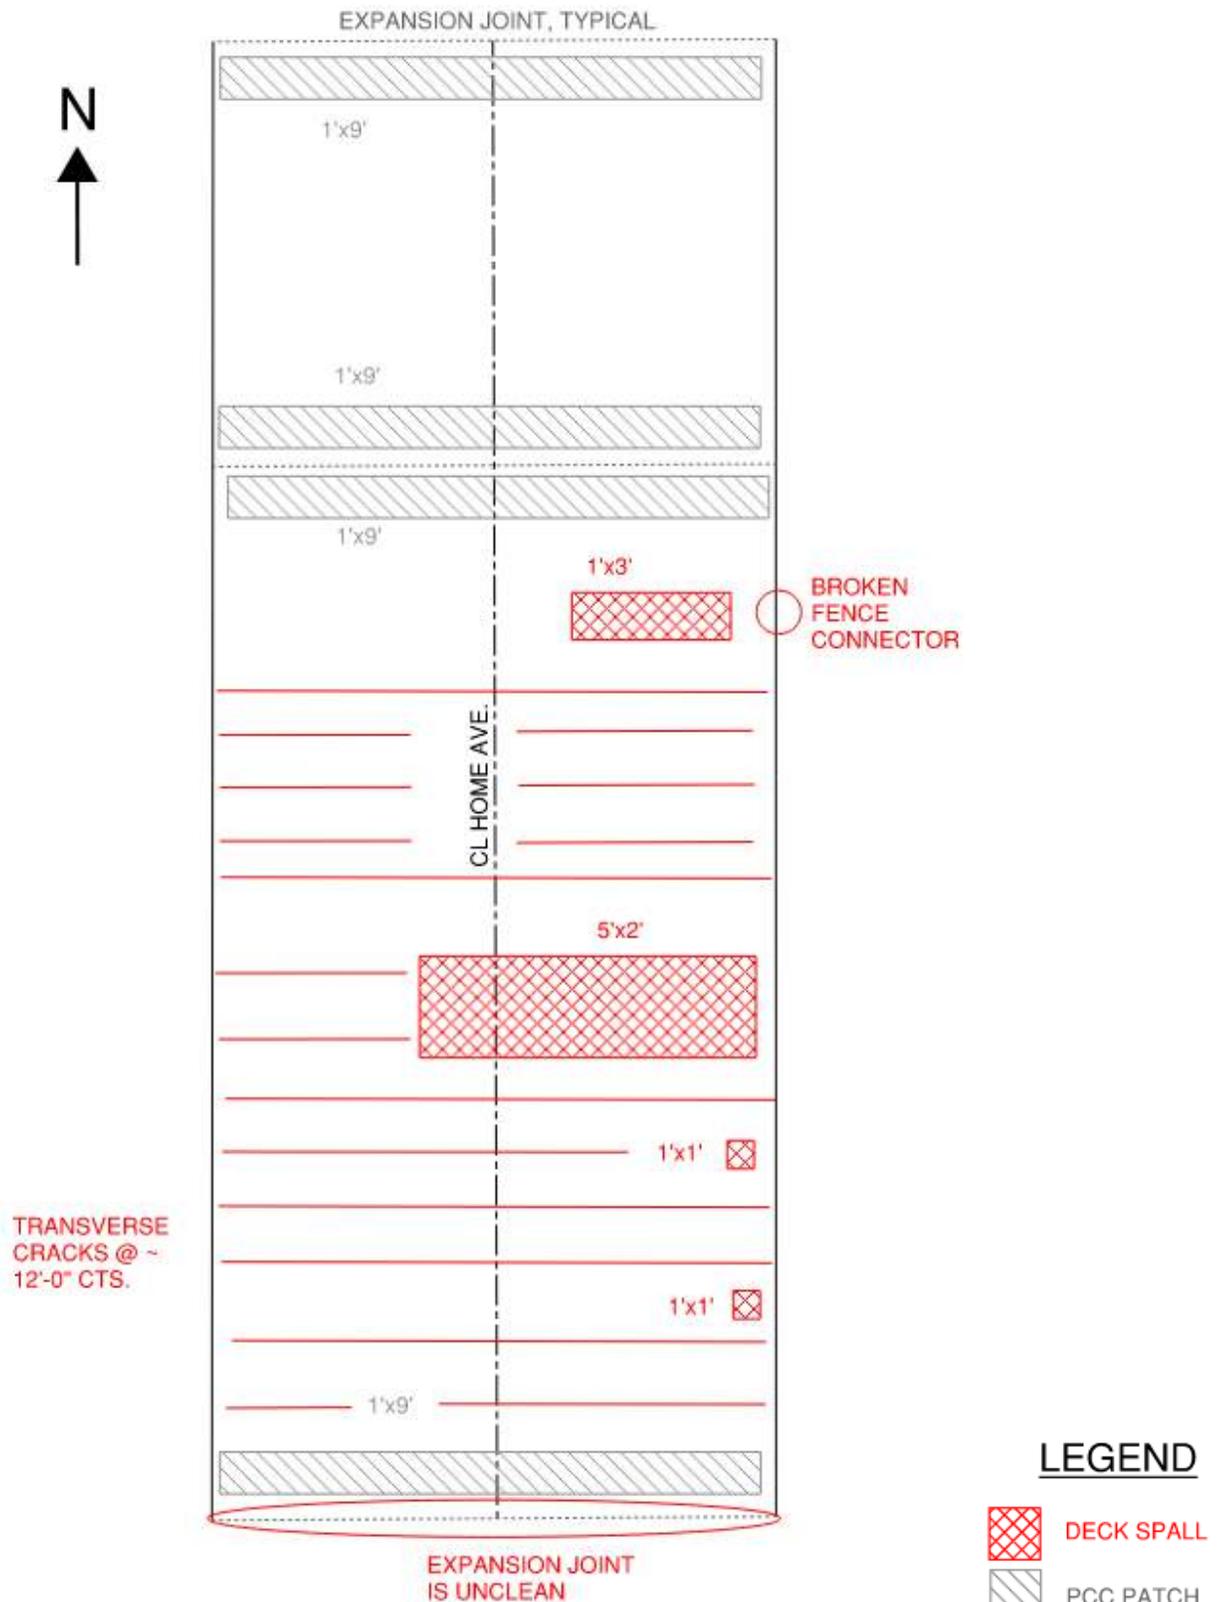
TRANSVERSE  
 CRACKS @ ~  
 12'-0" CTS.

- \* ~ 10% OF CHAIN LINK FENCE ANCHORS ARE NOT CONNECTED TO THE CHAIN LINK FENCE
- \* ~ 35% OF THE DECK SURFACE AREA HAS BEEN REPAIRED WITH PCC PATCHES THAT ARE NOT SHOWN
- \* ~ 33% (EVERY THIRD POST) OF THE FENCE POSTS HAVE FAILED BASE PLATE WELDS OR ARE MISSING ANCHOR BOLTS

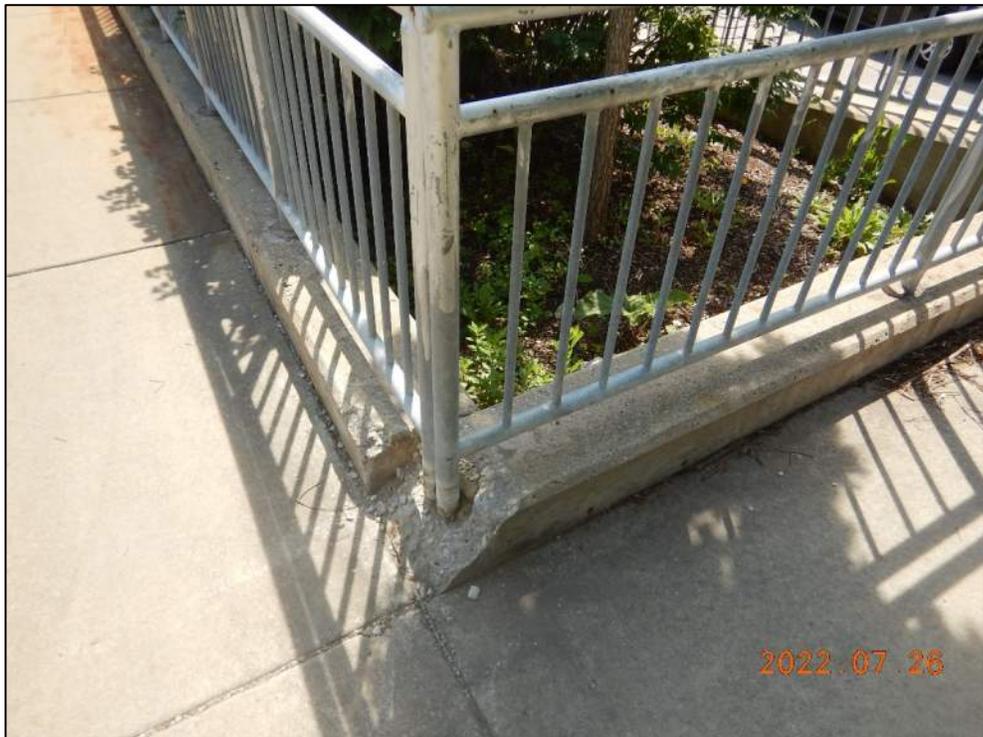
Photo F2: Curb Deterioration.

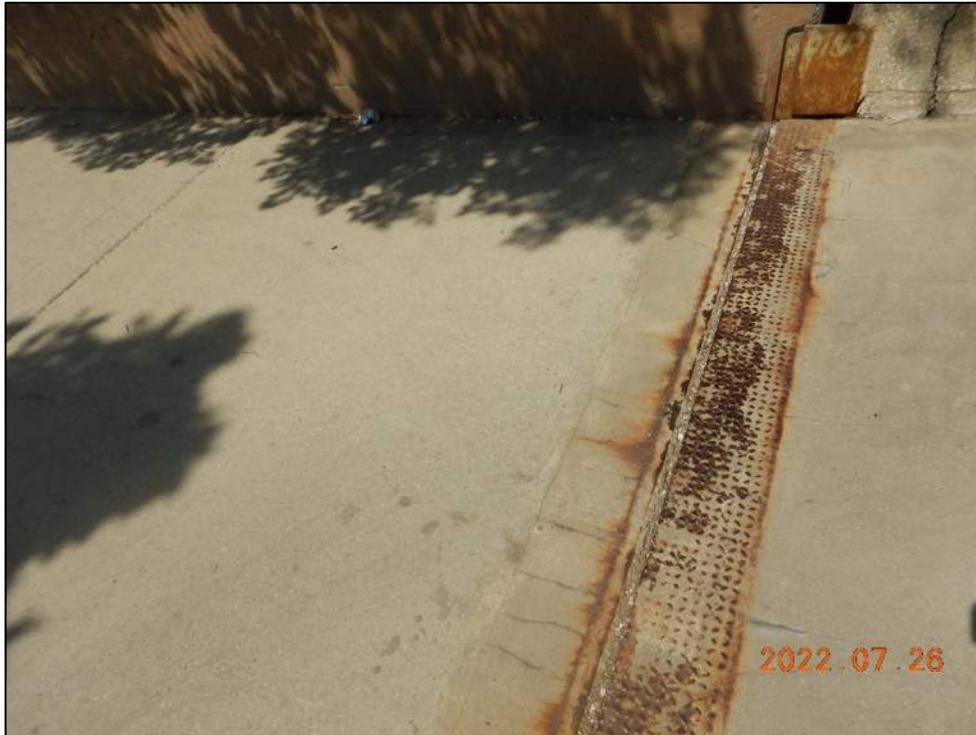
Photo F3: Expansion Joint at the South Abutment (Looking West).

It is recommended that the expansion joints be blast cleaned within 2 years to help assess any additional repair locations and remove any debris that may impact the joints’ performance. This work shall consist of either dry abrasive blast cleaning, wet abrasive blast cleaning, or water jetting with abrasive injection the surface to be cleaned so that the surface is free of all visible oil, grease, dirt, dust, mill scale, rust, paint, oxides, corrosion products, and other foreign matter, except for staining.

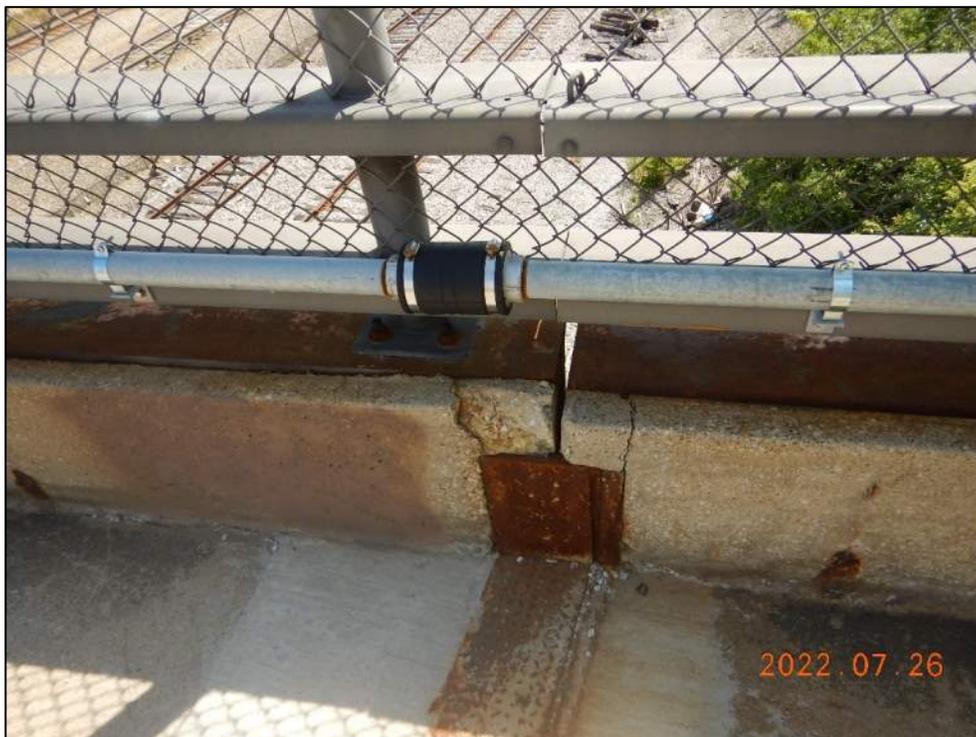
Photo F4: Curb Damage Near Expansion Joint at the South Abutment (Looking East).

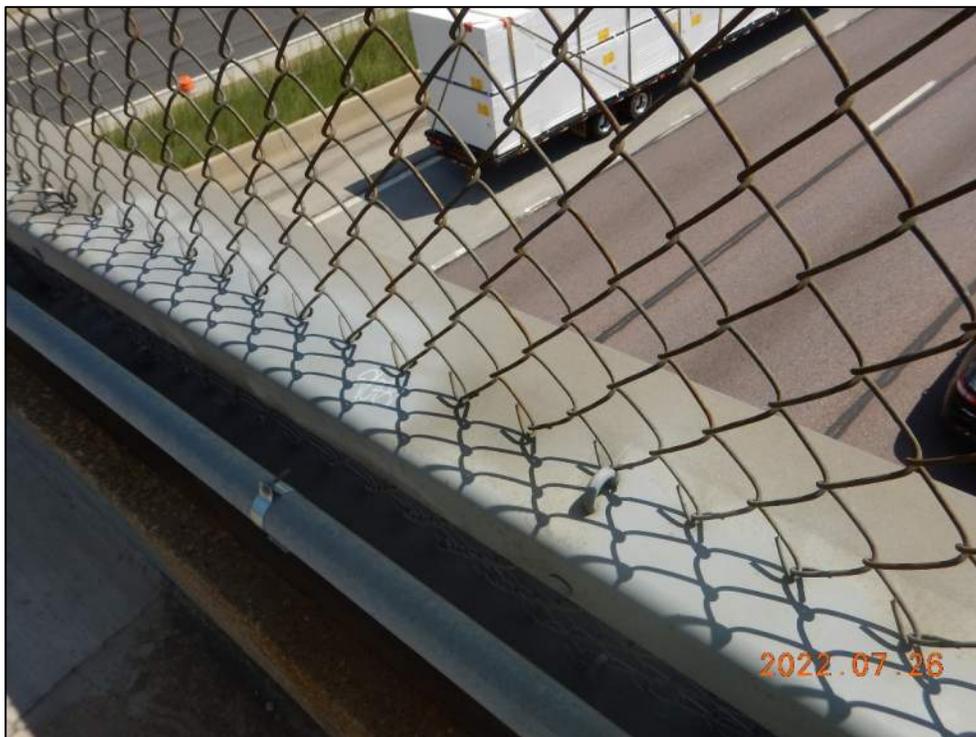
Photo F6: Disconnected Fence (Looking East).

Approximately ten percent of chain link fence anchors are no longer connected to the chain link fence. The fence should be reattached to the anchors. About 33% (~35) of the fence posts have failed base plate welds or anchor bolts. The posts should be reconnected to the bridge parapet. This work should be completed within 1 year. It shall consist of grinding the galvanized coating off both the poles and the base plates, including the welded areas, performing field welding with a certified welder – applying a fillet weld of the same size as existing. For welds that have separation beyond 3/16”, place a similar filler metal (shim/spacer) in the joint before welding. Use SMAW (stick) welding procedure. Touch-up repair welds with cold galvanize spray repair.

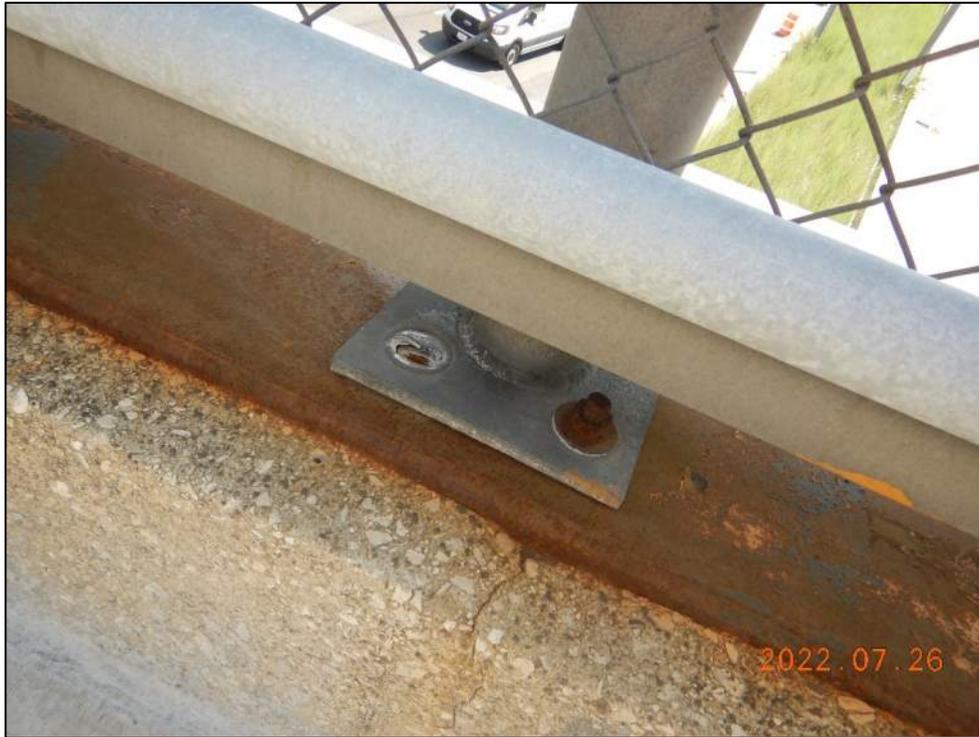
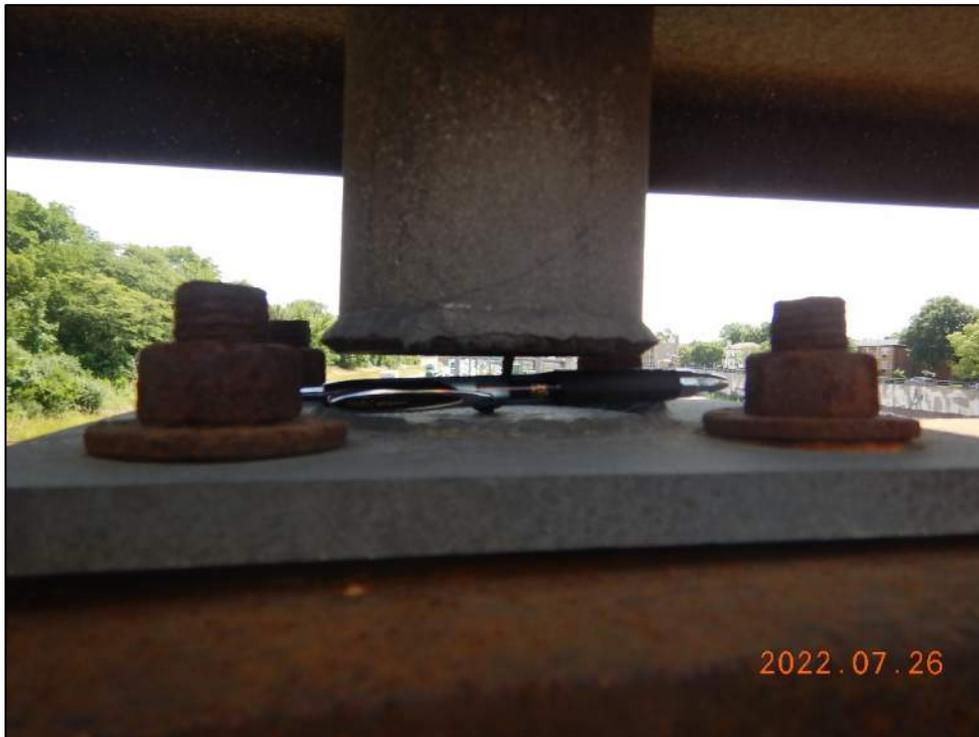
- Approximately 33% (~35) of the fence posts have either failed base plate welds or anchor bolts (Photos F7 and F8).
- Approximately 10% of chain link fence anchors are not connected to the fence (Photo F6).
- Debris has accumulated on the bridge expansion joints (Photo F3).
- Spalls were observed on the top side of the deck.
- Full width transverse cracks in the deck approximately every 12'-0" between the expansion joints at the south abutment and pier 5.

Photo F7: Missing Anchor Bolt (Looking East).

Photo F8: Failed Handrail Post Weld (Looking East).
