Walker Consultants (Walker) was on site on the date listed above to perform a limited slab post-tensioned (PT) tendon evaluation of the second tier (first supported tier), west bay of the Village of Oak Park Avenue Parking Structure located at 720 North Boulevard in Oak Park, Illinois. The following is a summary of our findings and conceptual repair recommendations based on our limited slab PT tendon evaluation.

Village of Oak Park Avenue Parking Structure  
 Limited Slab Post-Tensioned (PT) Tendon Evaluation

Walker No. 31-009465.20  
 Field Report

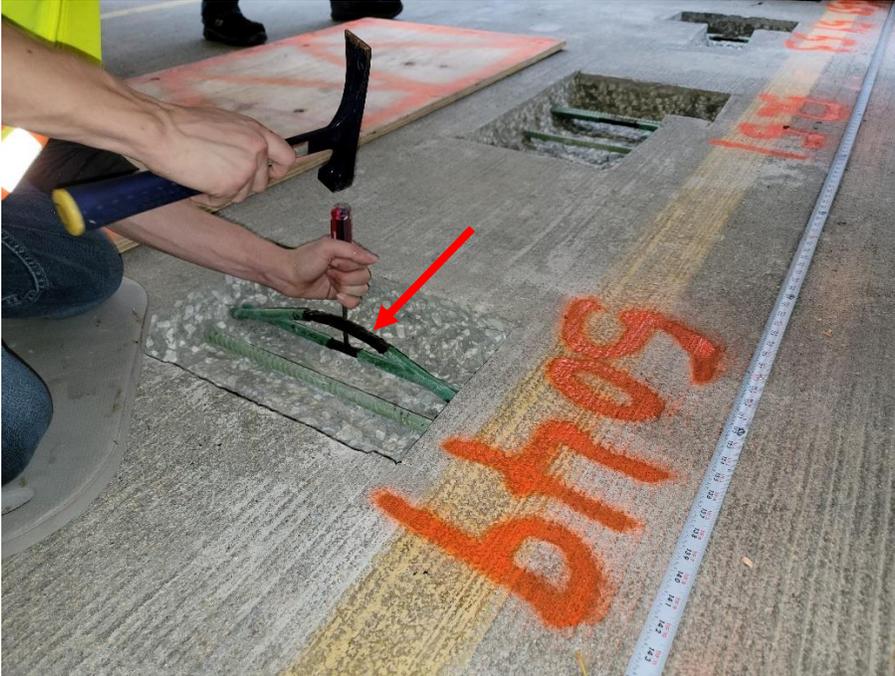
Photo 5. Walker performing “screwdriver penetration” test on slab PT tendons. Note broken/de-tensioned tendon (arrow).

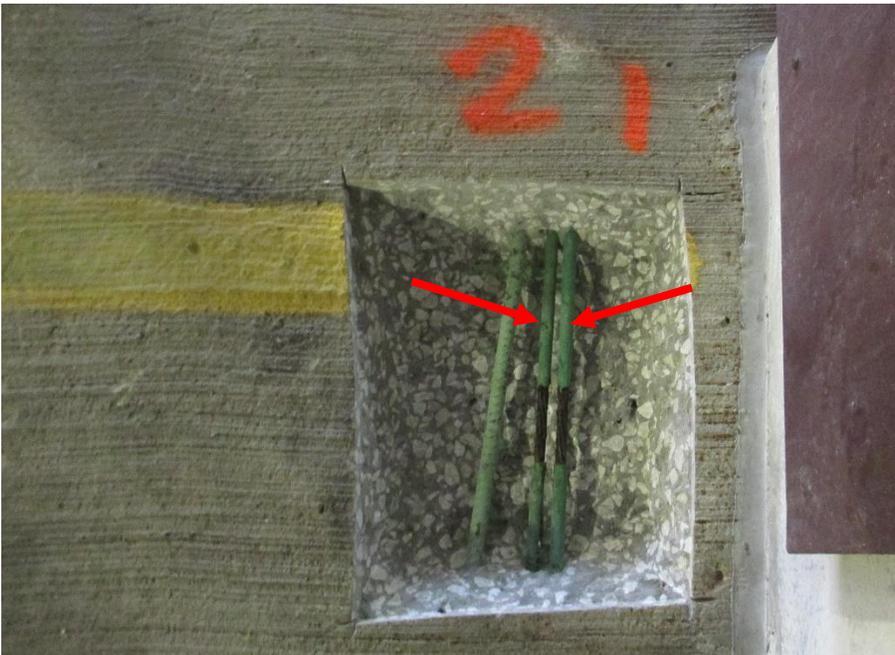
Photo 8. Example of tensioned (good) PT tendons in excavation.

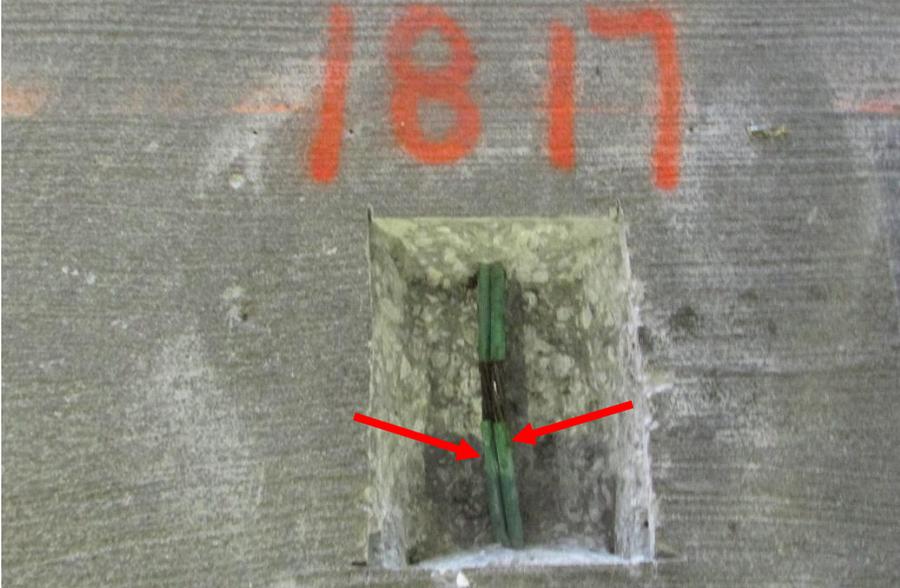
5. Out of the approximately 34 total full-length tendons reviewed within this bay, 14 tendons were identified during our limited PT tendon evaluation as being broken/de-tensioned and recommended for repairs. In isolated areas, several broken/de-tensioned tendons were located adjacent to other broken/de-tensioned tendons in the same general area, leaving few slab tendons with tension within these areas.

Photo 9. Example of broken/de-tensioned PT tendons identified during the evaluation.

9. Walker recommends that the slab be repaired or strengthened by one of the following two methods:
  - a. Method 1: Repair slab PT tendons - To repair the slab tendons in place, the broken/corroded tendons will be removed, and new tendons will be installed and restressed. The necessary temporary shoring will require closing the parking structure for approximately 8 to 12 weeks for this repair method. We would expect the approximate repair design life for this method to be

- b. Method 2: Install new steel beams to permanently support the slabs - Installation of new steel beams will occur on the underside of the slab for this entire bay. The new steel beams will be supported by the existing PT beams. The parking structure will likely be able to remain open during this repair method. We would expect the approximate repair design life for this method to be 20+ years along with proper maintenance repairs. Our opinion of probable construction cost for this method ranges from approximately \$500,000 to \$600,000.

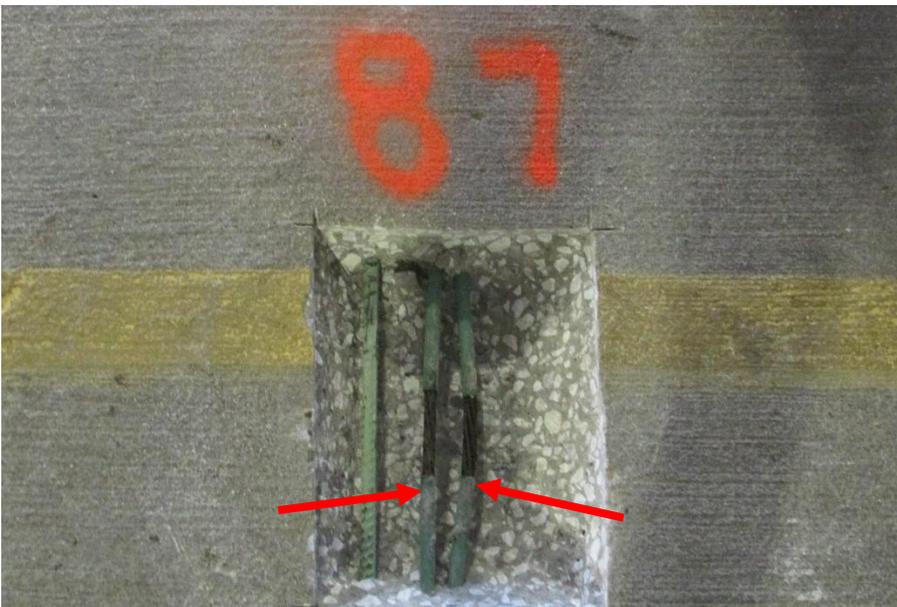
Photo 10. Example of broken/de-tensioned PT tendons identified during the evaluation.

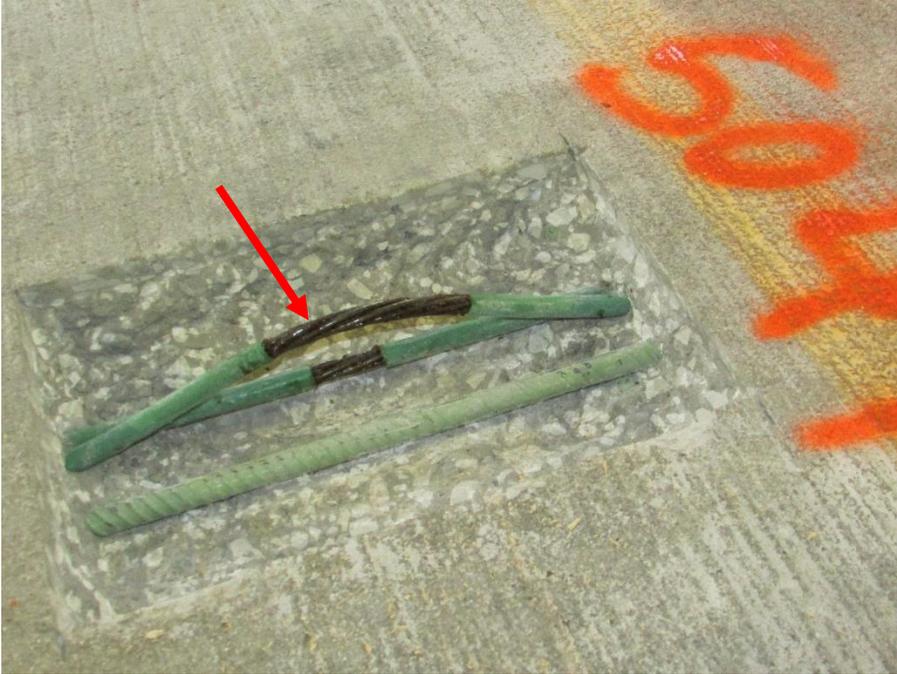
Photo 11. Example of broken/de-tensioned PT tendons identified during the evaluation.

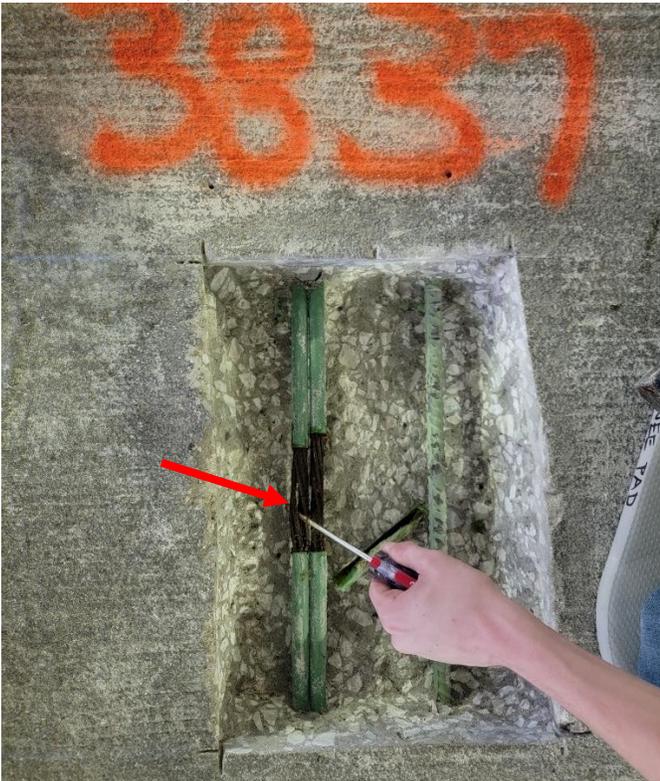
Photo 12. Example of broken/de-tensioned PT tendons identified during the evaluation.

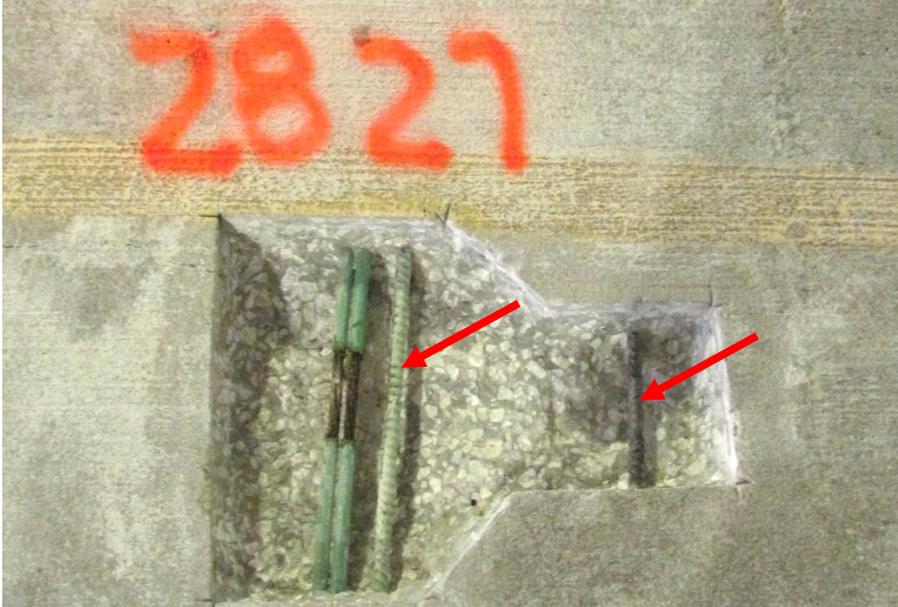
7. Walker observed mild steel reinforcement in the slab within the investigative openings. These reinforcing bars help to supplement the slab structural capacity. However, even with the reinforcing bars, the slab needs the original PT tendons to have code required full structural capacity.

Photo 13. Example of slab excavation showing mild steel reinforcement.
