# HISTORIC STRUCTURES REPORT: **FOLEY-RICE DEALERSHIP (1924-27)**

THE SCHOOL OF THE ART INSTITUTE OF CHICAGO  
HISTORIC PRESERVATION PROGRAM  
MAY 2008

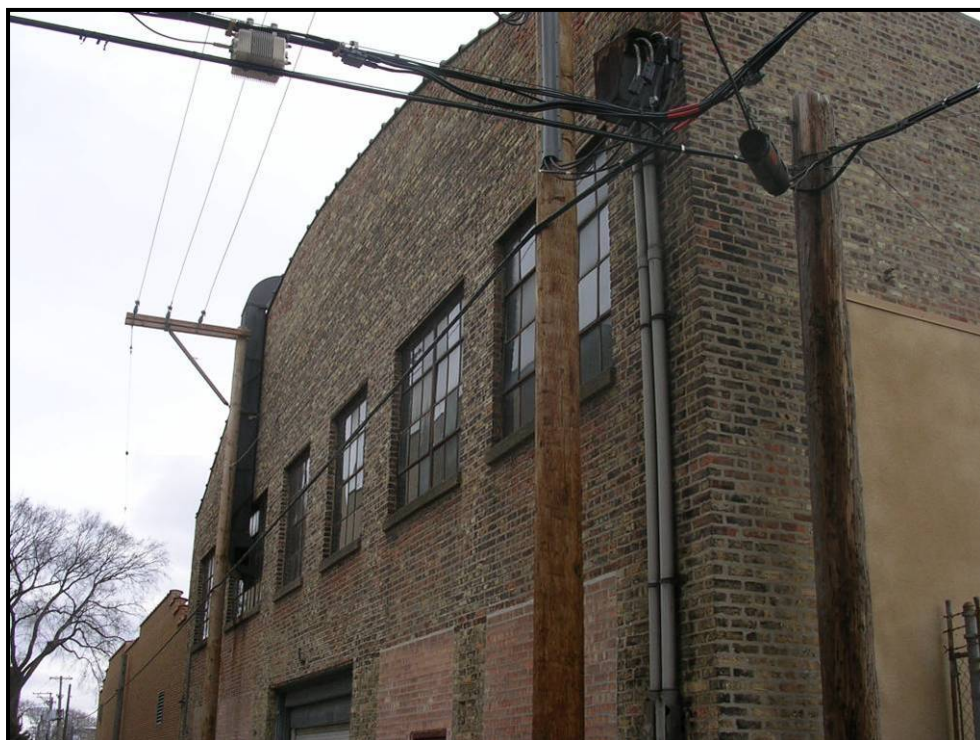
The 1927 building has retained the majority of its American bond, common brick wall, although repairs in a different red-brick are evident in several areas [Figure III-9]. This same brick has been used to fill in what appears to have been three windows and an entrance on the ground floor of the building. The barrel-vaulted roof is evident from this side of the building, as there is no parapet. Pipes leading to the internal gutters on the roof are visible on the interior of the building. The coping used here has the same profile as that on the 1924 building side; however, it is a dark grey color. Continuing with the use of steel-sash awning windows in the service areas of the building, the second floor has six of these windows, resting on cast-stone sills. This side of the building also has a garage door, which, as on the east facade, has a modern aluminum door fitted into the original wood framing of the previous door. To the right of the garage door is an

**Figure III – 9: North Façade  
Significant infill**

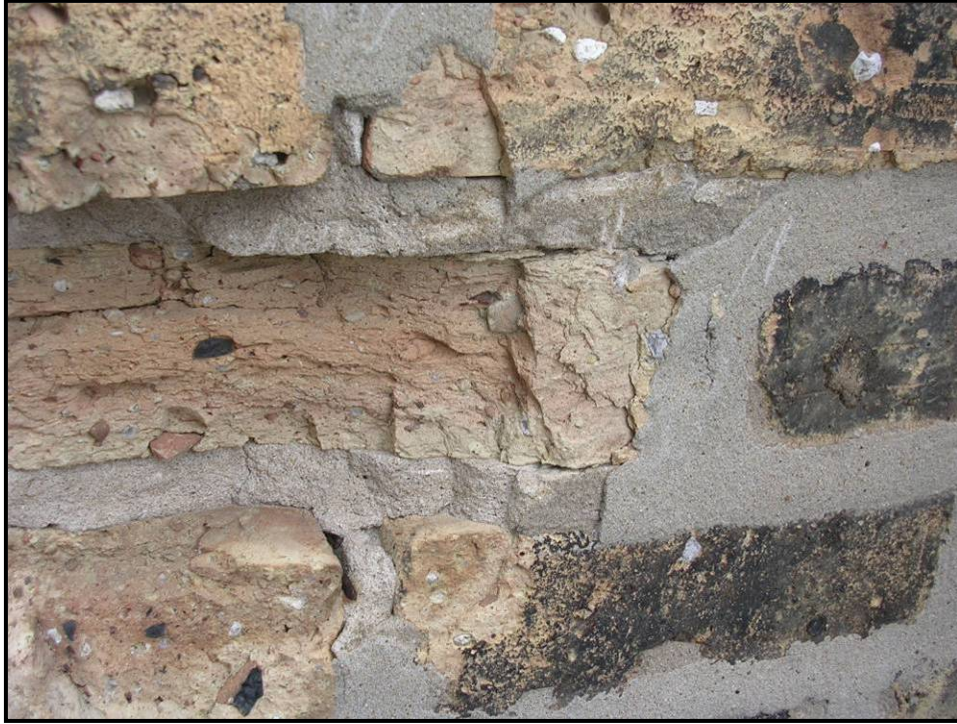
**Figure IV - 1: View of Original Mortar**

Due to its grey color and hardness when scratched appears to have some Portland cement in it

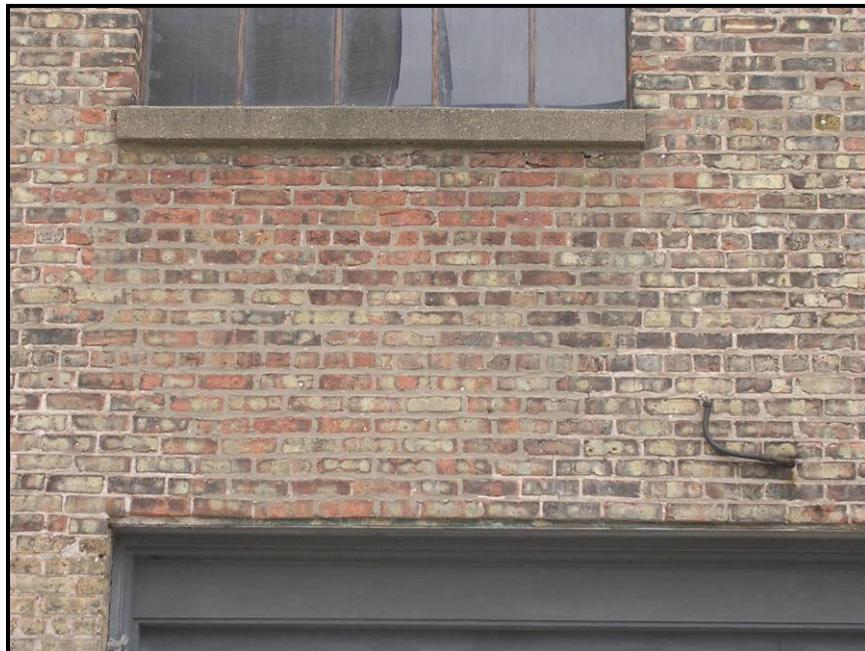
**Figure IV – 2: North Façade Window**

The brick under the window sills has been replaced and continues to erode

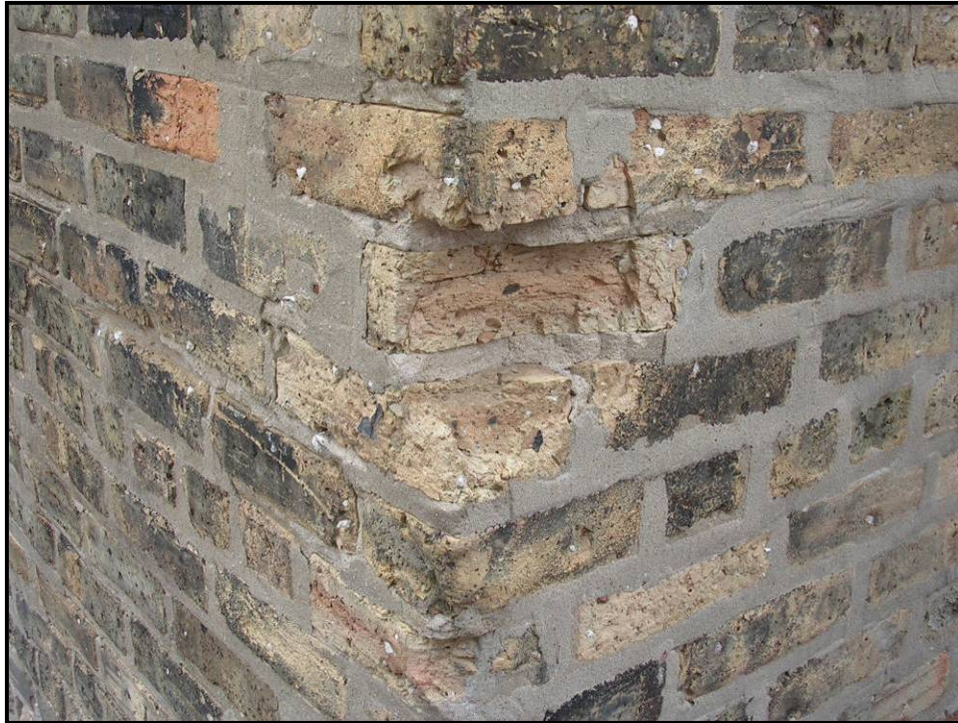
**Figure IV – 3 – North Façade  
Crumbling brick due to impact**

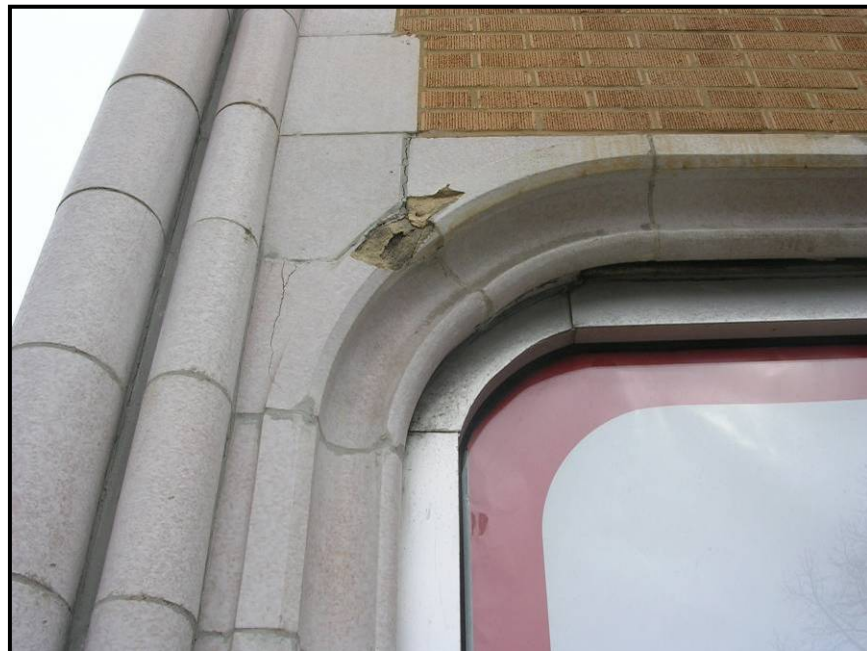
**Figure IV - 4: Cracked Terra-Cotta  
At corner of display window**

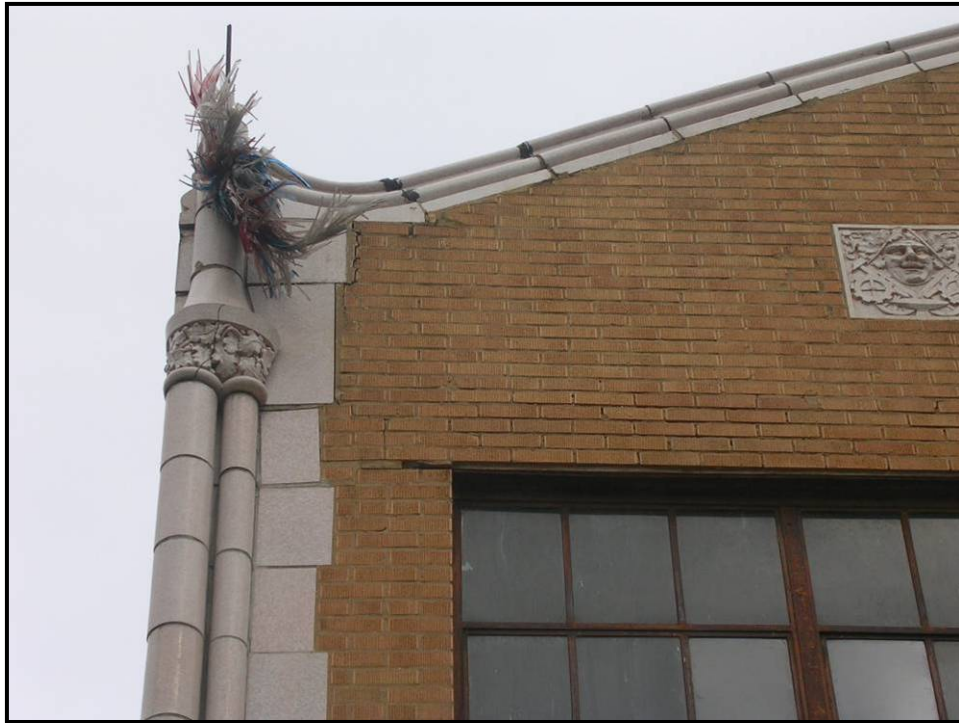
**Figure IV – 5: Terra Cotta Quoining on the top  
Out of plumb with the rest of the building**

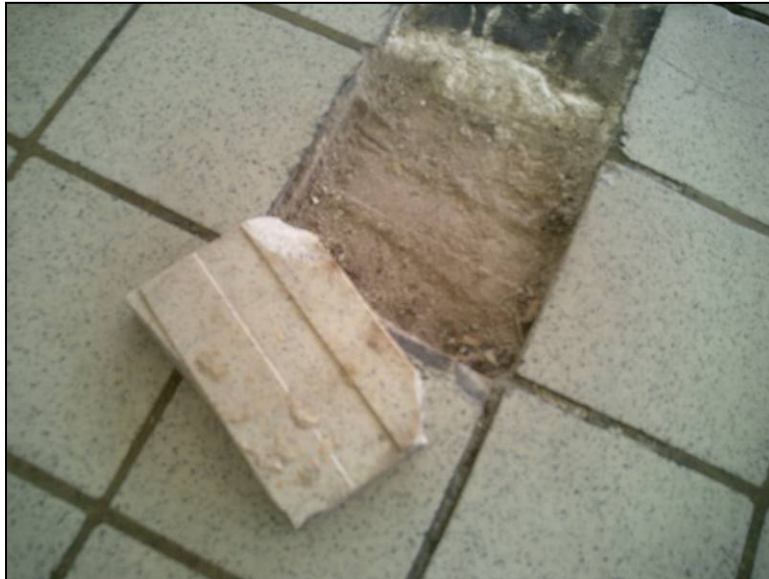
**Figure IV – 10: Cracked tile**

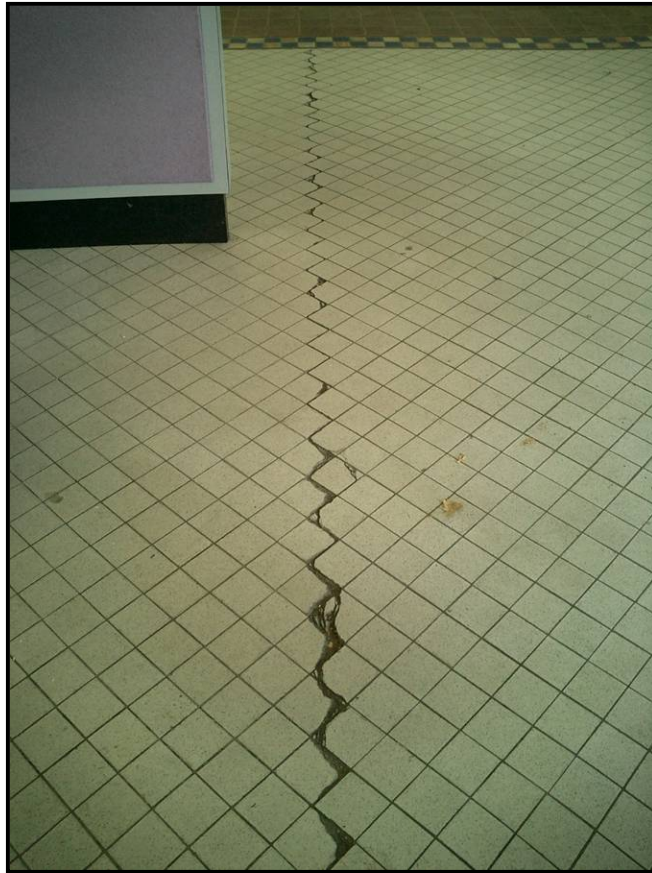
**Figure IV – 11: Continuous cracking**

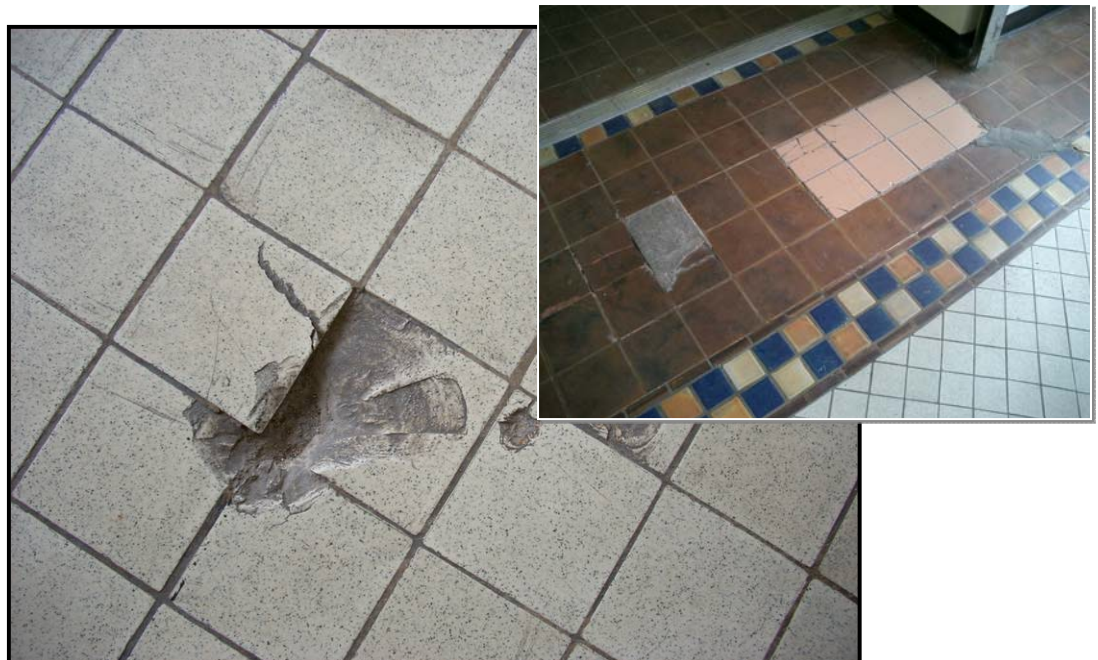
**Figure IV – 12: Impact damage & Inappropriate Repair & Replacement**

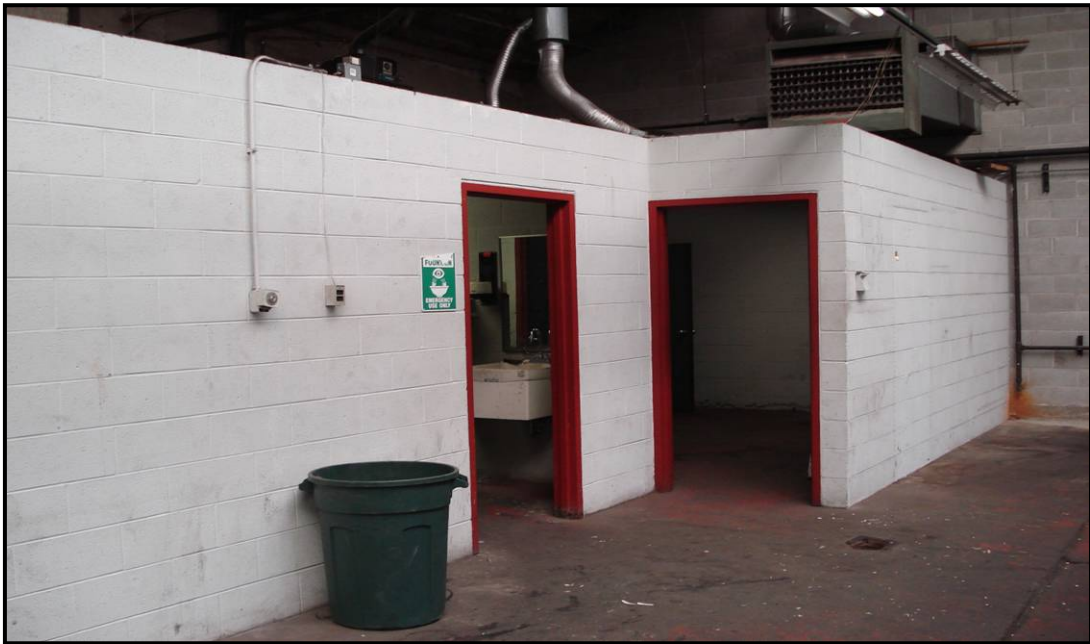
During the inspection of the building we came across a basement that is not currently in use. There was approximately one to three inches of water in this basement with some of the original fixtures that are sitting in this water corroding. What the basement does yield is information about the original mechanical systems.

**Figure IV-14: Basement entry; unable to investigate basement foundation due to standing water**

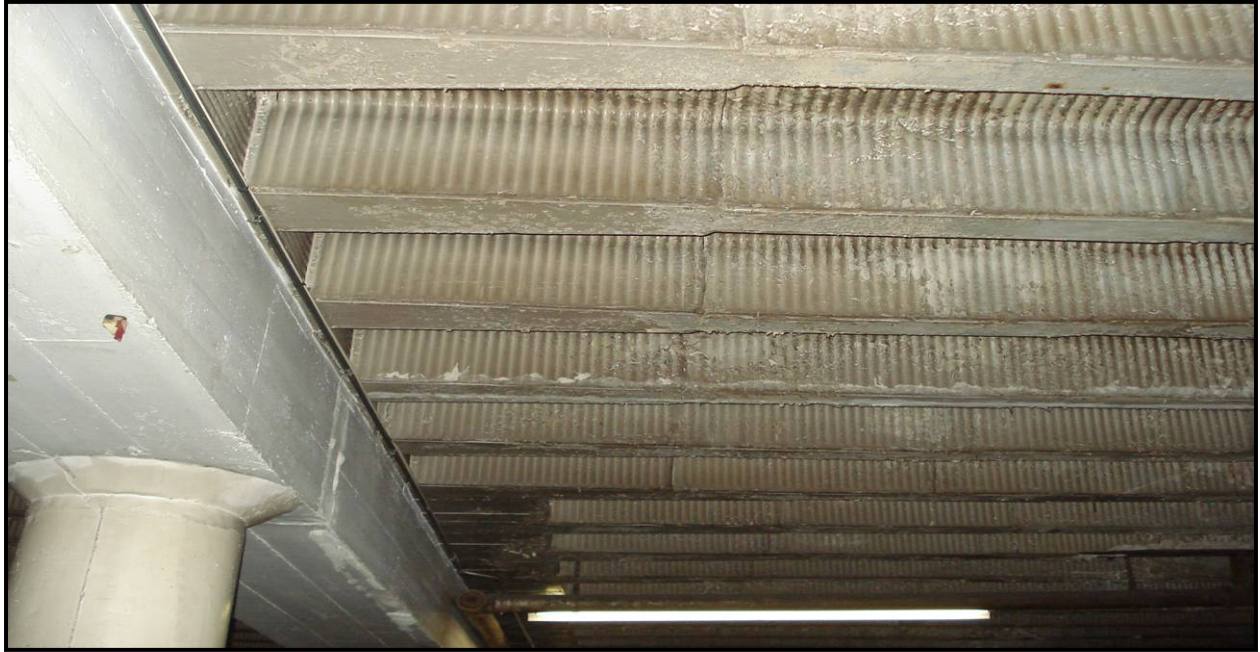
**Figure IV- 15: Bowed concrete support beam in West service area.**
