LAKE STREET  
PLAN AND PROFILE

**GROUND  
PENETRATING  
RADAR  
SYSTEMS, INC.**

*Subject: Ground Penetrating Radar (GPR) scanning at downtown area Oak Park,  
IL street scape extending along Lake St from Harlem to Euclid Ave and  
Marion Street from Lake Street to Ontario Street.*

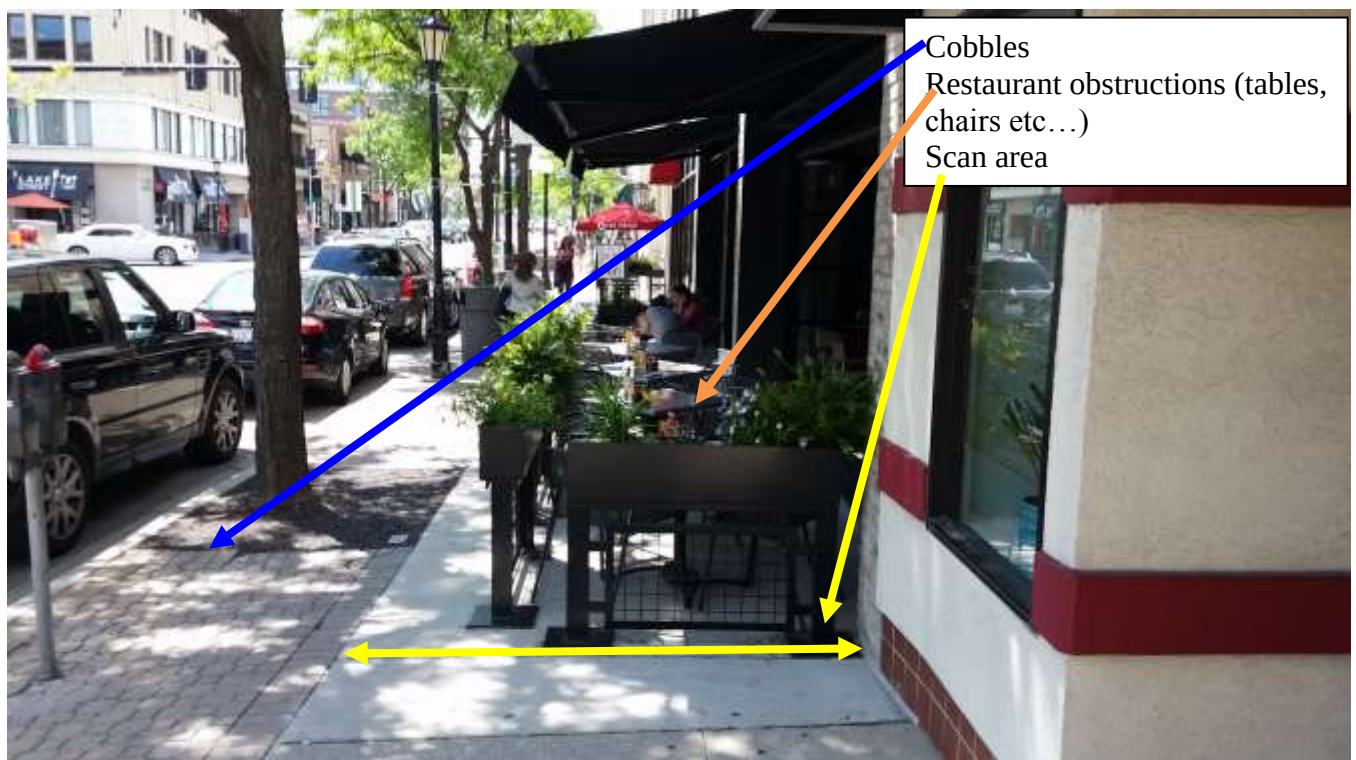
This image shows some of the obstructions found along the scanning path.

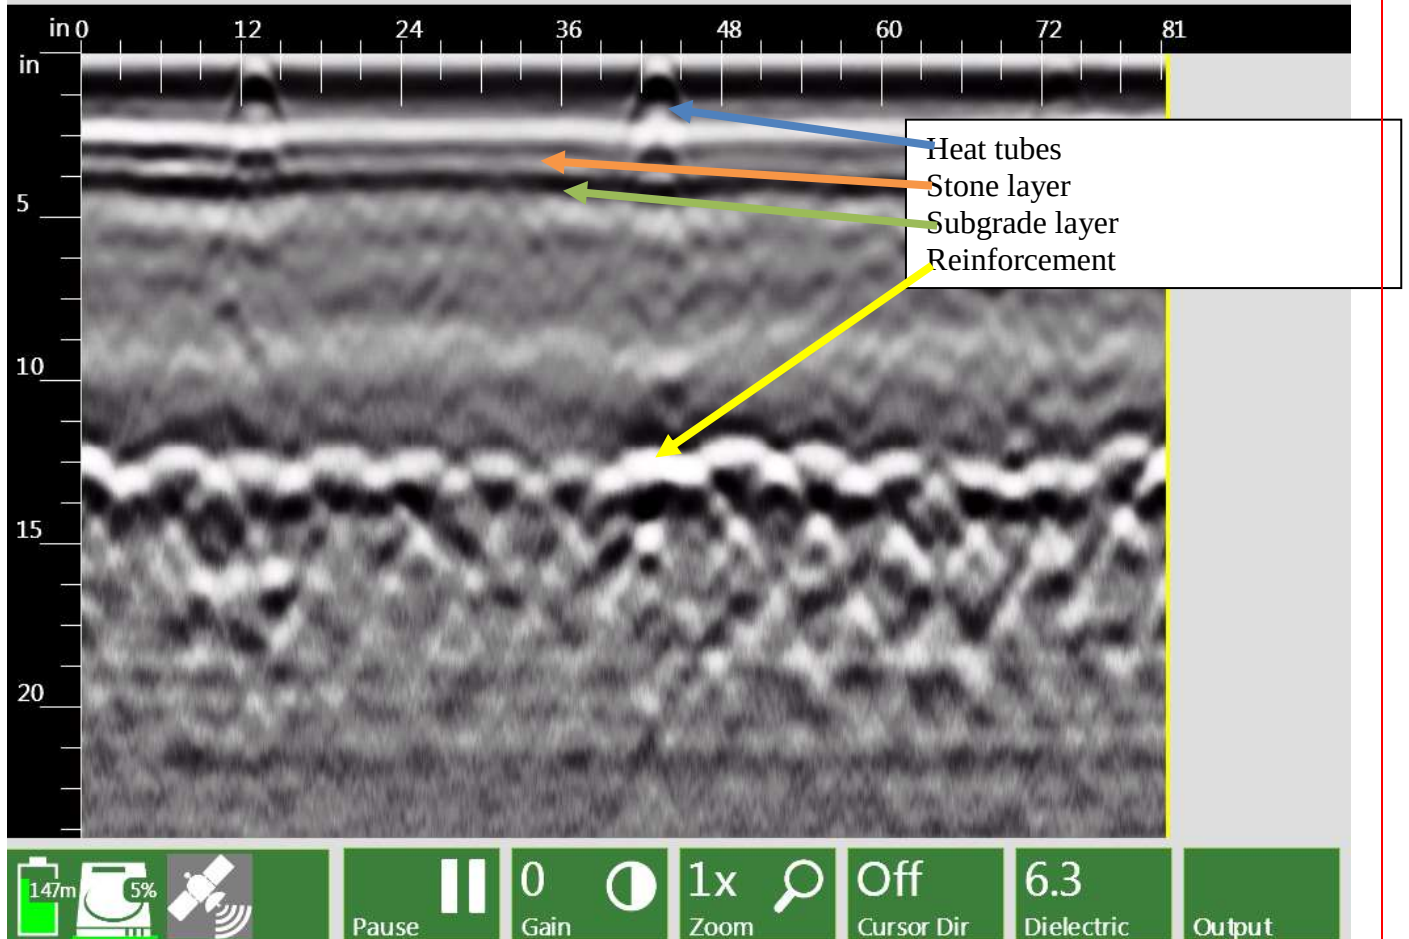
Existing believed to be Blue Stone Construction

Existing blue stone construction was found to have heating tubes and reinforcement present, not believed to be a vault. This area was found along the south leg of Marion Street

This image shows what is believed to be existing blue stone construction. This area was found along the south leg of Marion St

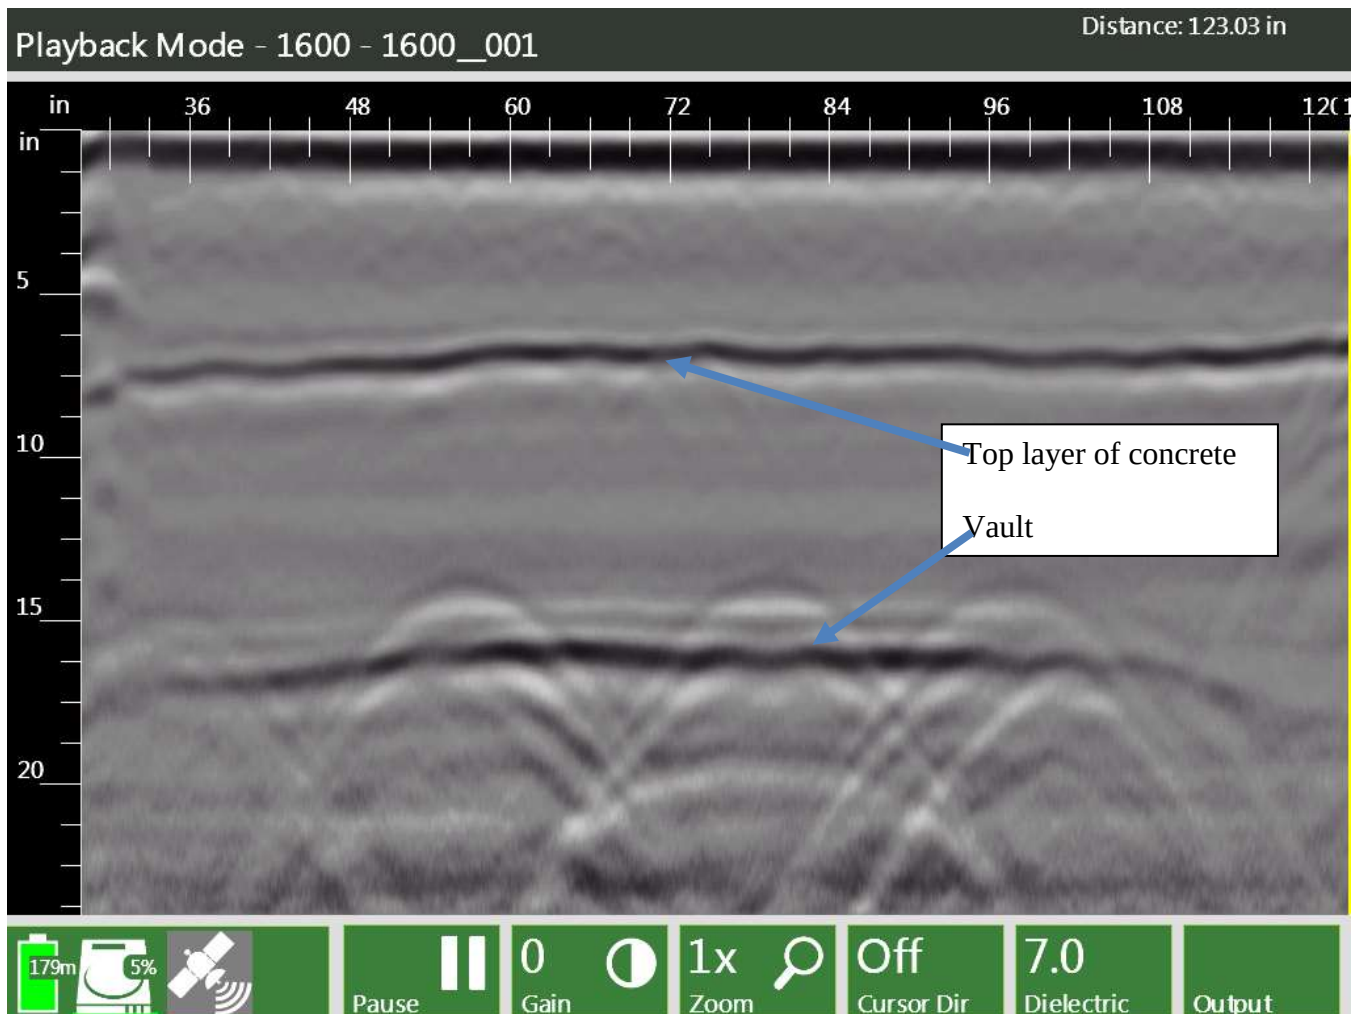
## **Area 1**

Suspect area believed to a vault based on the data and the size was 12' x by full length of building along south and west sides

This image is in the north to south scan direction. The top layer of concrete appears to be 6 to 7 inches thick and the bottom of the vault is at approximately 16 inches. Depth scale on the left

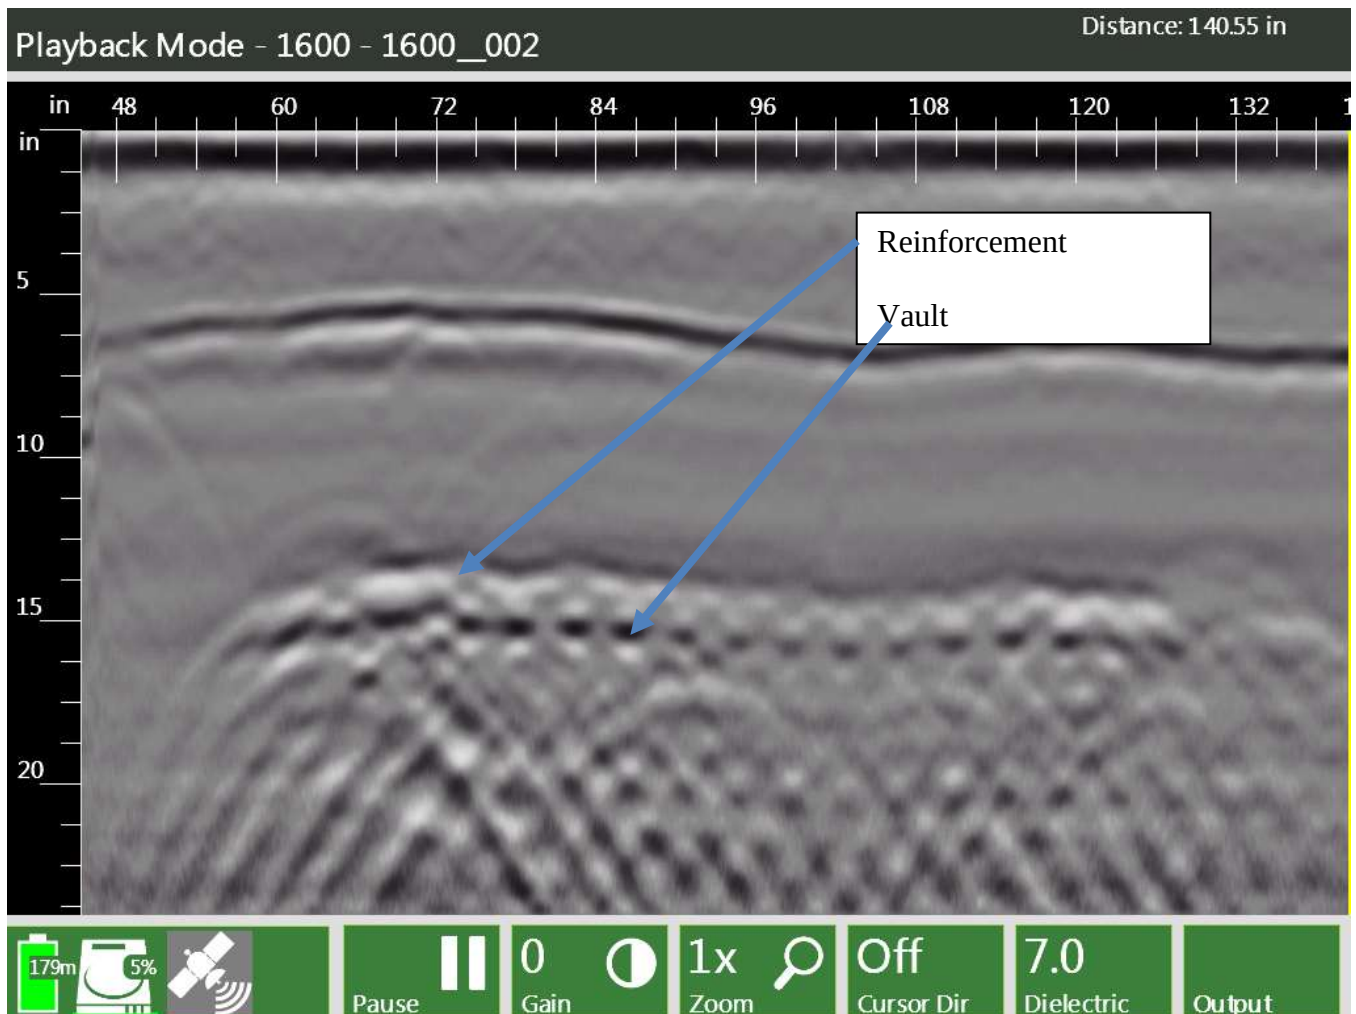
This image is from the scan in the east to west direction

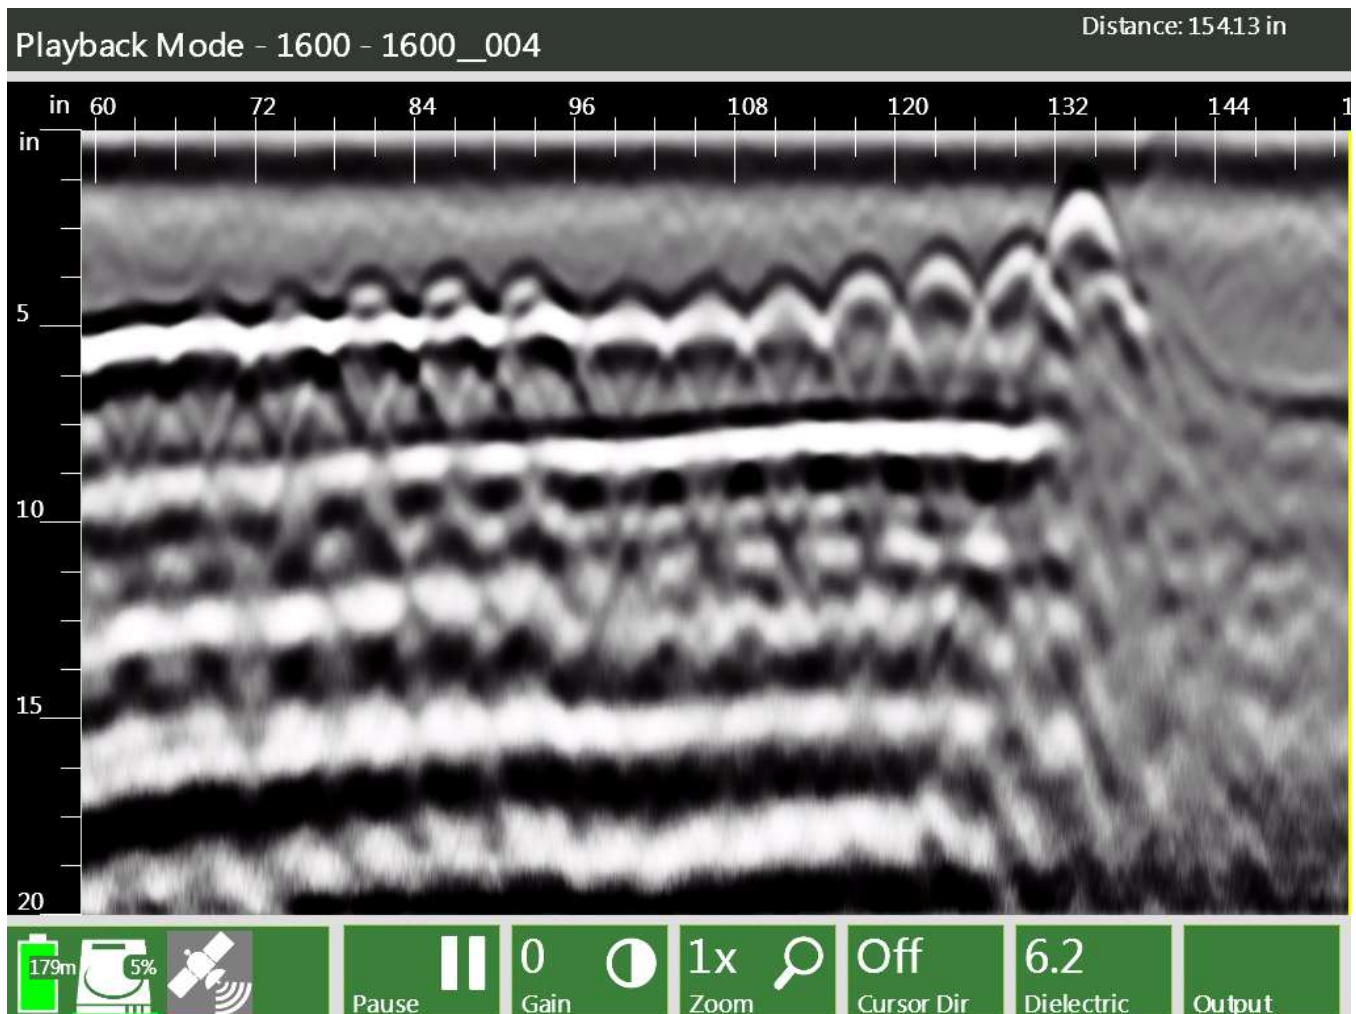
## **Area 2**

Suspect area believed to a vault based on the data and the size was 10 x 12 feet

This image is from the north to south scan direction . Concrete appears to be approximately 5 to 6 inches thick

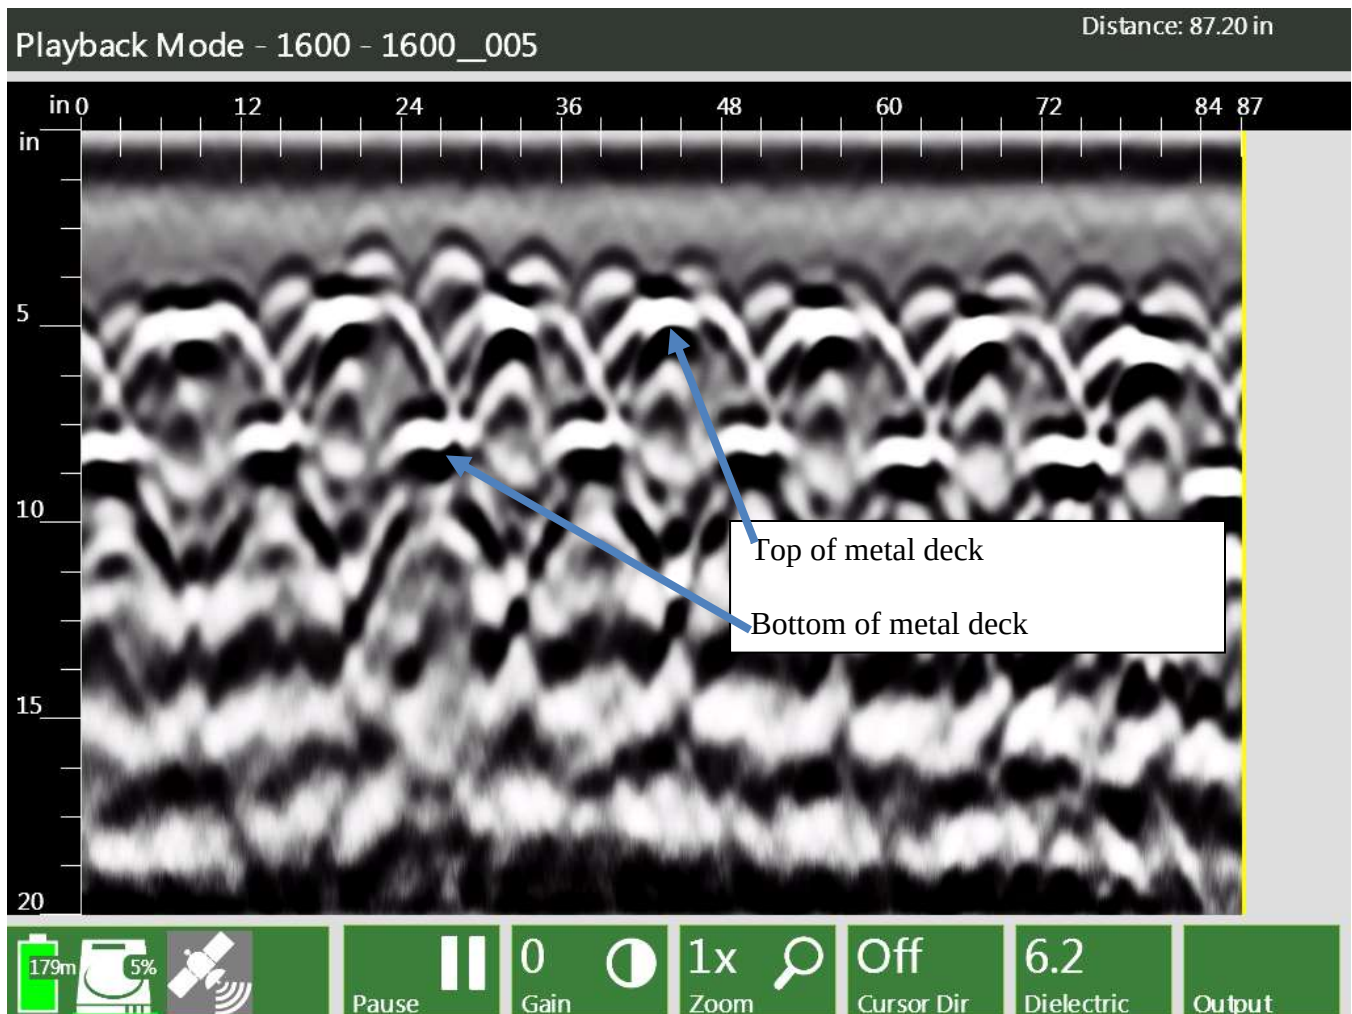
This image is the east west direction. Concrete appears to be a pan deck construction with top of concrete approximately 5 inches and bottom approximately 7 inches.

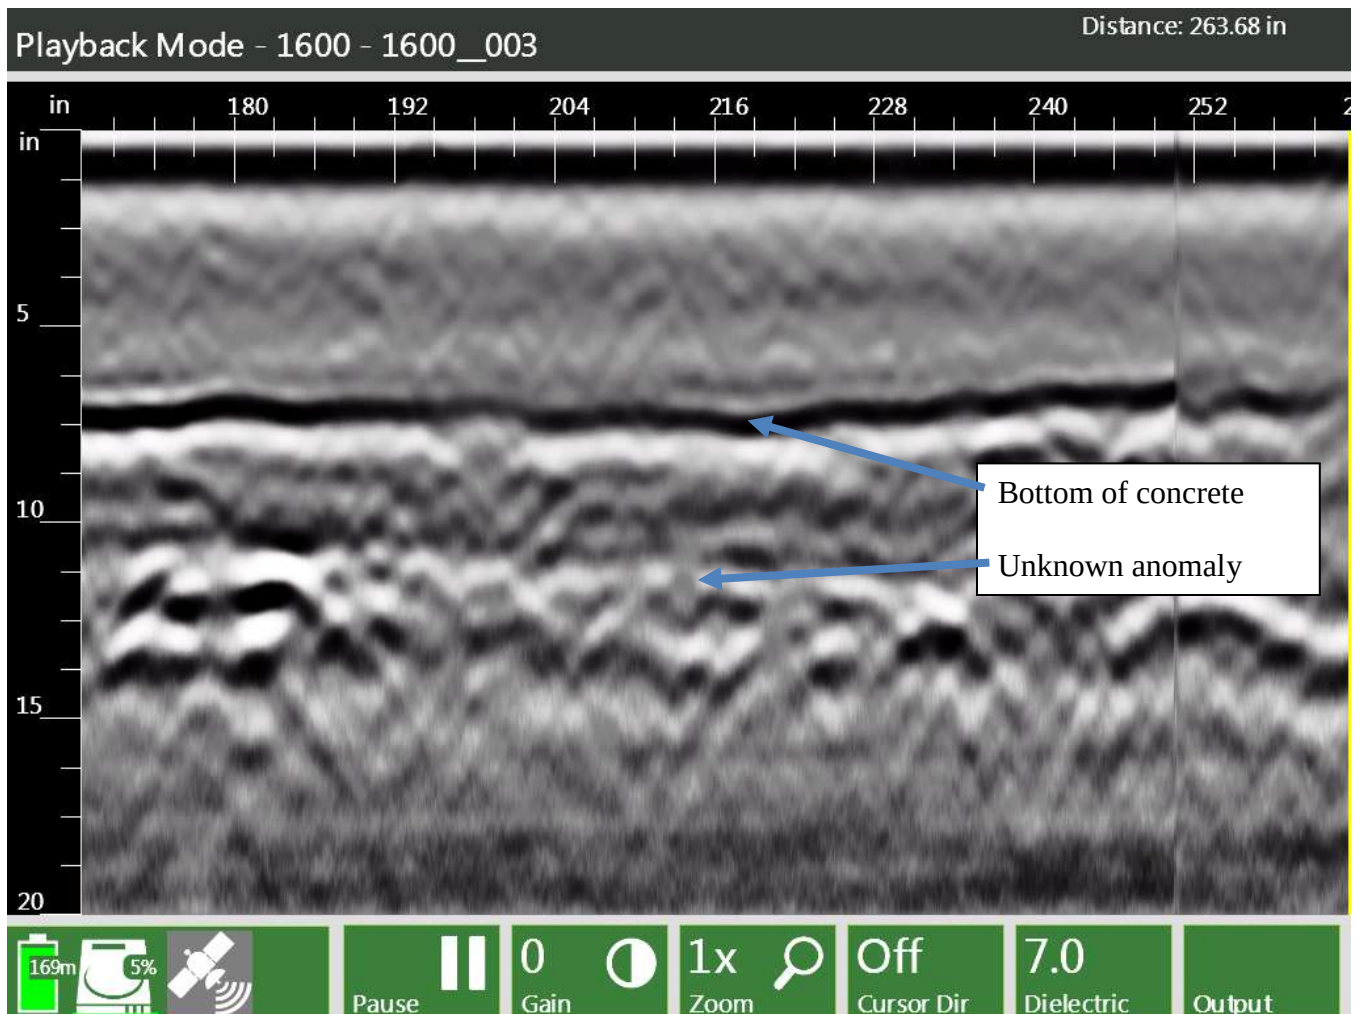
### **Area 3**

Suspect area based upon the data unknown anomaly was present, anomaly may be vault or other unknown the size was 3 x 33 feet

This image shows data of an unknown anomaly. The top of the anomaly is at 10 inches in depth. Unclear if the anomaly is a vault or some other unknown. In this area further investigation may be required.

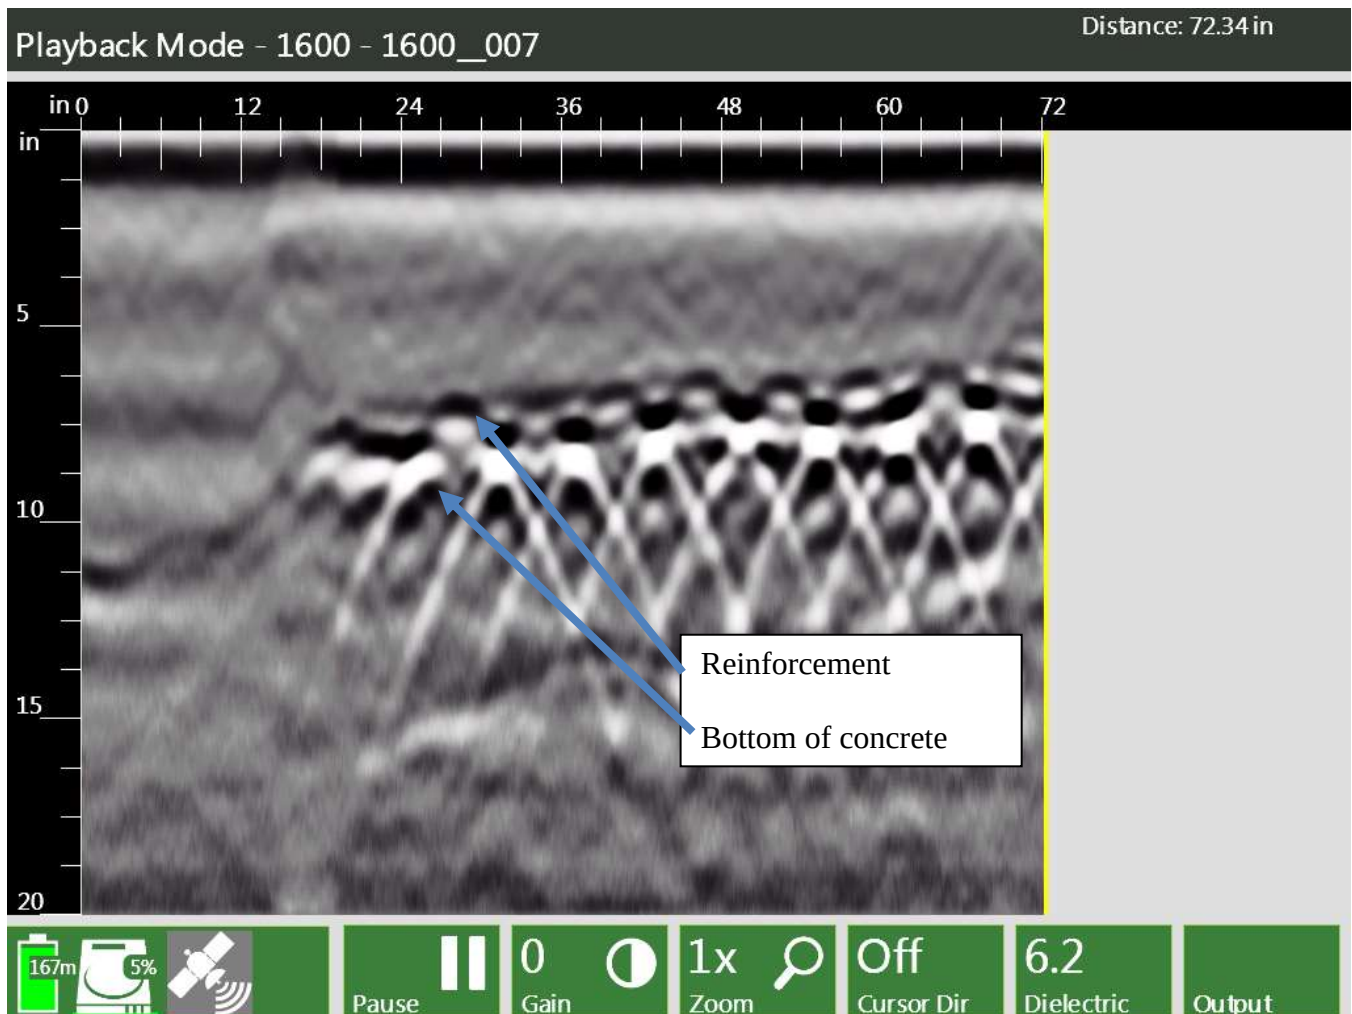
#### **Area 4**

Suspect area believed to a vault based on the data and the size was 9 x 15 feet

This image is in the north to south direction. Bottom of concrete is approximately 7 to 8 inches.

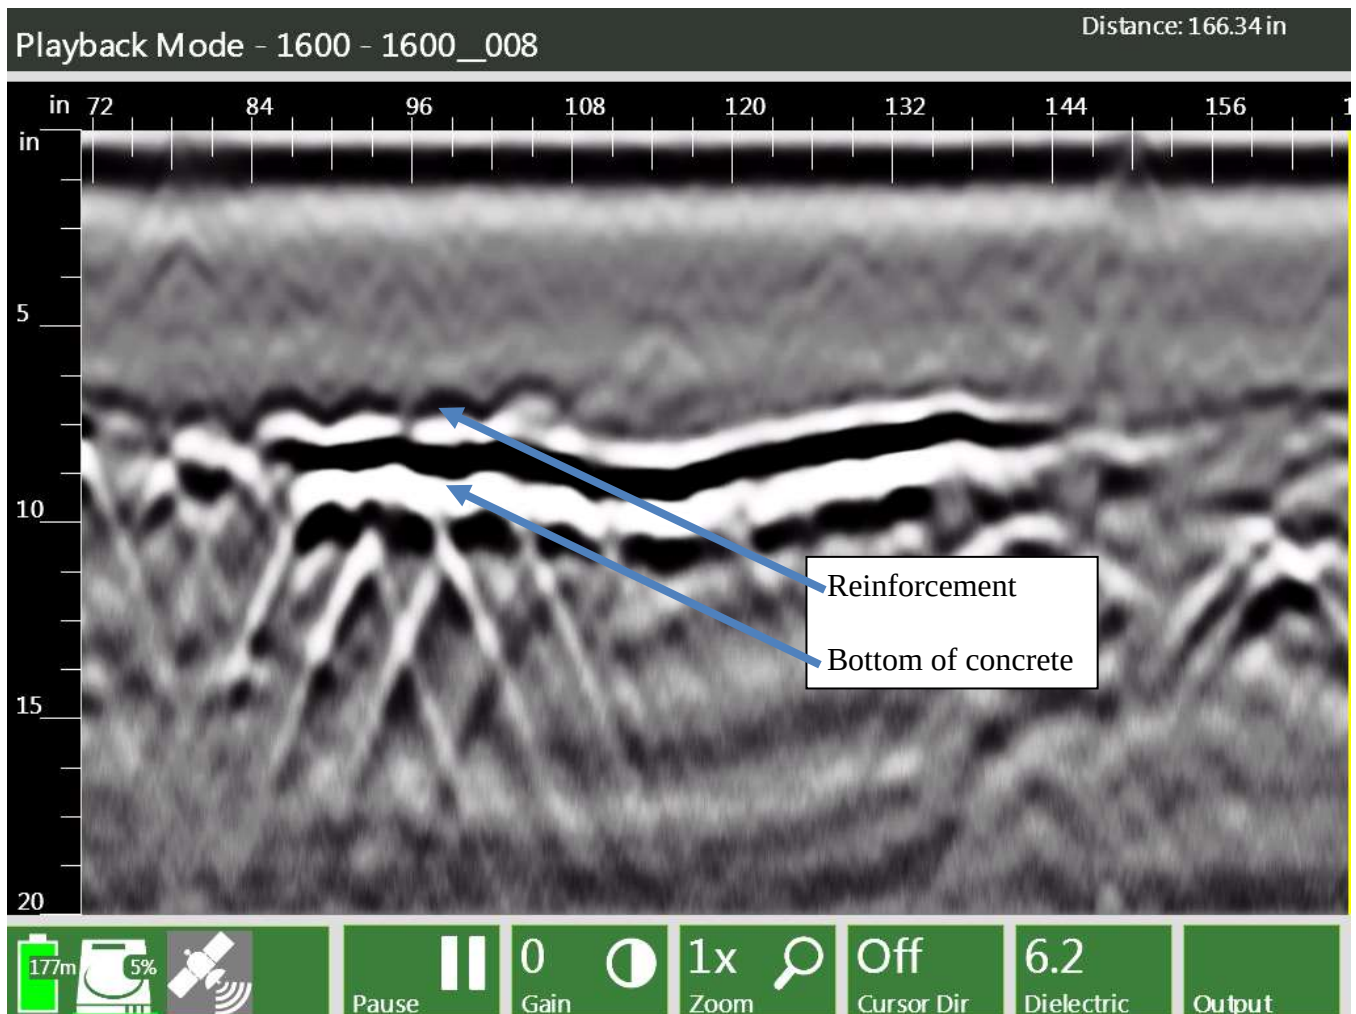
This image is in the east west direction.

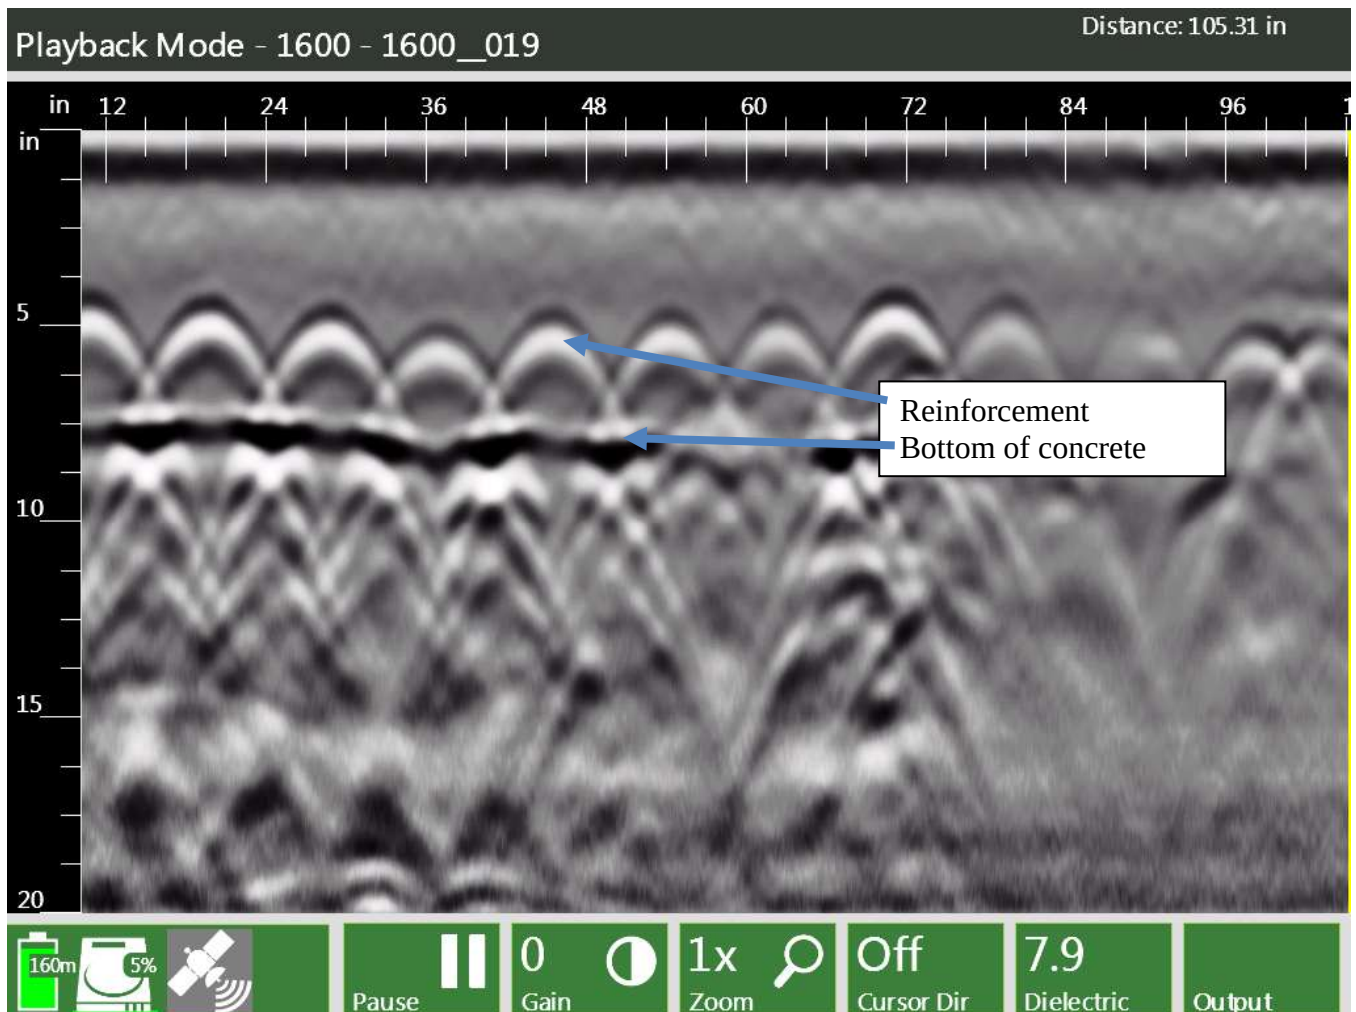
## Area 5

Suspect area believed to a vault based on the data and the size was 8 x 12 feet

This image is the north south scan direction. Concrete is approximately 7 to 8 inches thick.

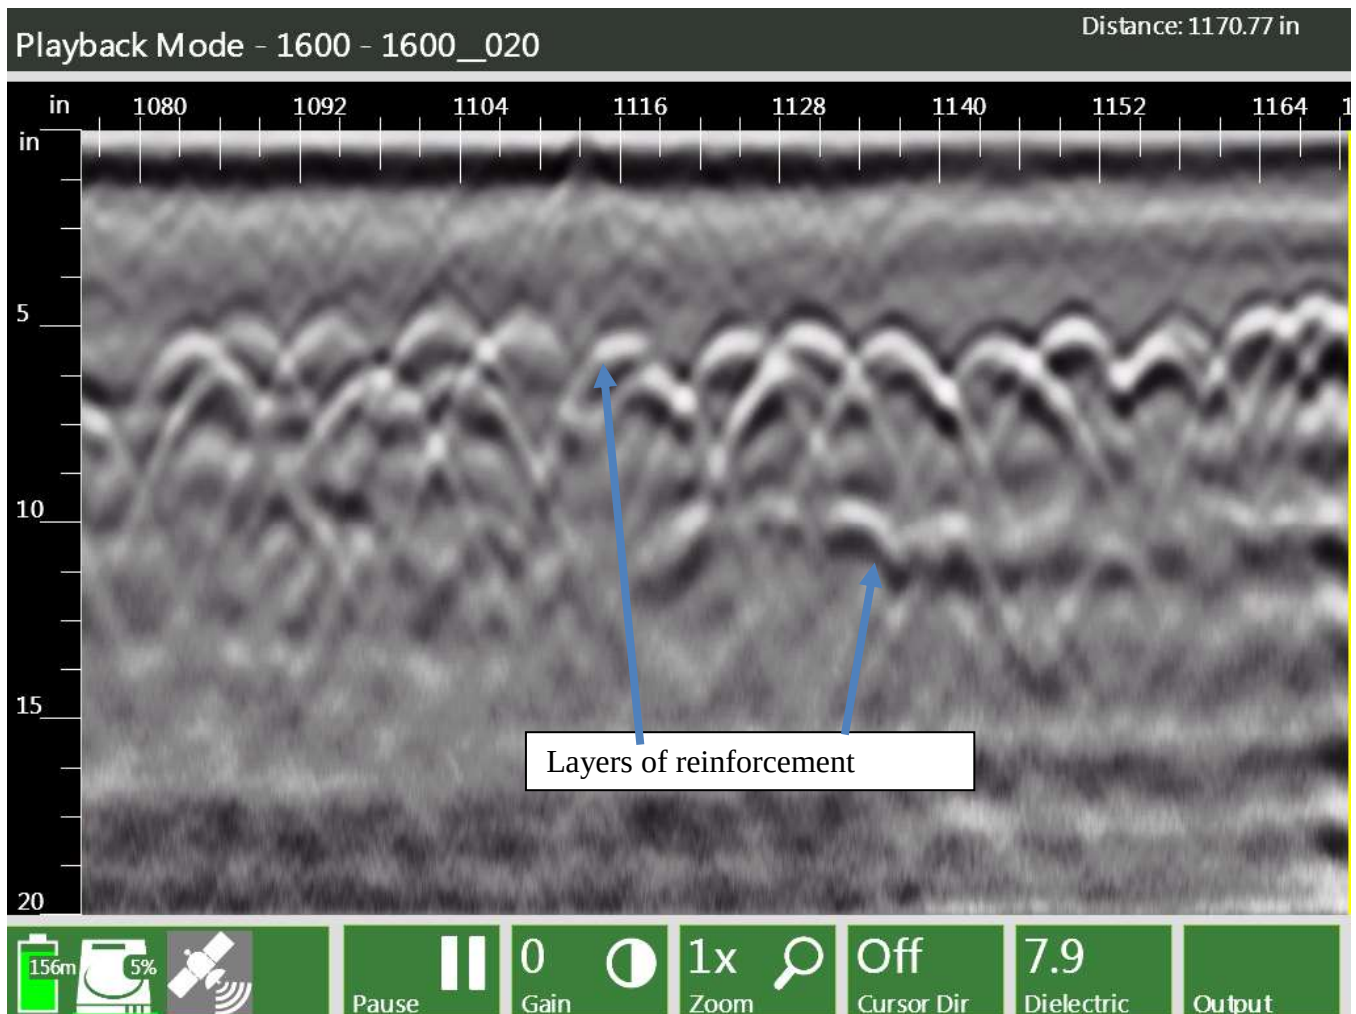
## **Area 6**

Suspect area believed to a utility vault based on the data and the size was 21 x 33 feet

This image is from the north south direction. This is the utility vault area. There are several layers of reinforcement present and due to this the bottom of the concrete could not be determined.

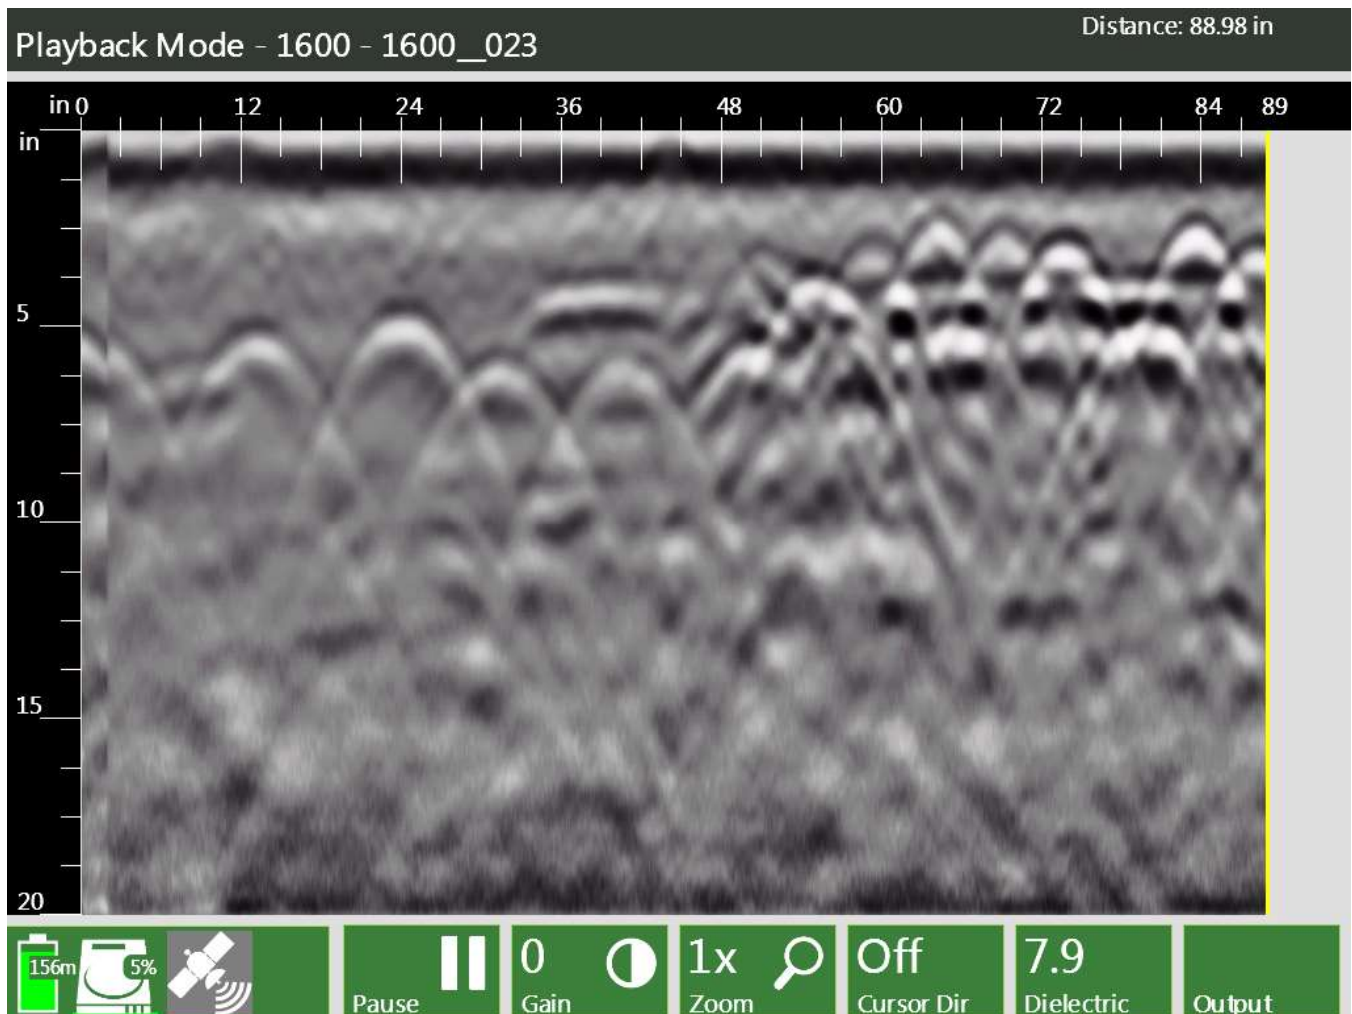
This image is from the east west direction. This is the utility vault area. There are several layers of reinforcement present and due to this the bottom of the concrete could not be determined.

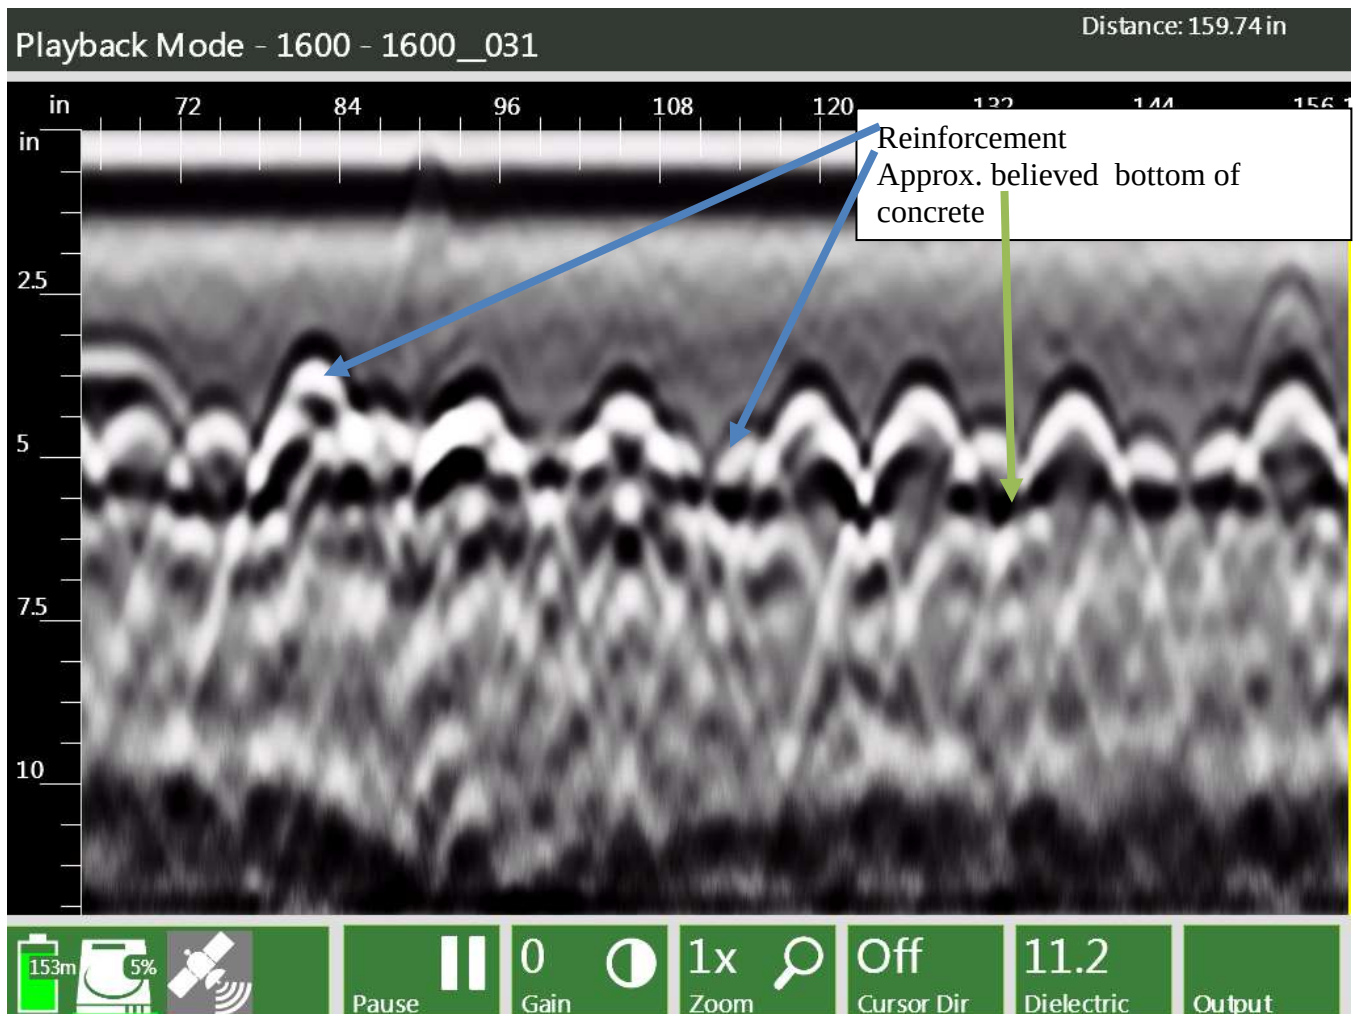
## **Area 7**

Suspect area believed to a vault based on the data and the size was 10 x 36 feet.

Area had several layers of reinforcement from wire mesh and rebar. The area may be a utility vault or extra reinforcement present due to the sidewalk construction.

This image is the north south direction. Two layers of reinforcement are present. Concrete thickness is approximately 5 to 6 inches.

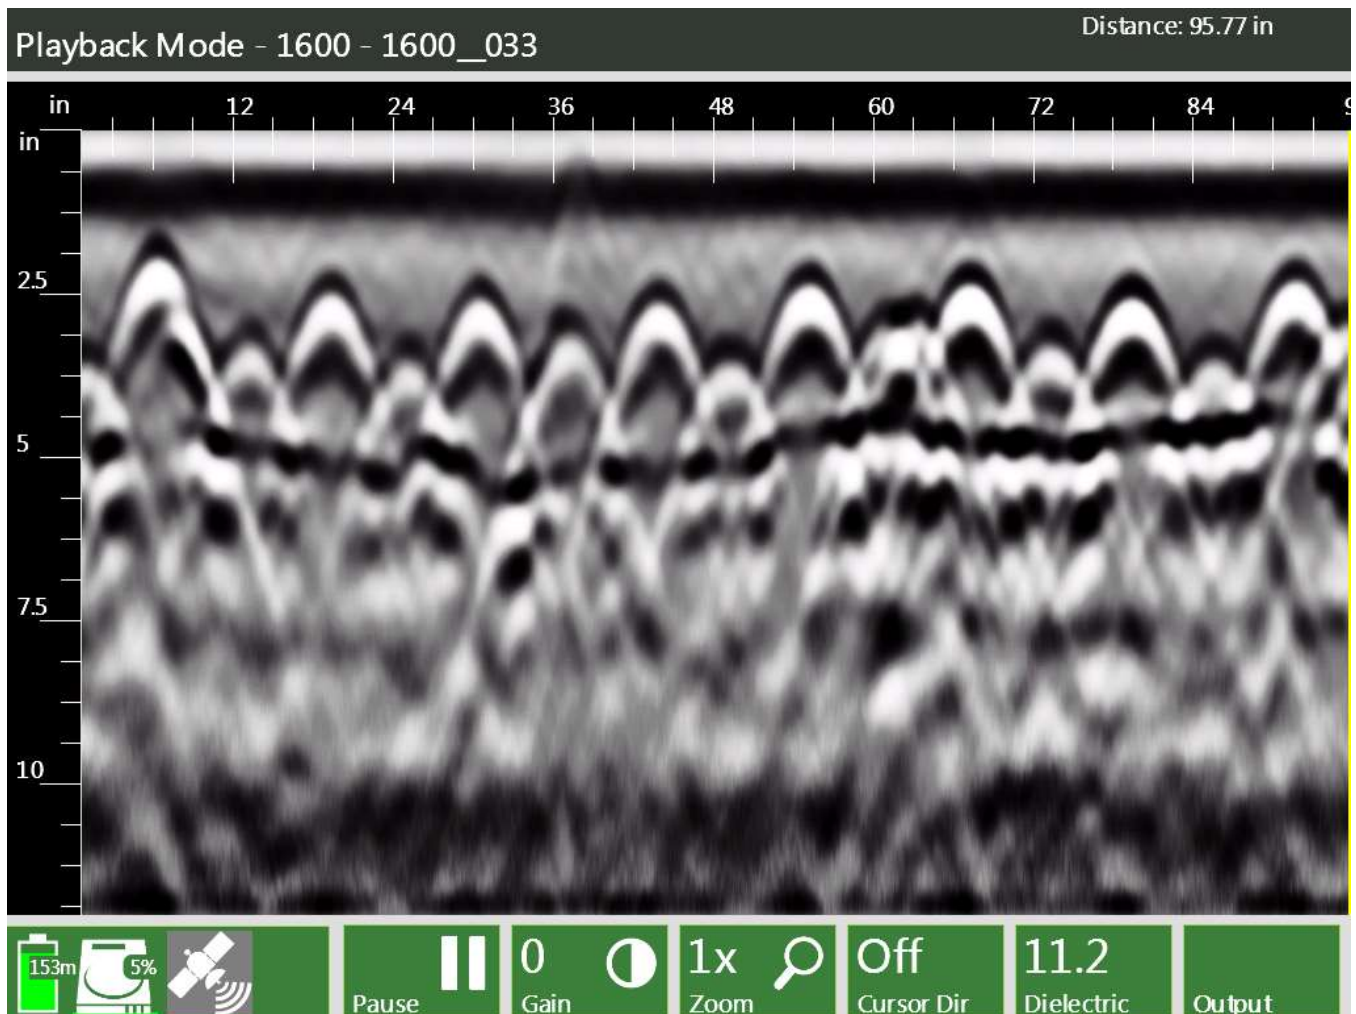
This image is the east west direction. Two layers of reinforcement are present. Concrete thickness is approximately 5 to 6 inches.

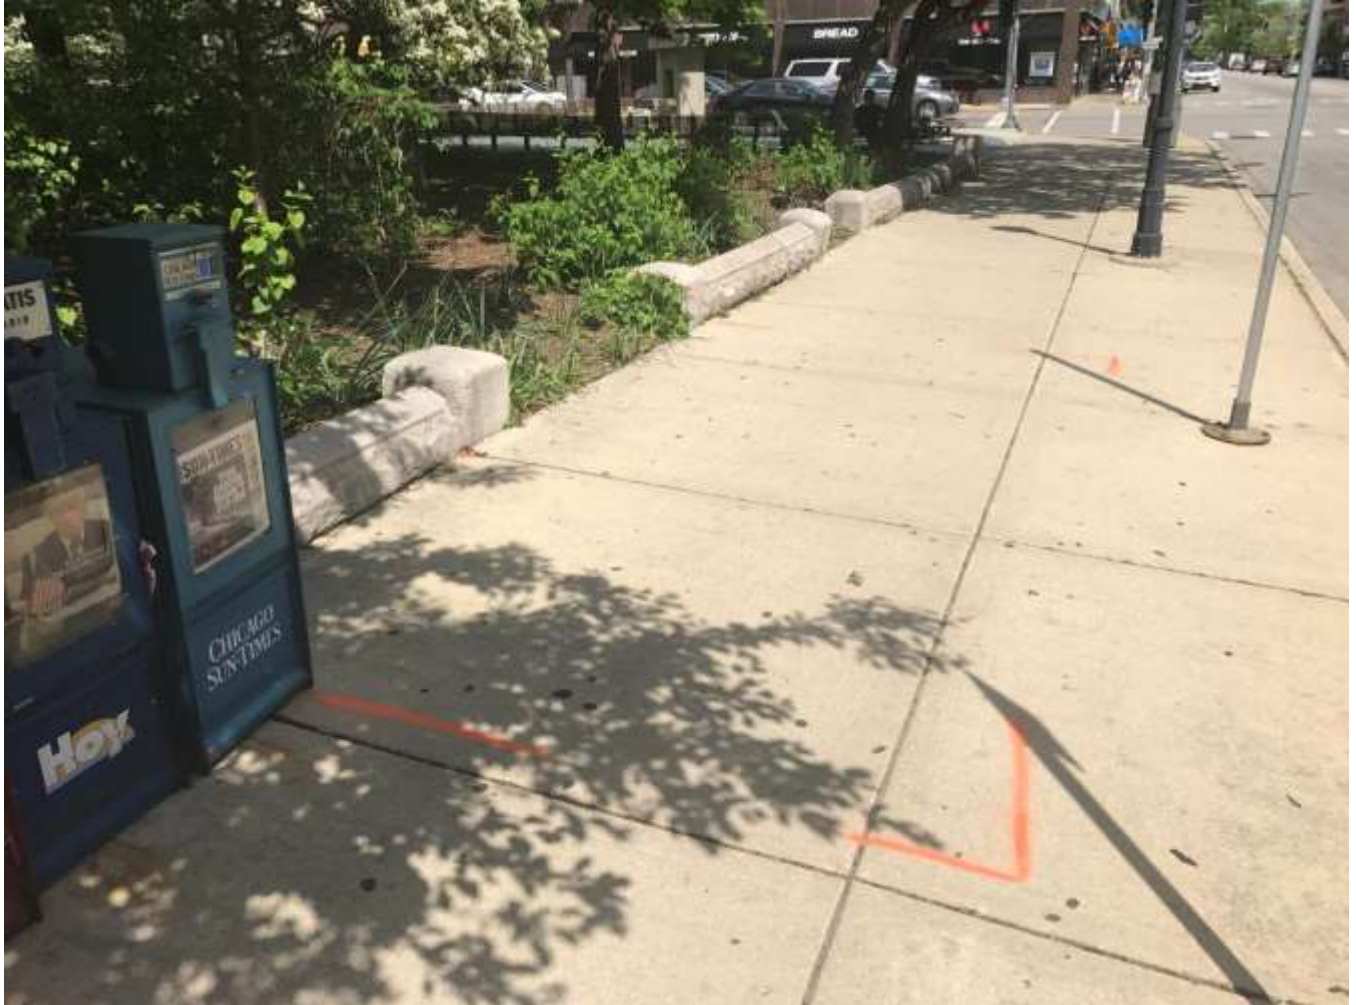
## Area 8

This area is not a vault, but the soil under the sidewalk appears to be disturbed. Area may be a possible excavation or unknown. Further investigation maybe required here

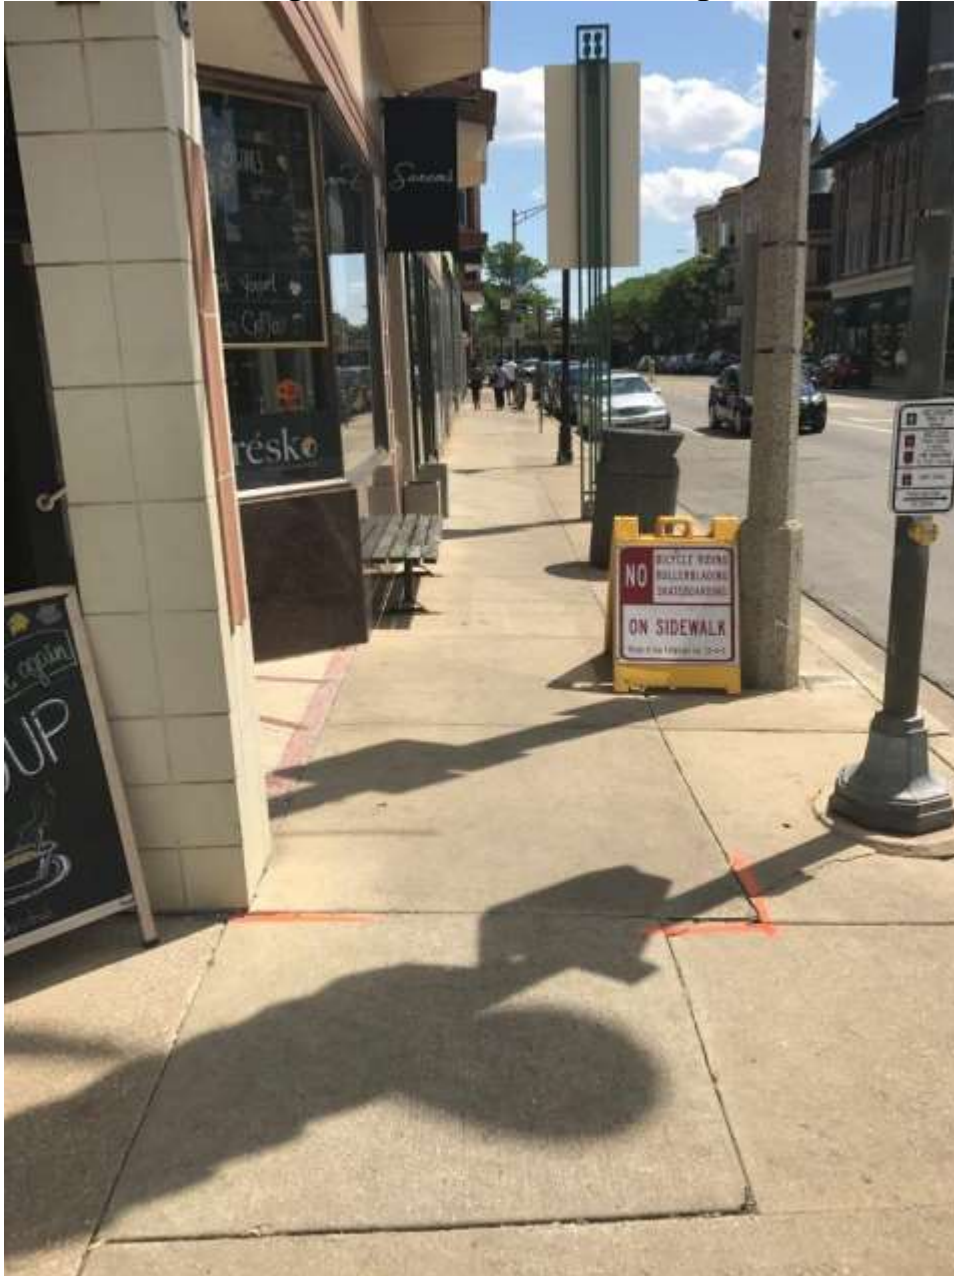
Known vaults along the south east and west leg of Oak Park Ave.

South east side of the street
