LAKE STREET  
PLAN AND PROFILE

**GROUND  
PENETRATING  
RADAR  
SYSTEMS, INC.**

*Subject: Ground Penetrating Radar (GPR) scanning at downtown area Oak Park,  
IL street scape extending along Lake St from Harlem to Euclid Ave and  
Marion Street from Lake Street to Ontario Street.*

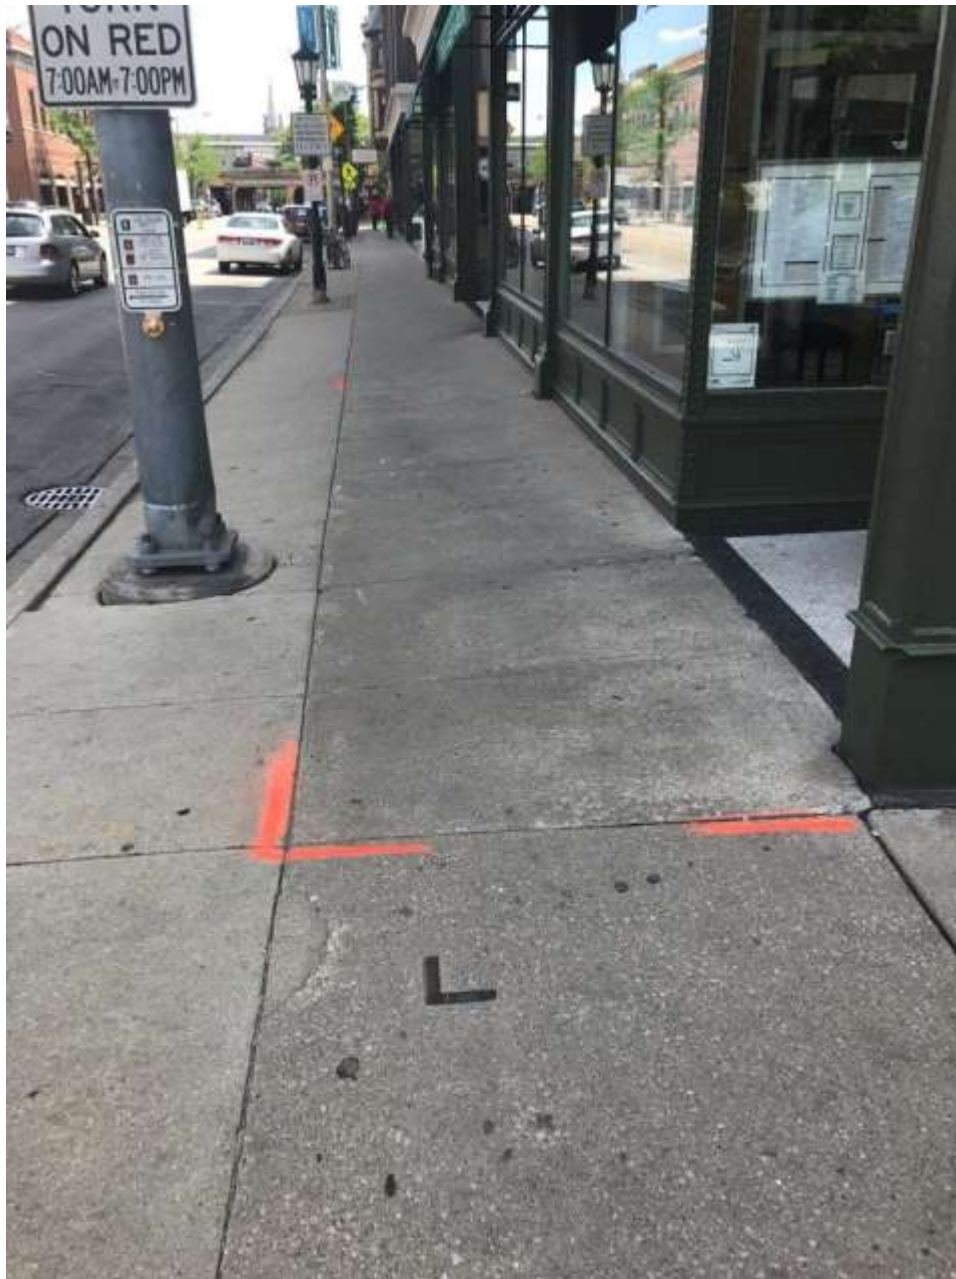
South west side of the street.

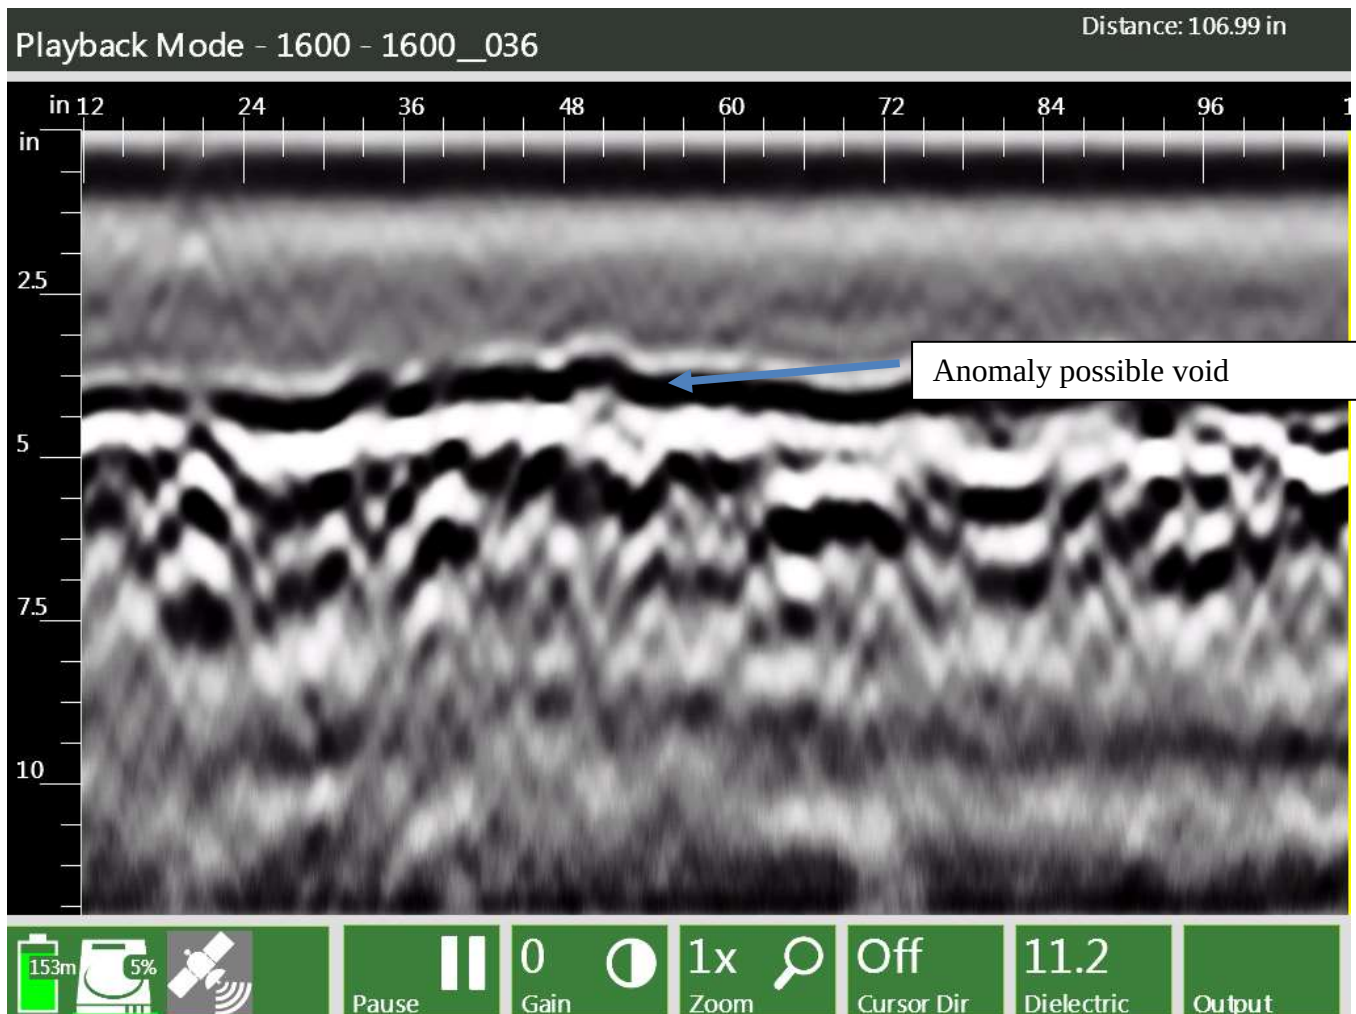
## **Area 10**

Suspect area based upon the data unknown anomaly was present, anomaly may be vault or other unknown the size was 4 x 24 feet

This data was from the east to west scan, there is anomaly at approximately 4 inches consistent with that of a void, no reinforcement is present. Anomaly may be a change in soil type or other unknown. If the anomaly is a vault the surface would be the top of the concrete sidewalk. Further investigation will be required to determine what anomaly is.

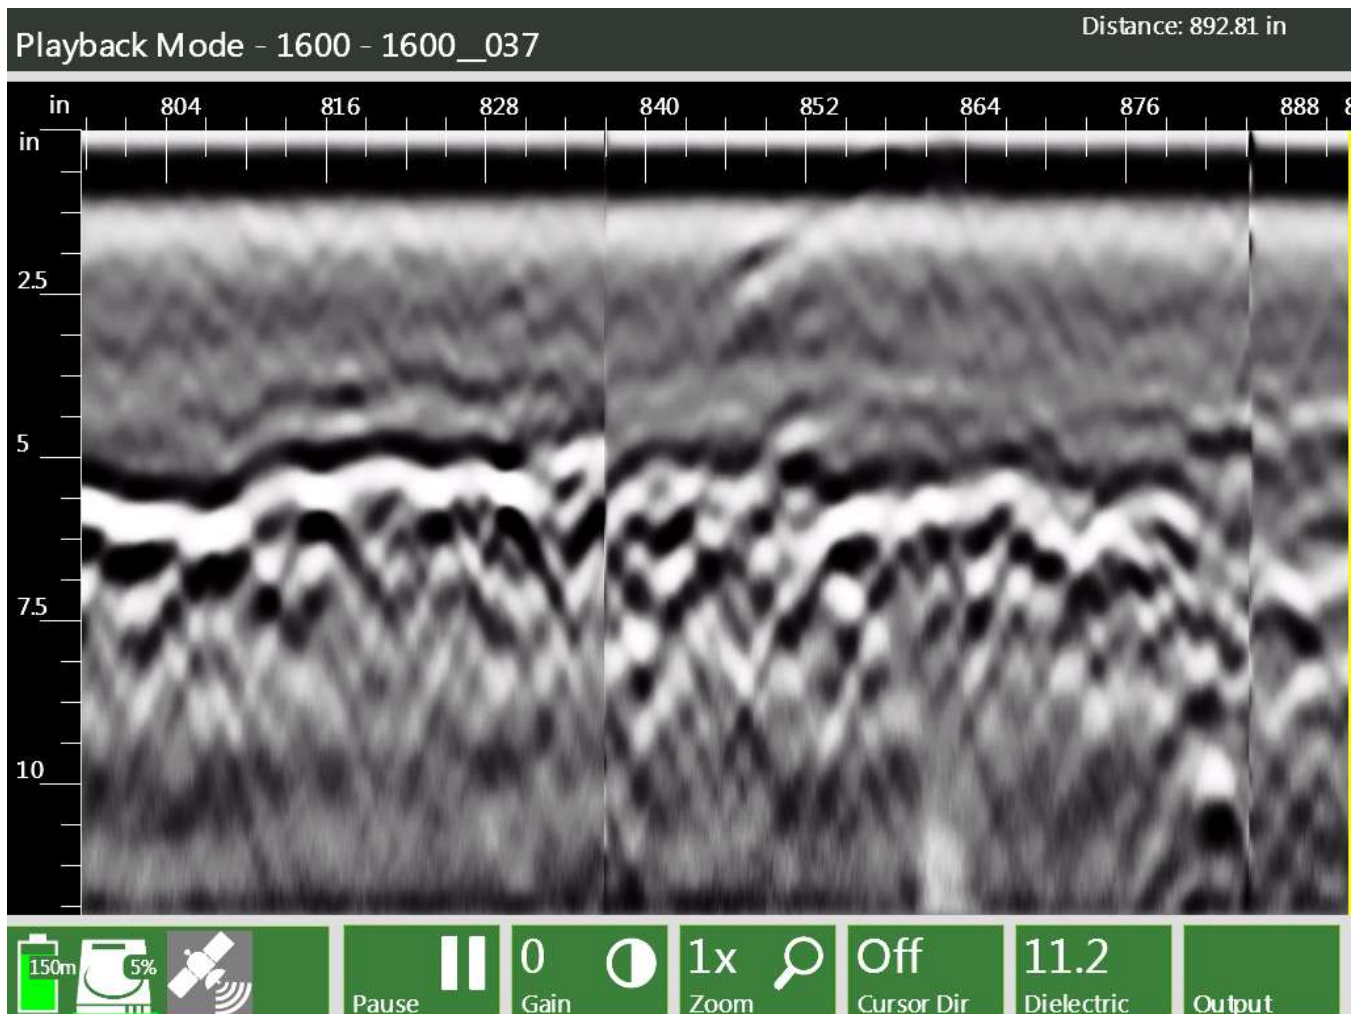
This data was from the north to south scan, there is anomaly at approximately 4 inches consistent with that of a void, no reinforcement is present. Anomaly may be a change in soil type or other unknown. Further investigation will be required to determine what anomaly is.

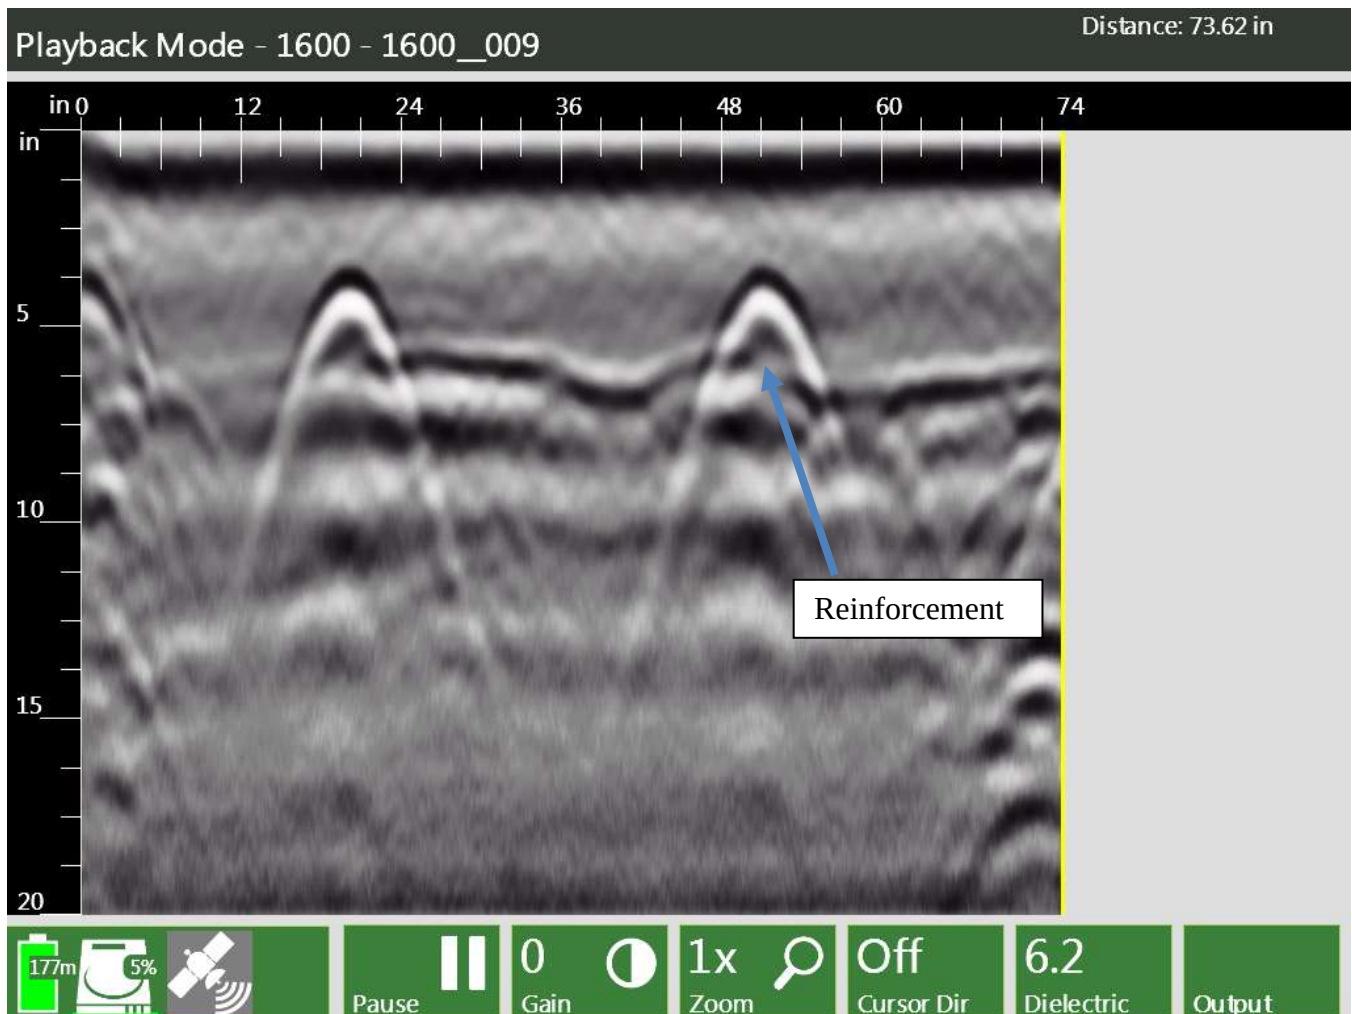
## **Area 12**

Suspect area believed to a utility vault based on the data and the size was 5 x 5 feet.

This is the north south direction around the utility vault. There is reinforcement present; depth of concrete was unable to be identified here

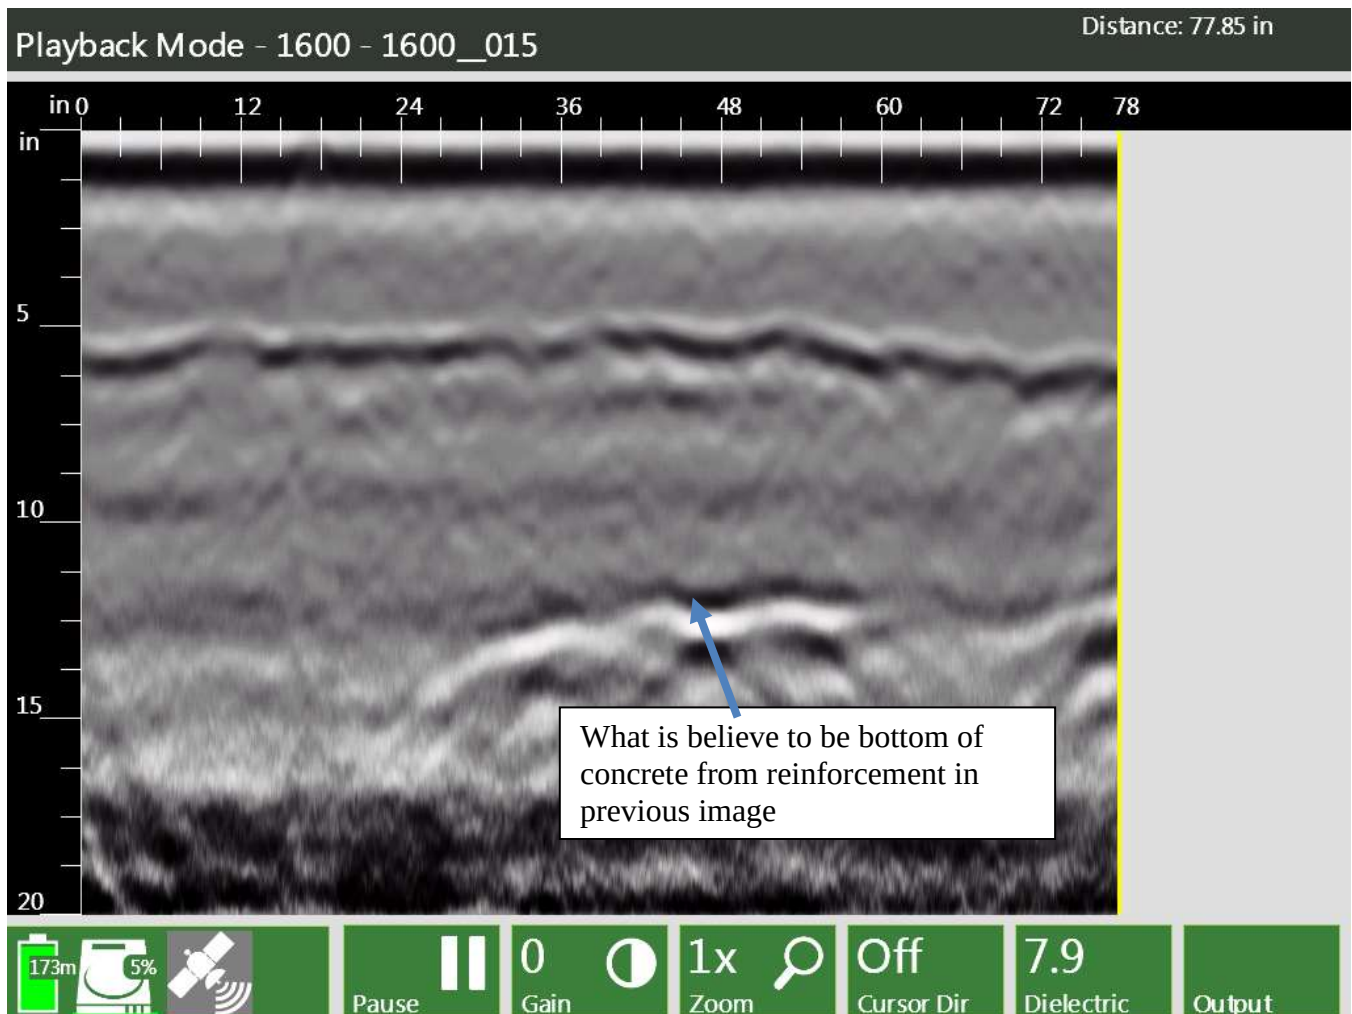
This image is the east west direction. The anomaly is at approximately 11 to 12 inches. There appears to be a possible void at that depth possibly related to a potential vault. Further investigation maybe required.
