CONDITION ASSESSMENT

## THE VILLAGE OF OAK PARK PARKING STRUCTURES

Prepared for:  
VILLAGE OF OAK PARK

WRC PROJECT NO. 31-8130.00  
MAY 2017

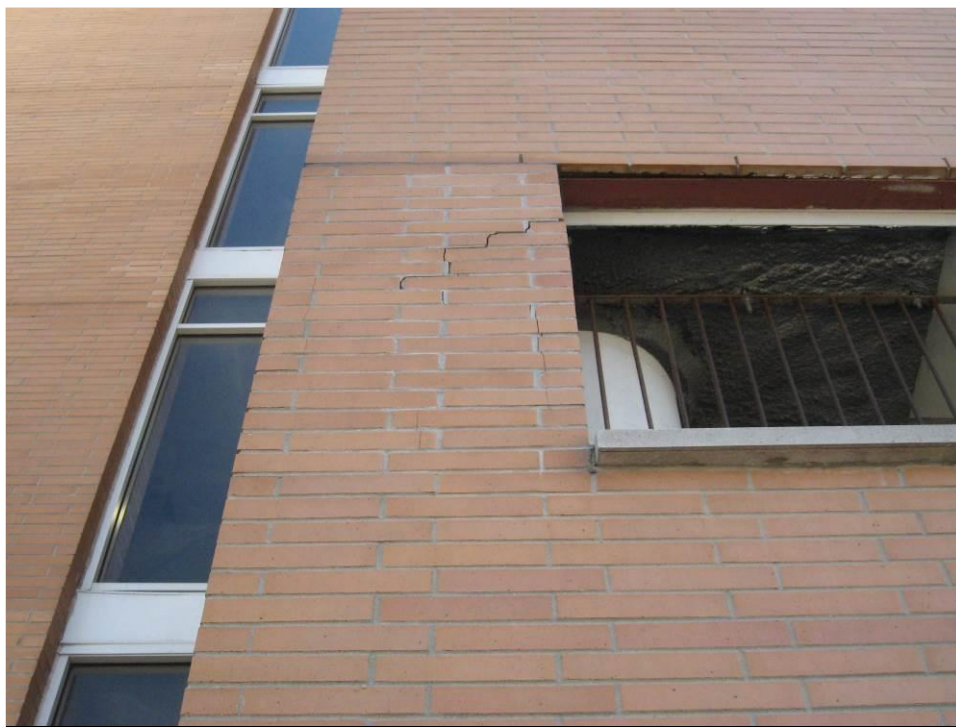
Photo 5 – Crack in masonry on façade.

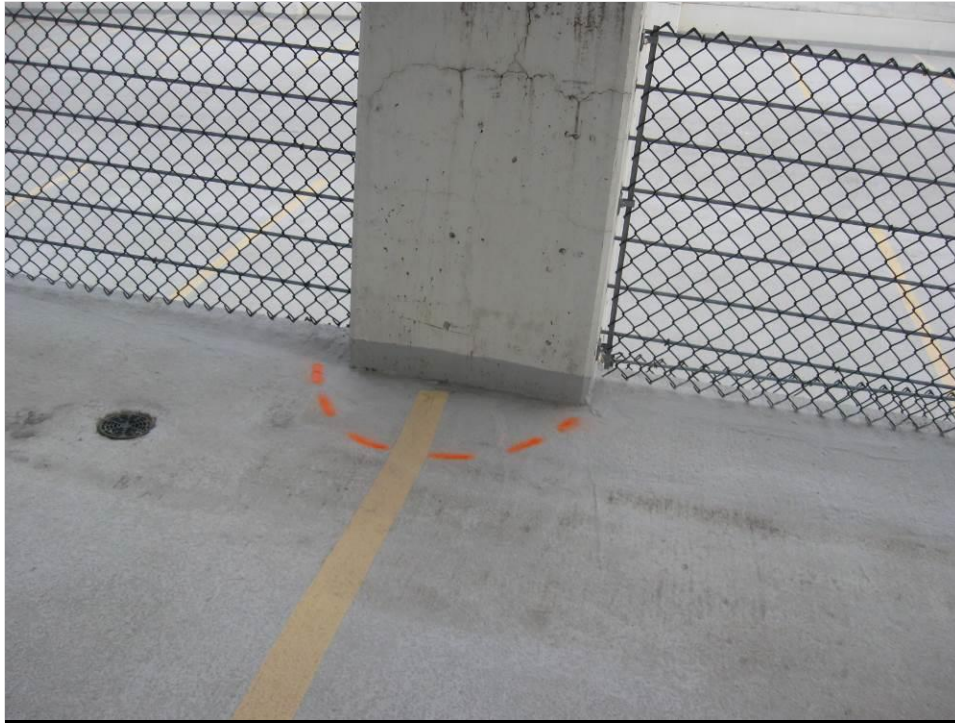
Photo 1 – Typical concrete delamination on floor slabs over top of post-tensioned beams.

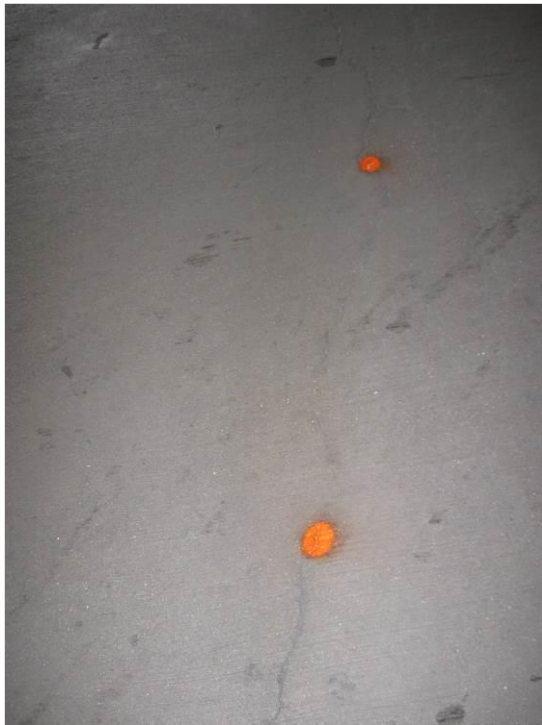
Photo 2 – Typical random floor crack in floor slab.

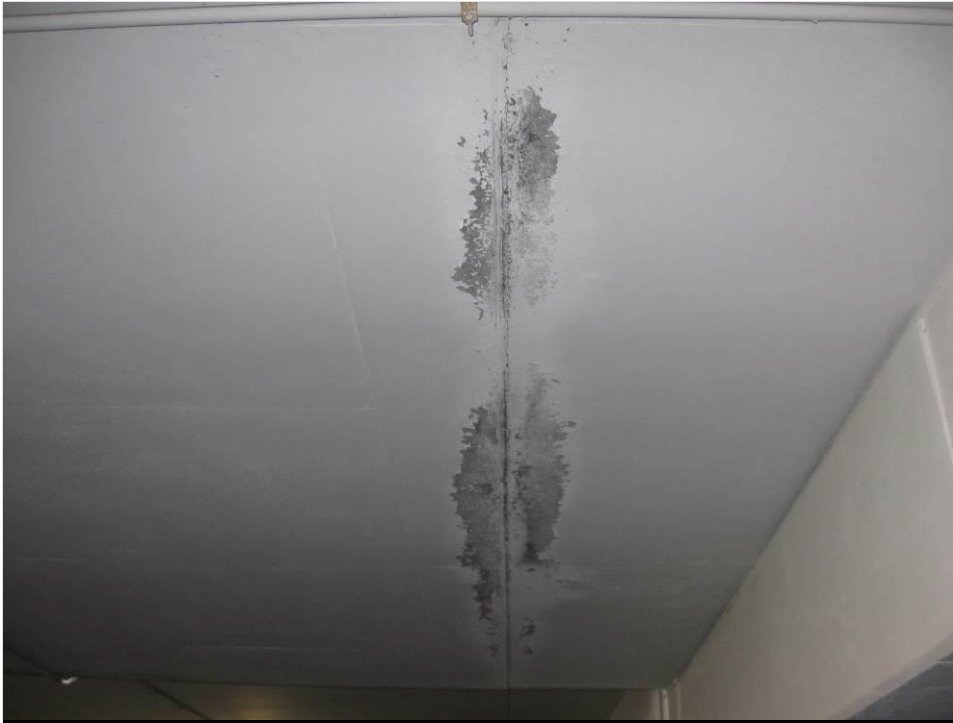
Photo 3 – Active leaking construction joint seen from below slab.

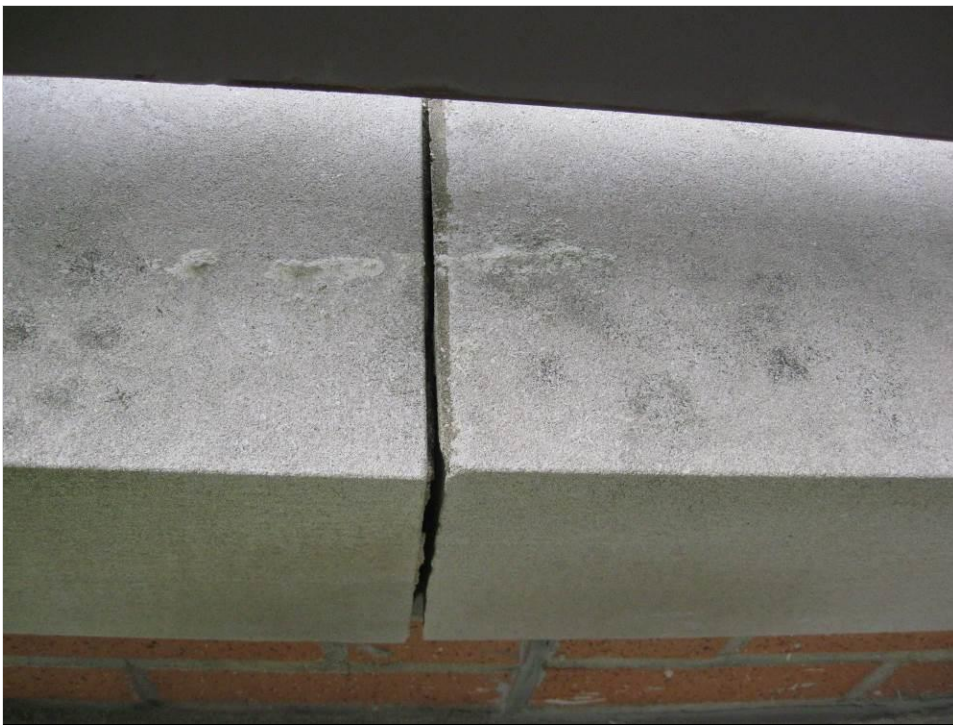
Photo 4 – Typical severely deteriorated mortar joint on cap stone.

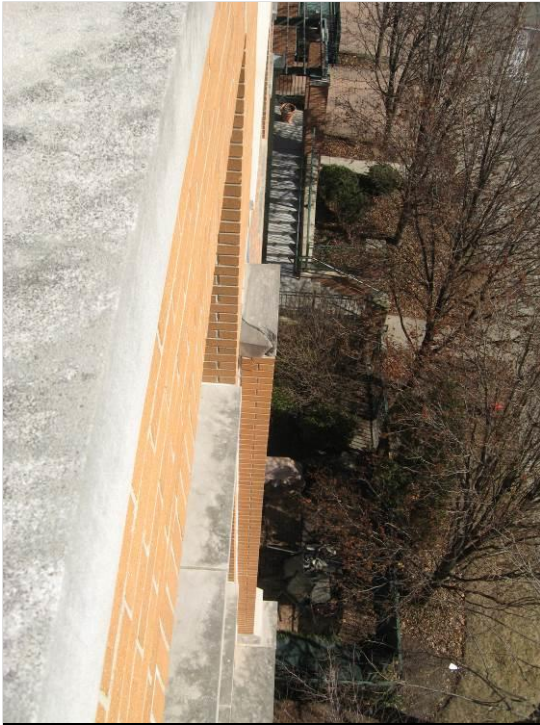
Photo 13 – Broken cap stone with the potential to fall off, south elevation.

We did note a condition that we recommend that should be addressing immediately. The two capstones that are cracked and broken cap stones, on south façade elevation along North Avenue, should be removed until repairs can be done. Refer to photographs 12 and 13 for Avenue Parking Structure in Appendix A.

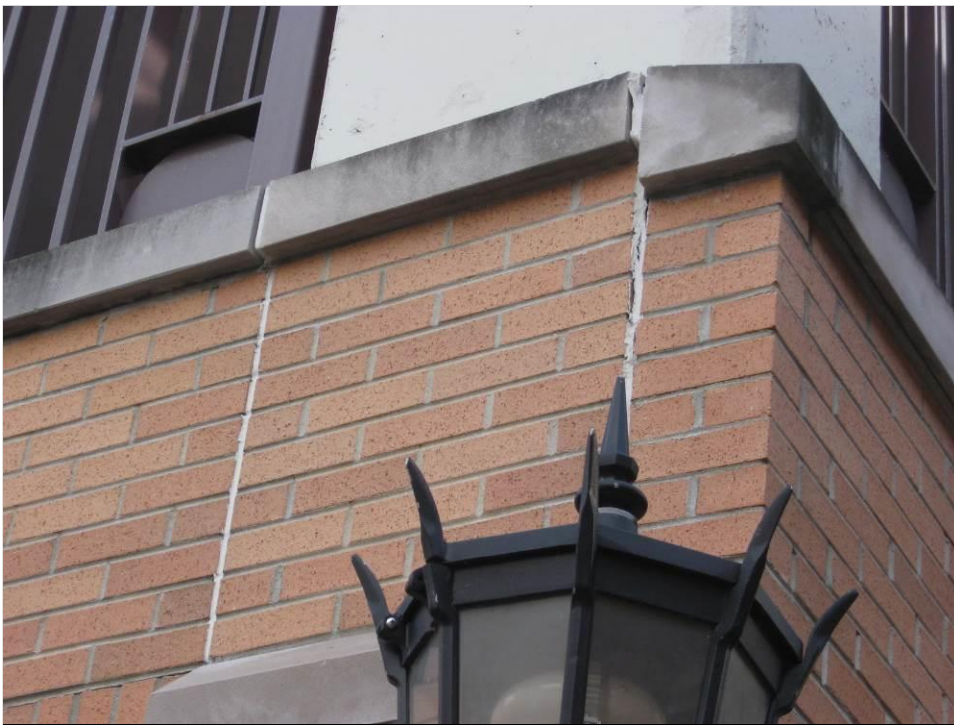
Photo 14 – Severely deteriorated vertical joint sealant on exterior masonry wall.

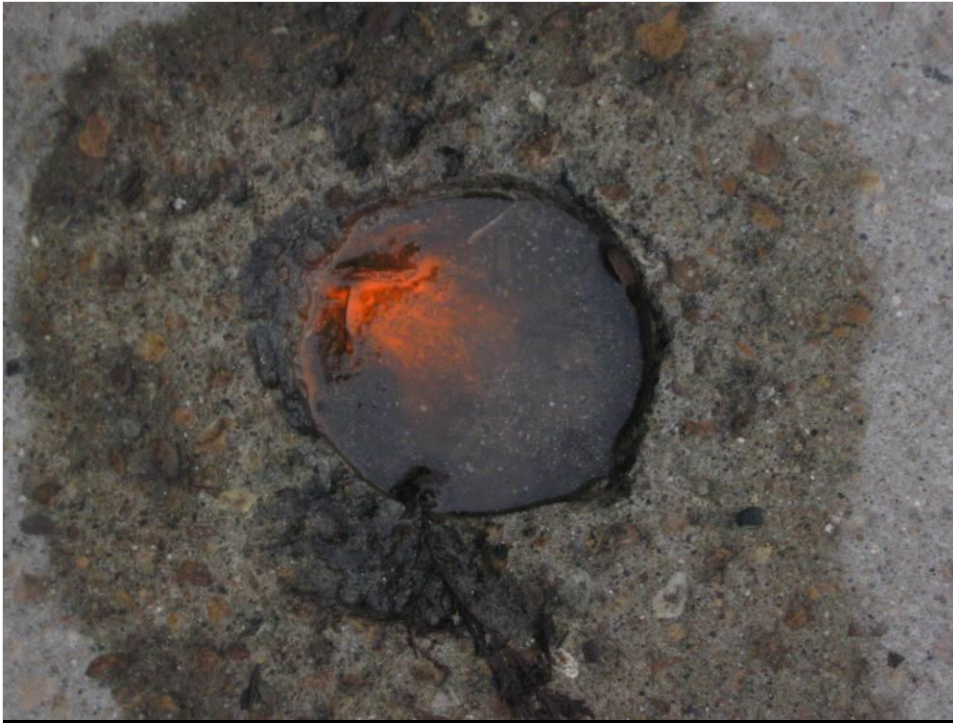
Photo 3 – Floor delamination over lifting loop.

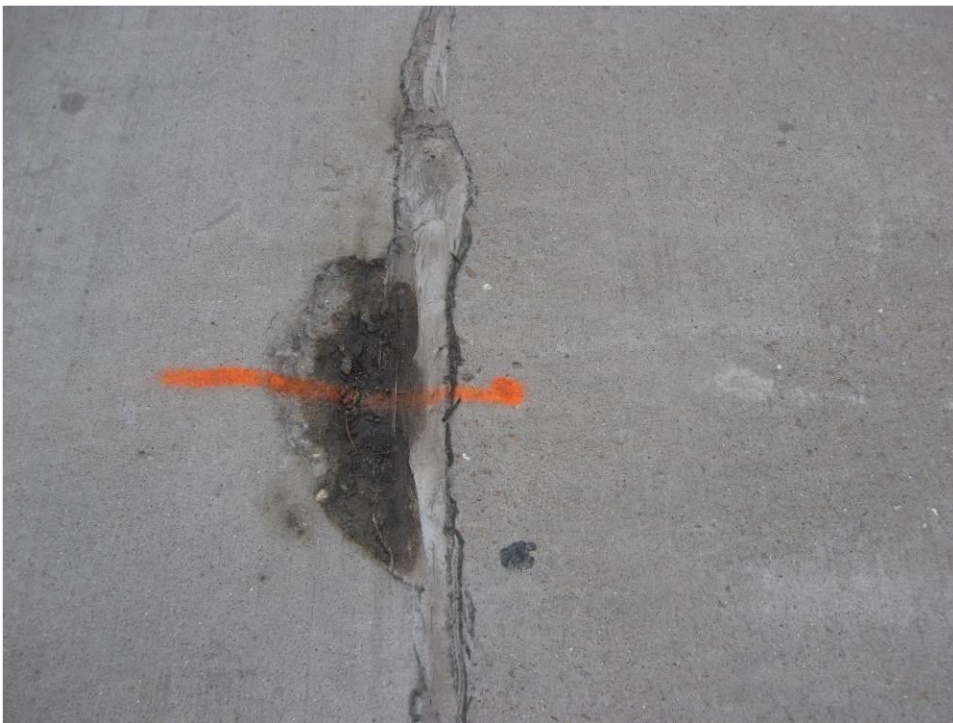
Photo 4 – typical floor spall over shear connector.

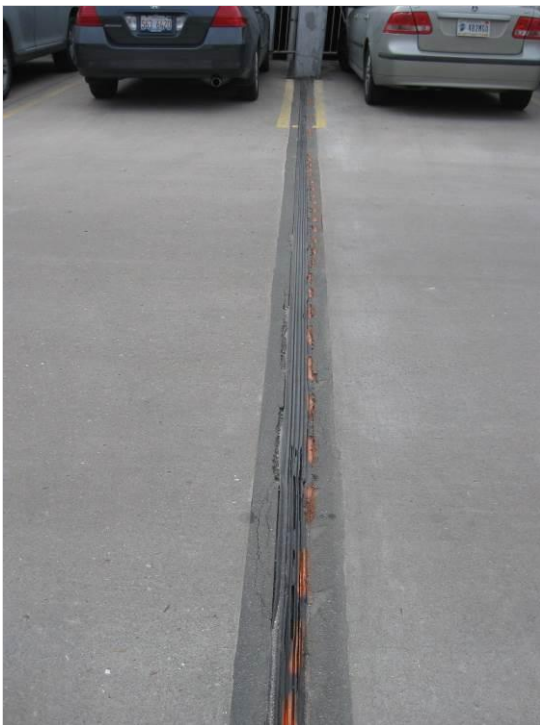
Photo 14 – Severely deteriorated expansion joint at grade slab.

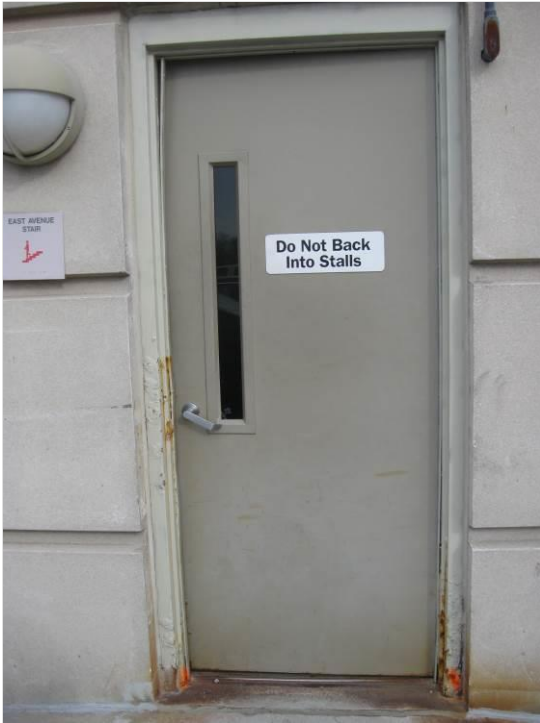
Photo 3 – Severely corroded door and frame.

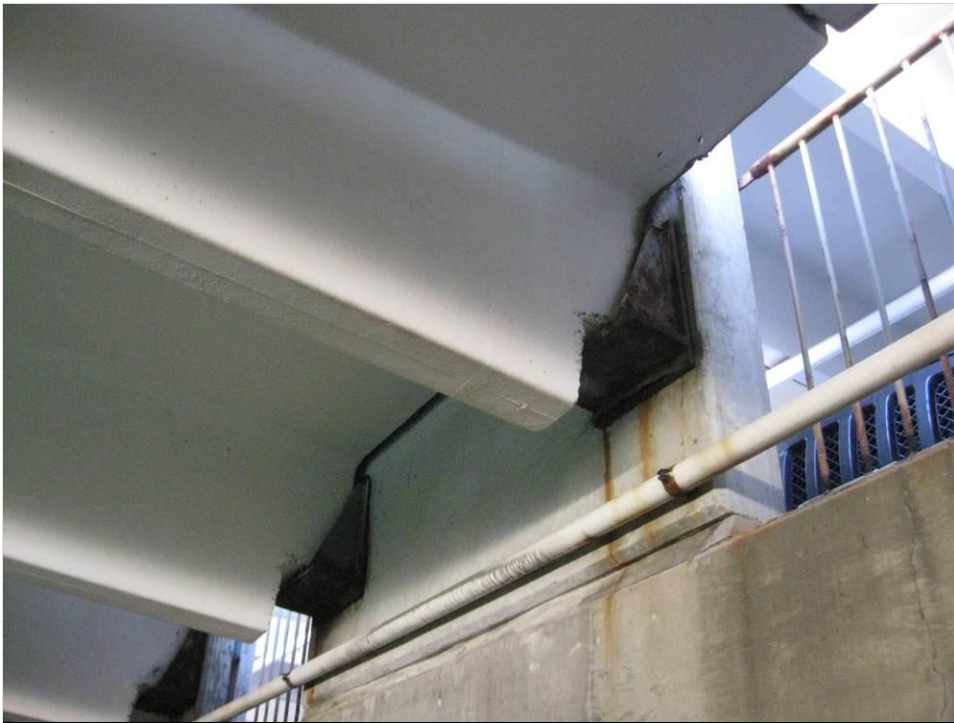
Photo 4 – Corroded tee stem support angles.

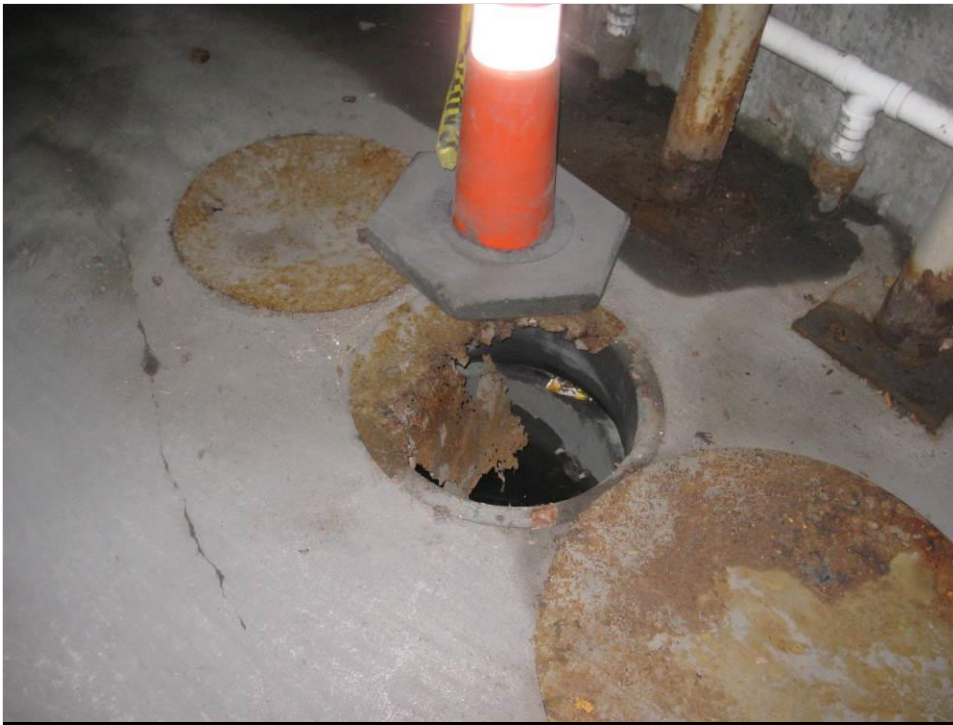
Photo 5 – Corroded cover on triple basin.

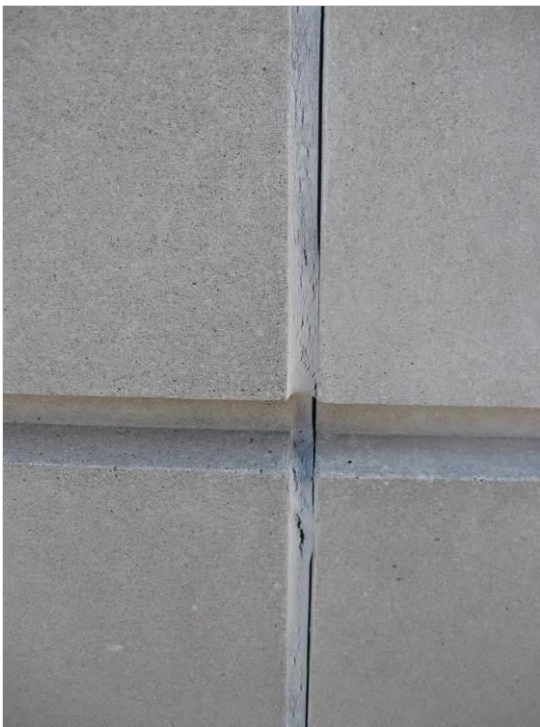
Photo 8 – Severely deteriorated vertical joint sealant on façade panel.
