203 S. MARION ST. OAK PARK, IL

HISTORIC OVERVIEW - ADDENDUM

HISTORIC OVERVIEW

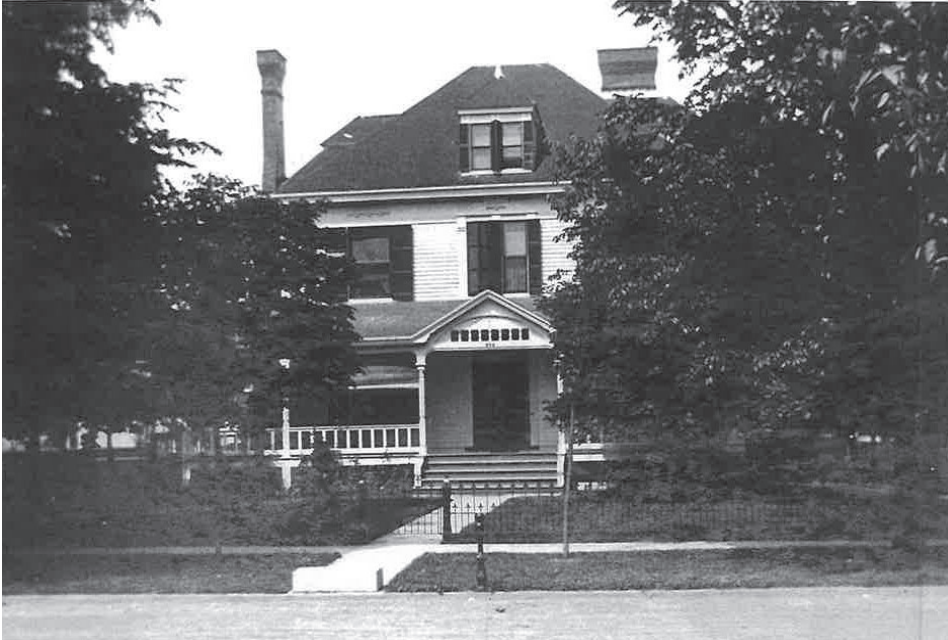
Original Marion Street View prior to 1929

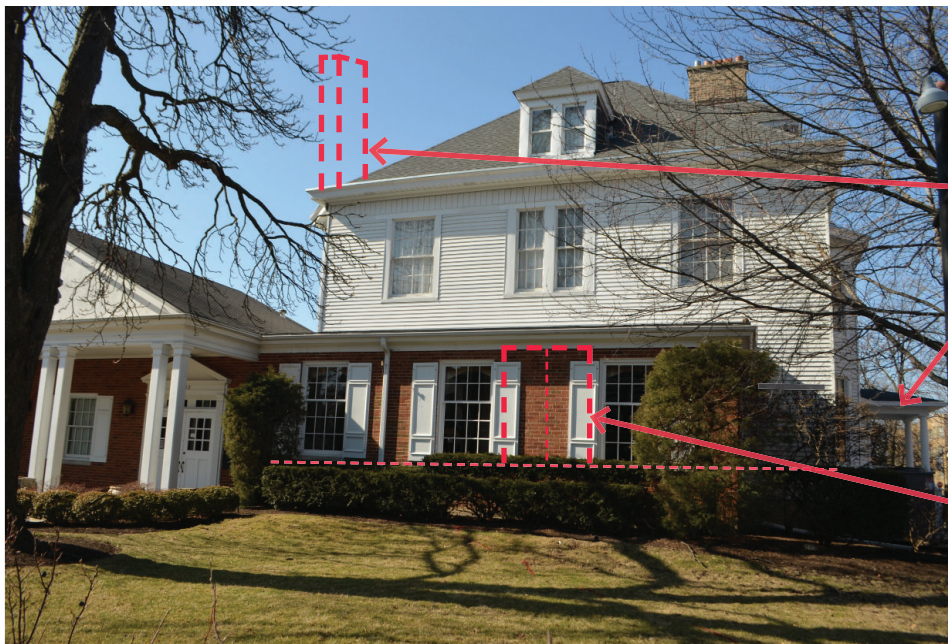
Existing Marion Street View of Funeral Home

Approximately 3,900 sf of additions were added to the original home to adapt to its current use.

One of the chimneys has been removed on the south side

North Side entry portico is believed to be added after major additions were added in the 1950's.

Prominent main entry Queen Anne style original porch with the front entry on the east side of the house facing Marion Street was removed and an entirely different Colonial architectural style brick portico was added in 1957.

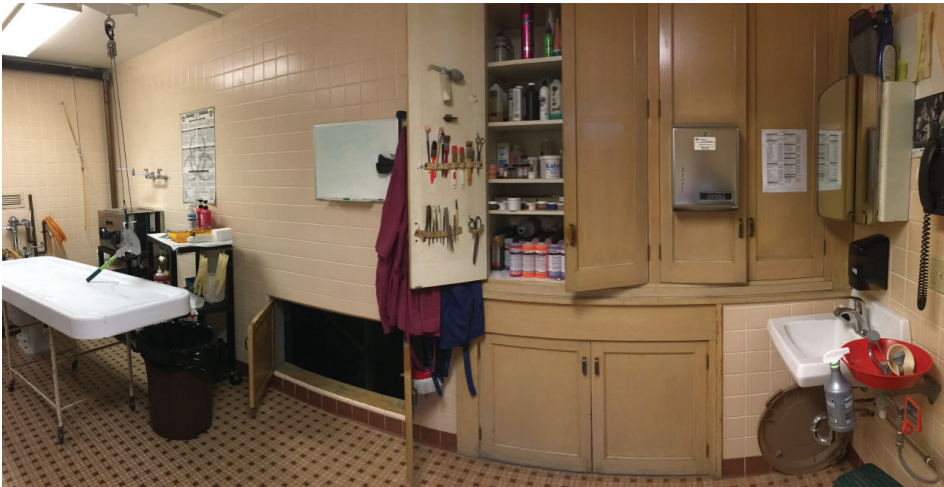
Embalming Room

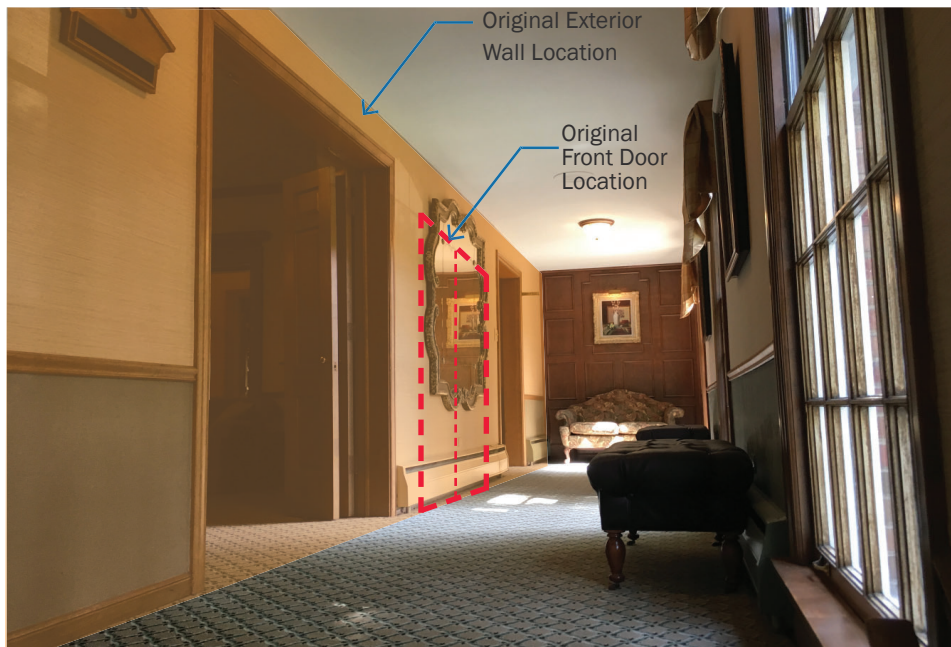
Entry Parlor (in location of original front porch - dashed line indicates approx. location of original front door. Original first floor windows were removed)

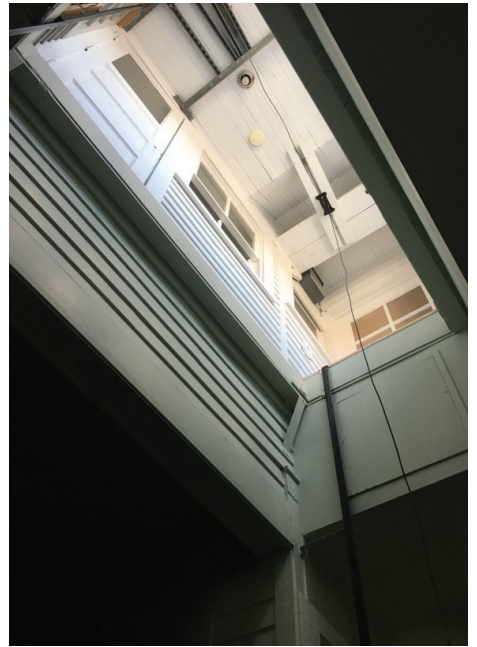
Two Story Casket Hoistway

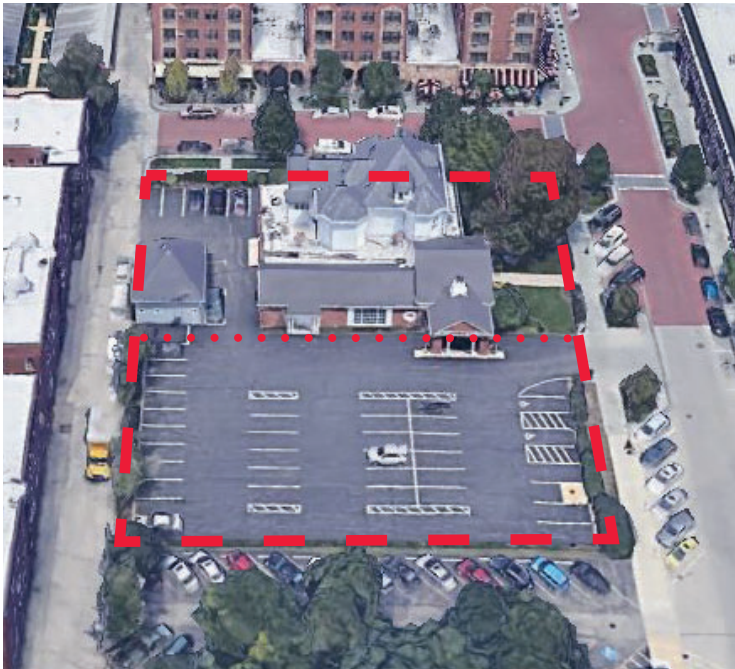
Aerial View - The red dotted line in middle of property indicates the location of a subdivided lot for a single family residence and adjacent development parcel. If house is restored to original design, only 50% of the property would be available for redevelopment.

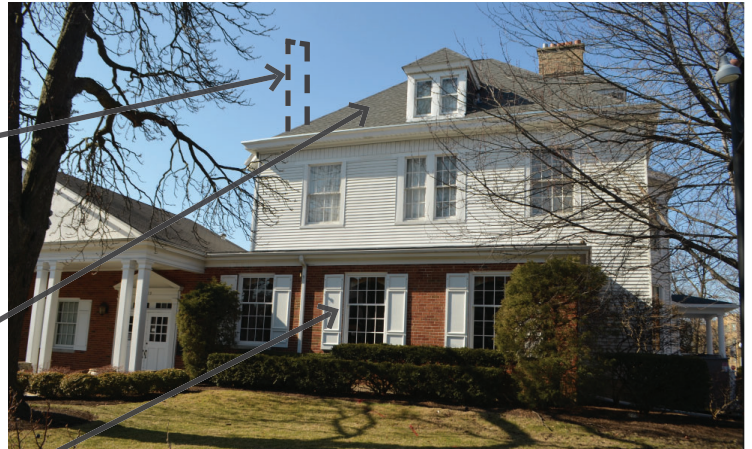
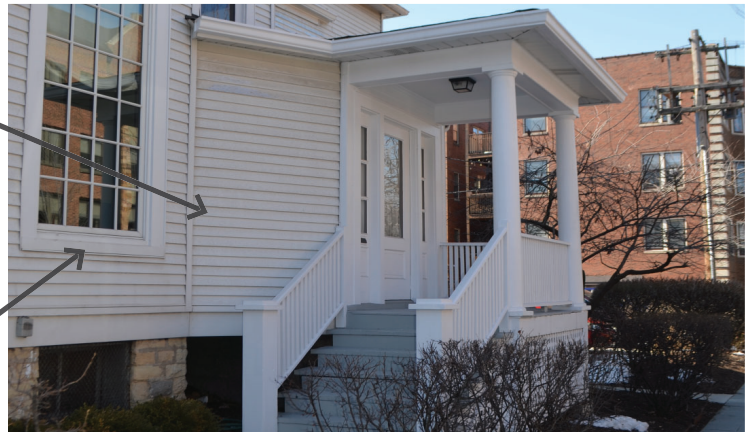
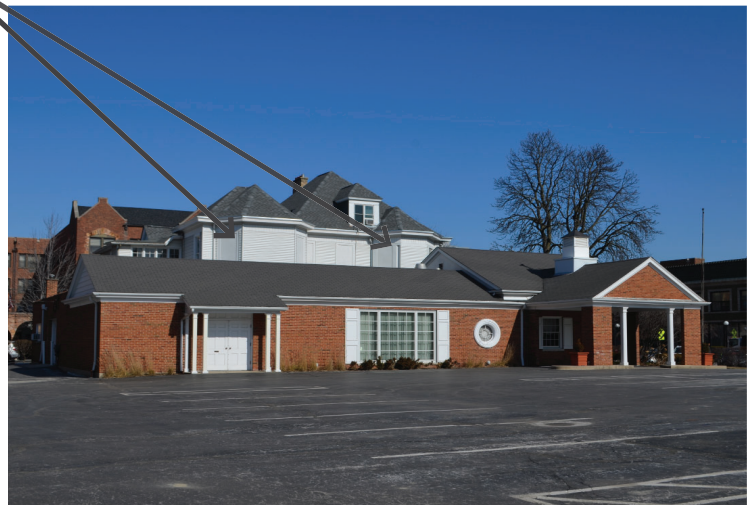
- One of the chimneys has been removed on the south side and the north one remains
- The foundation is the original stone at the house and brick on the newer additions.
- Hip Roof has replacement asphalt shingles
- Prominent main entry Queen Anne style original porch on the east side of the house facing Marion Street was removed and an entirely different Colonial architectural style brick portico was added in 1957.
- Exterior walls were modified with added colonial brick additions and the existing house was reclad in vinyl siding.
- Several of the original 6/6 double hung windows remain, several have been replaced with metal frame windows and many windows have been removed and boarded shut (south side). Original shutters are missing.

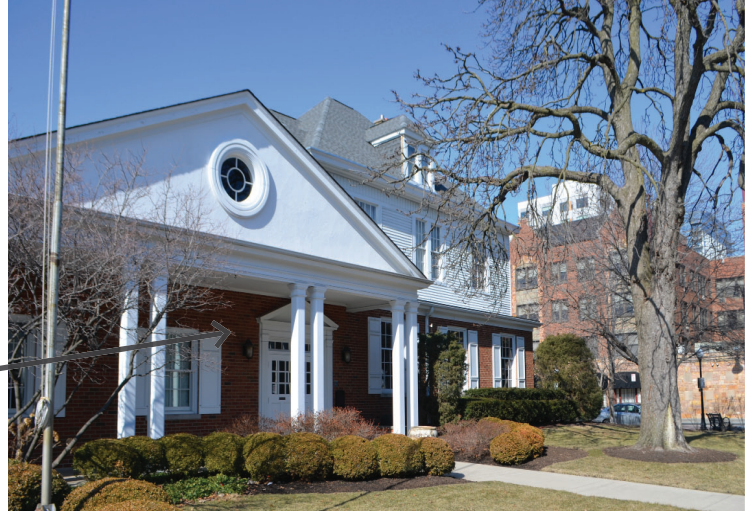
- There are several Colonial brick additions on the west, east, & south sides of the original house. These additions substantially change the aesthetic of the original Queen Anne house. These additions were constructed after the period of significance (1870-1929).

Note: Much of the interiors has been significantly modified from a residential plan to a funeral home with offices, viewing rooms, storage, etc. Many of the interior walls and functions have been removed. If the non-historic additions were to be removed, substantial reconstruction of the historic structure would be required to reestablish the exterior wall as was originally located.

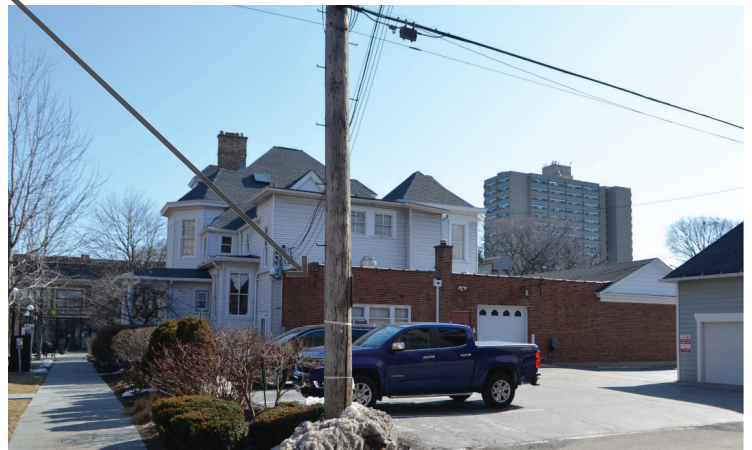
- There is a single story entry portico on the north side of the house that may have been added. Historic photos do not show it well but we believe that it is not original since the primary entry was previously on Marion Street and this entry would have been more of an understated service entry. Additionally the bay for this entry does not match the original design and massing. The door and sidelite does not appear original to the Queen Anne style.

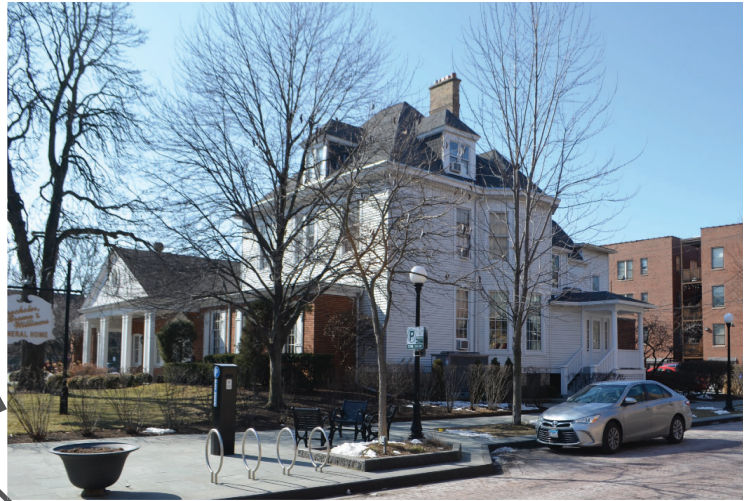
- Over 59% of the site is now covered with asphalt and concrete paving. This parking lot is not characteristic of the rest of the district and the original context of the house as a part of a row of houses on Marion Street that has not existed since the 1950's.

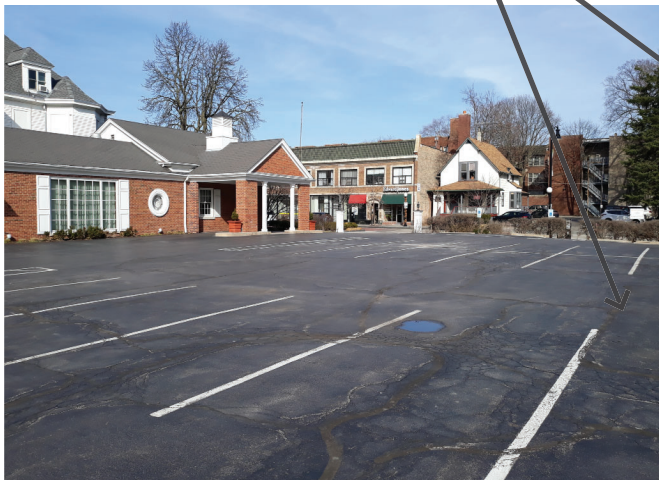
Original barn converted into vehicular garage in 1938.

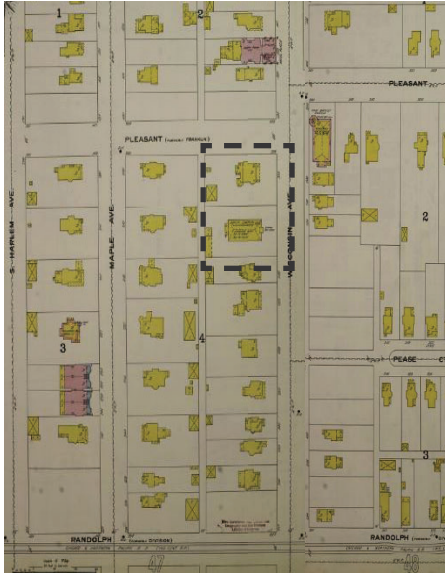
1895 Sanborn Map

The setting of the house as currently stands is completely different and modified from the original setting as evidenced by the Sanborn maps. Originally it was located on the west side of Wisconsin Street (now Marion Street) in a row of other single family residences and church parish house. Now it has been surrounded by more recent additions and three adjacent lots have been turned into asphalt parking lots.

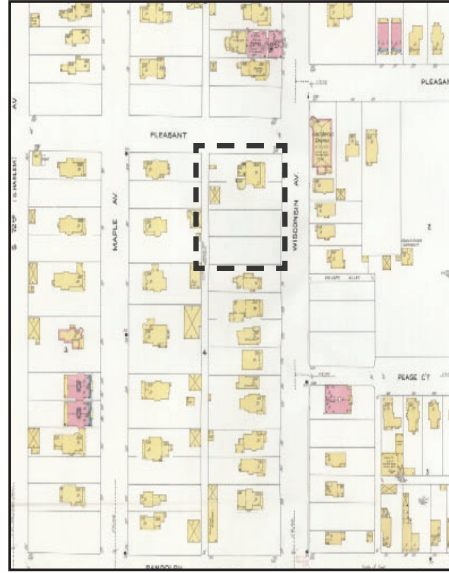
1908 Sanborn Map

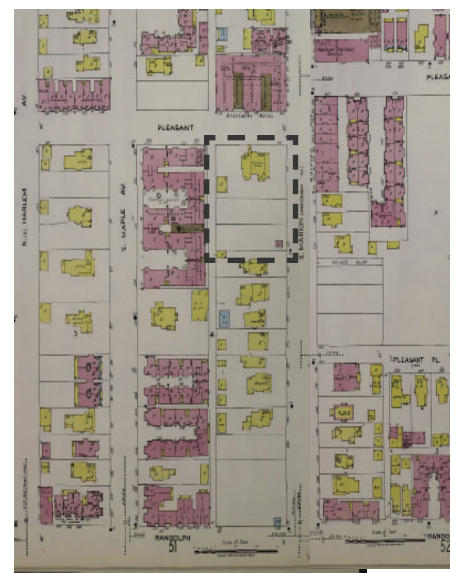
1950 Sanborn Map
