LAKE STREET  
PLAN AND PROFILE

**GROUND  
PENETRATING  
RADAR  
SYSTEMS, INC.**

*Subject: Ground Penetrating Radar (GPR) scanning at downtown area Oak Park,  
IL street scape extending along Lake St from Harlem to Euclid Ave and  
Marion Street from Lake Street to Ontario Street.*

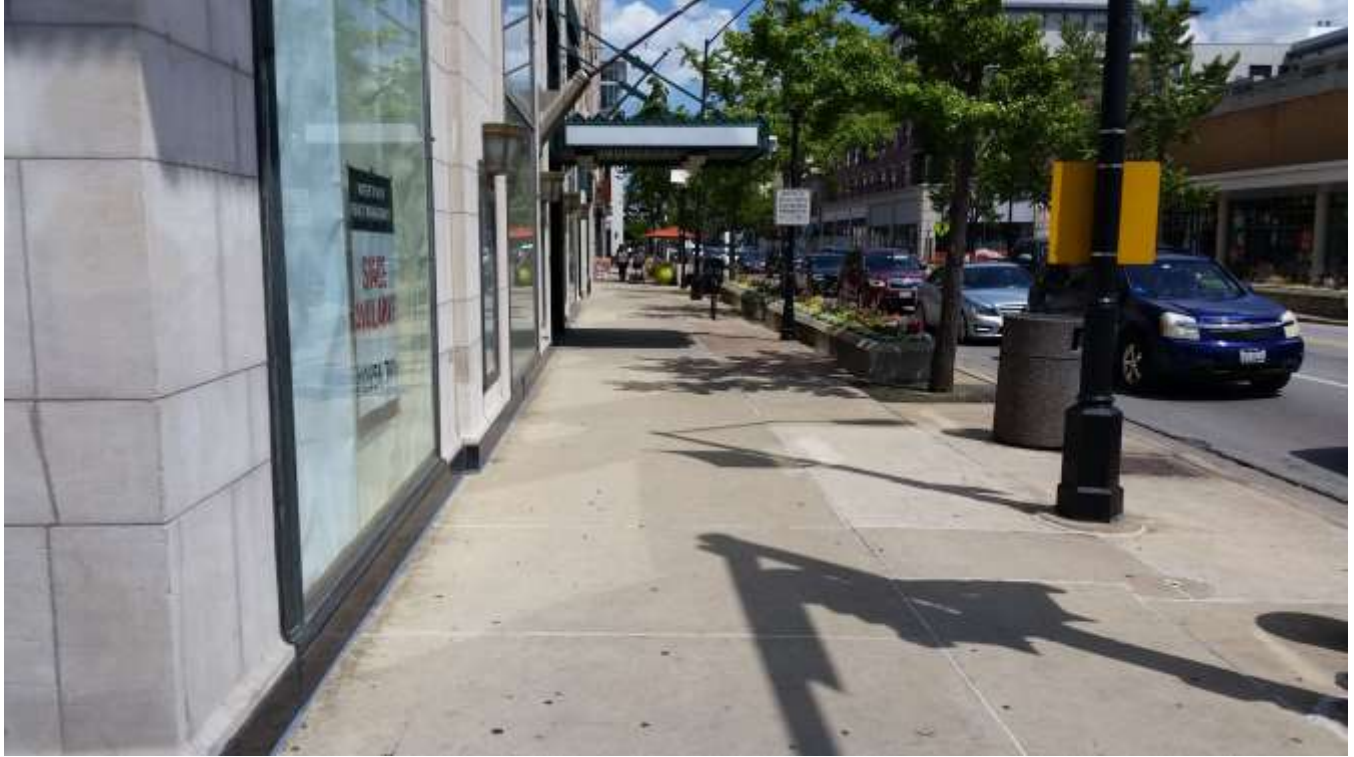
1144 W Lake St.

Suspect area believed to a vault based on the data and the size was 12' x by full length of building along south and west sides

This image is in the north to south scan direction. The top layer of concrete appears to be 6 to 7 inches thick and the bottom of the vault is at approximately 16 inches. Depth scale on the left

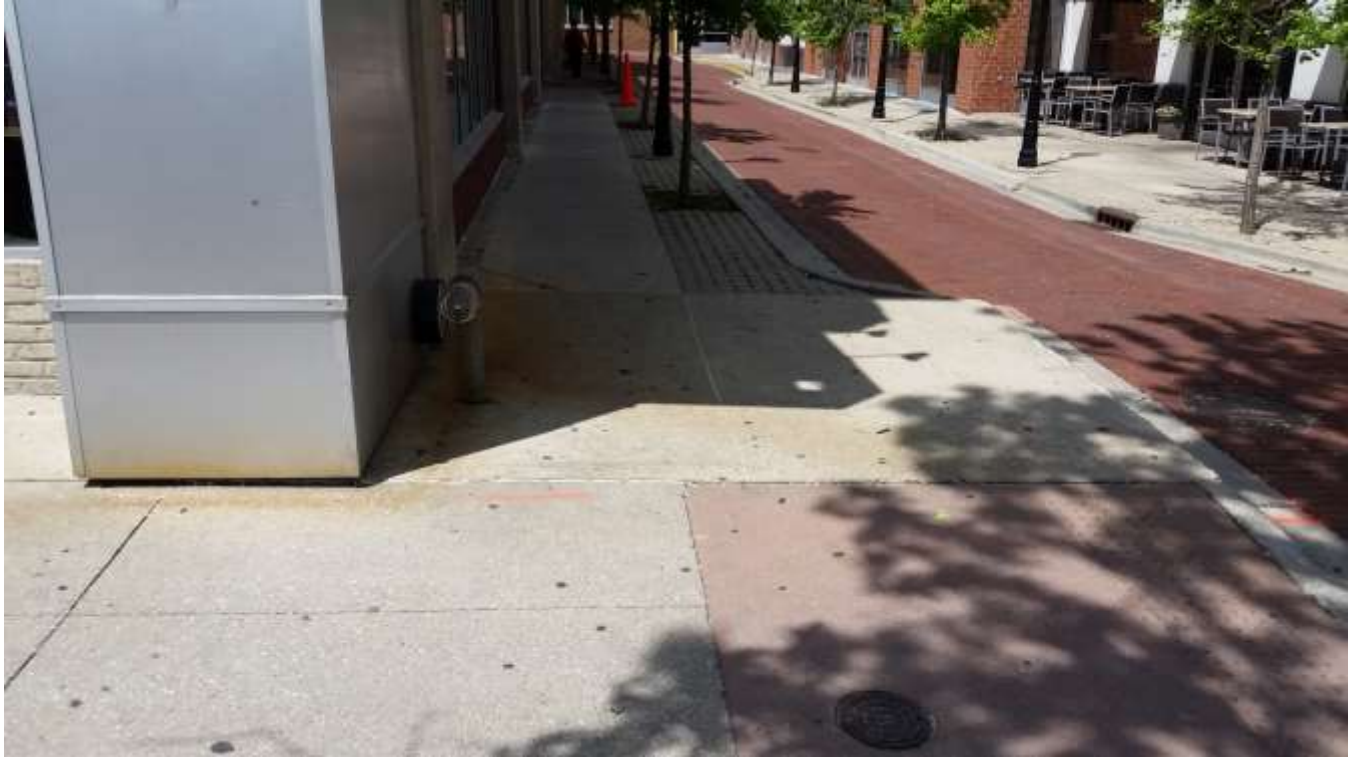
1128 W Lake St (Chipotle)

Suspect area believed to a vault based on the data and the size was 10 x 12 feet

This image is from the north to south scan direction . Concrete appears to be approximately 5 to 6 inches thick

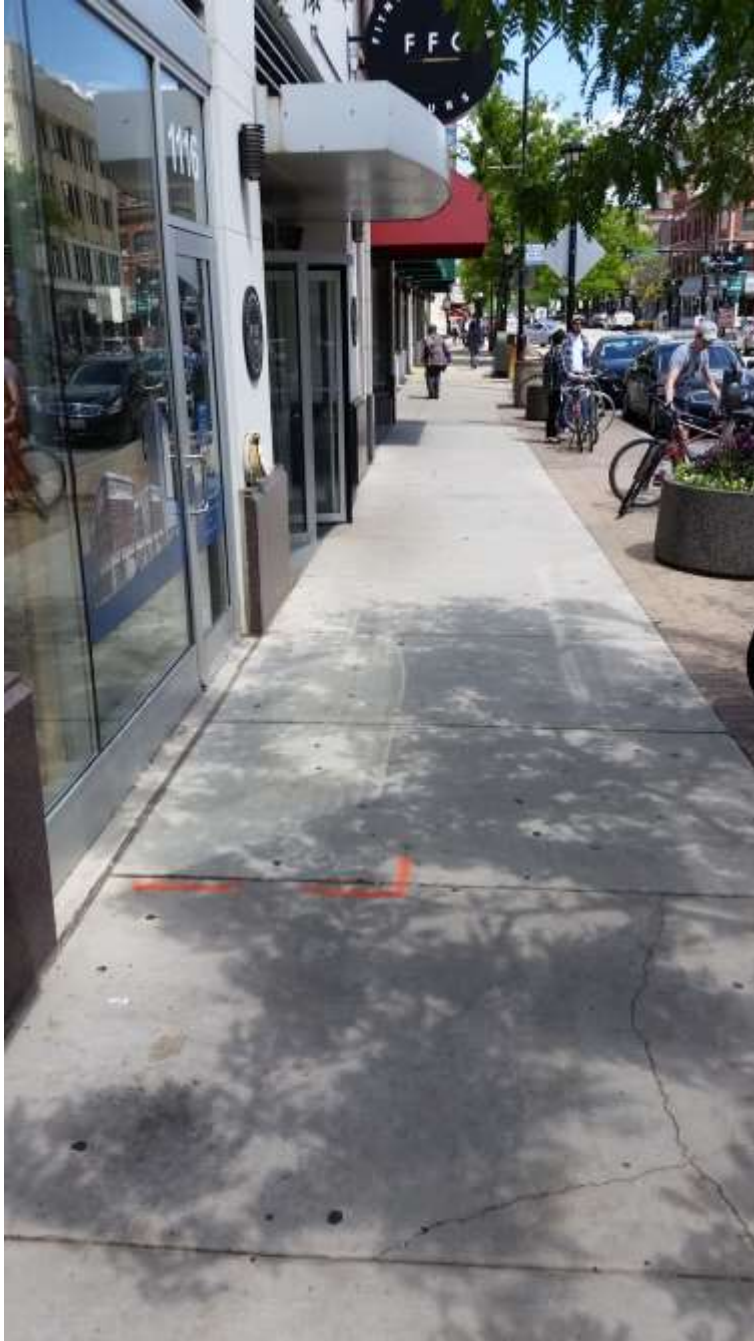
1116 W Lake St

Suspect area based upon the data unknown anomaly was present, anomaly may be vault or other unknown the size was 3 x 33 feet

This image shows data of an unknown anomaly. The top of the anomaly is at 10 inches in depth. Unclear if the anomaly is a vault or some other unknown. In this area further investigation may be required.

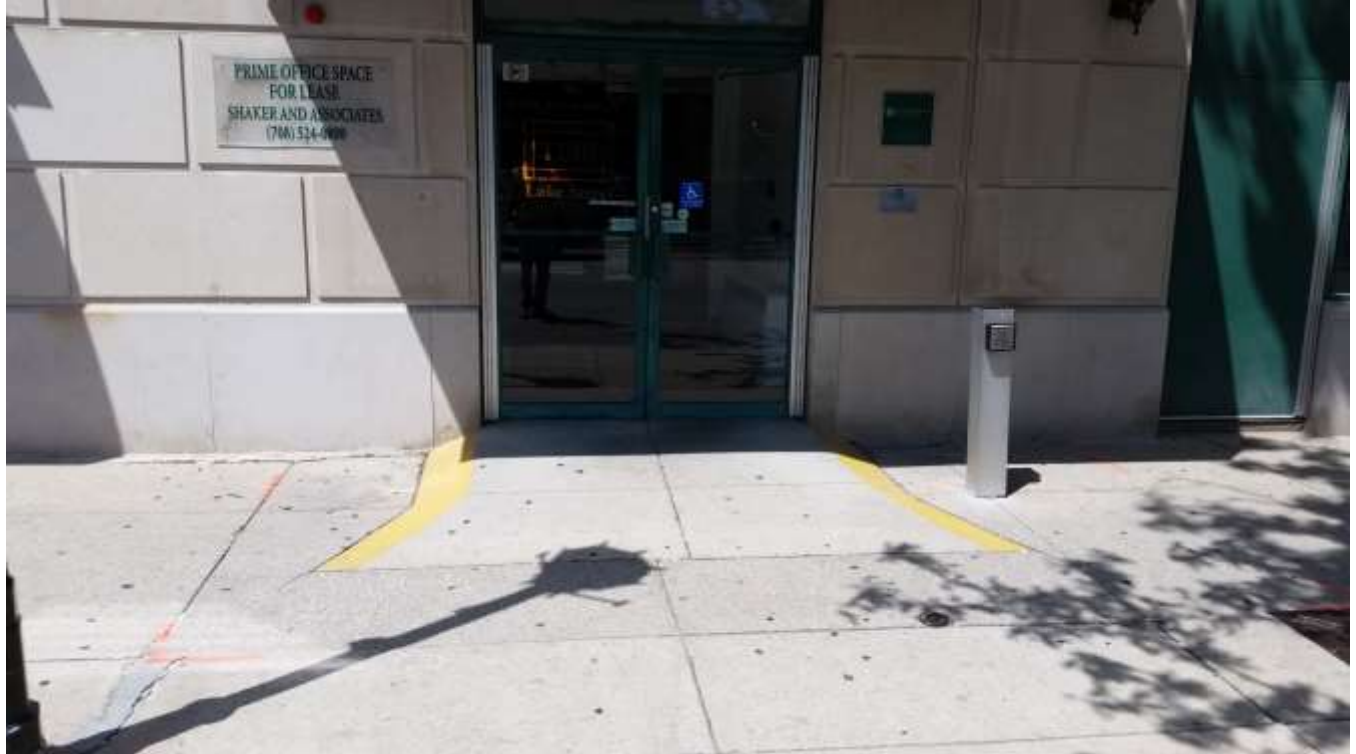
1100 W Lake St (Shaker building)

Suspect area believed to a vault based on the data and the size was 9 x 15 feet

This image is in the north to south direction. Bottom of concrete is approximately 7 to 8 inches.

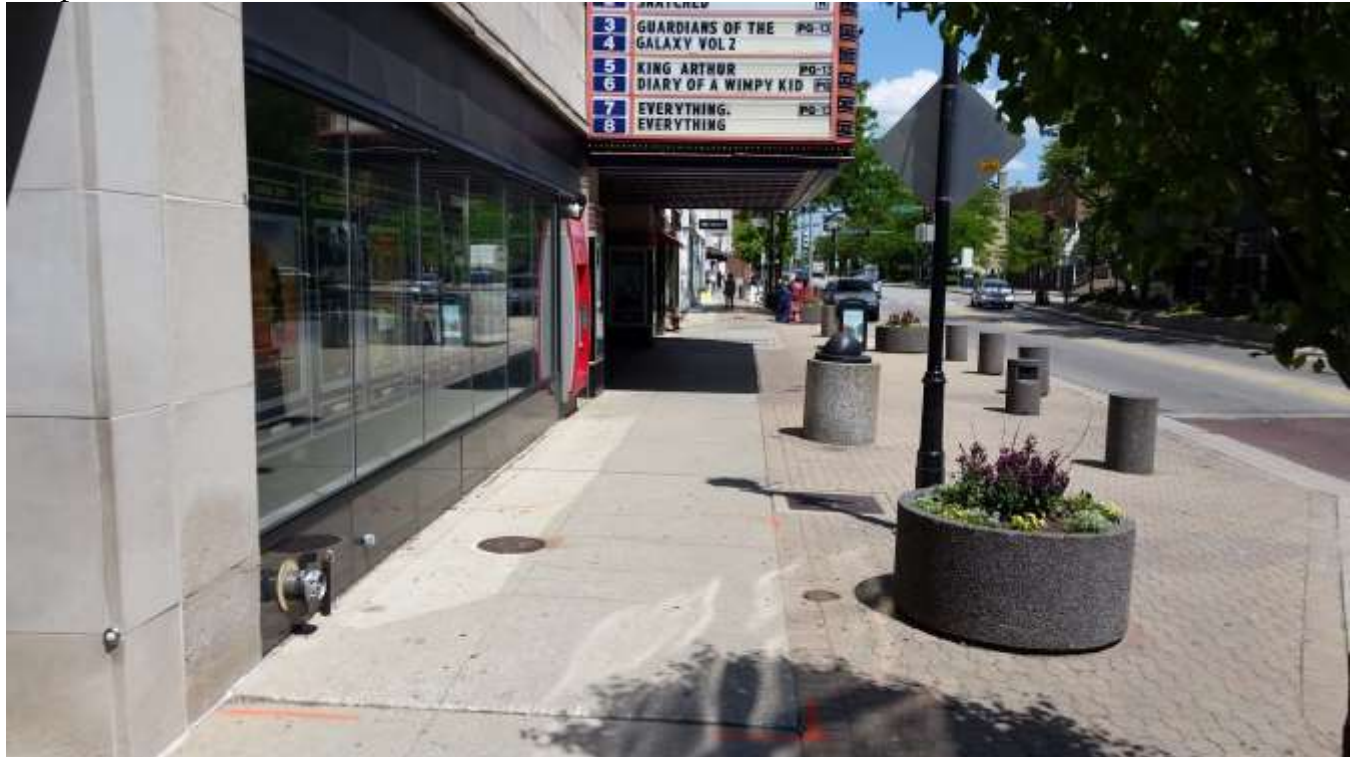
1022 W Lake St (theater)

Suspect area believed to a vault based on the data and the size was 8 x 12 feet

This image is the north south scan direction. Concrete is approximately 7 to 8 inches thick.

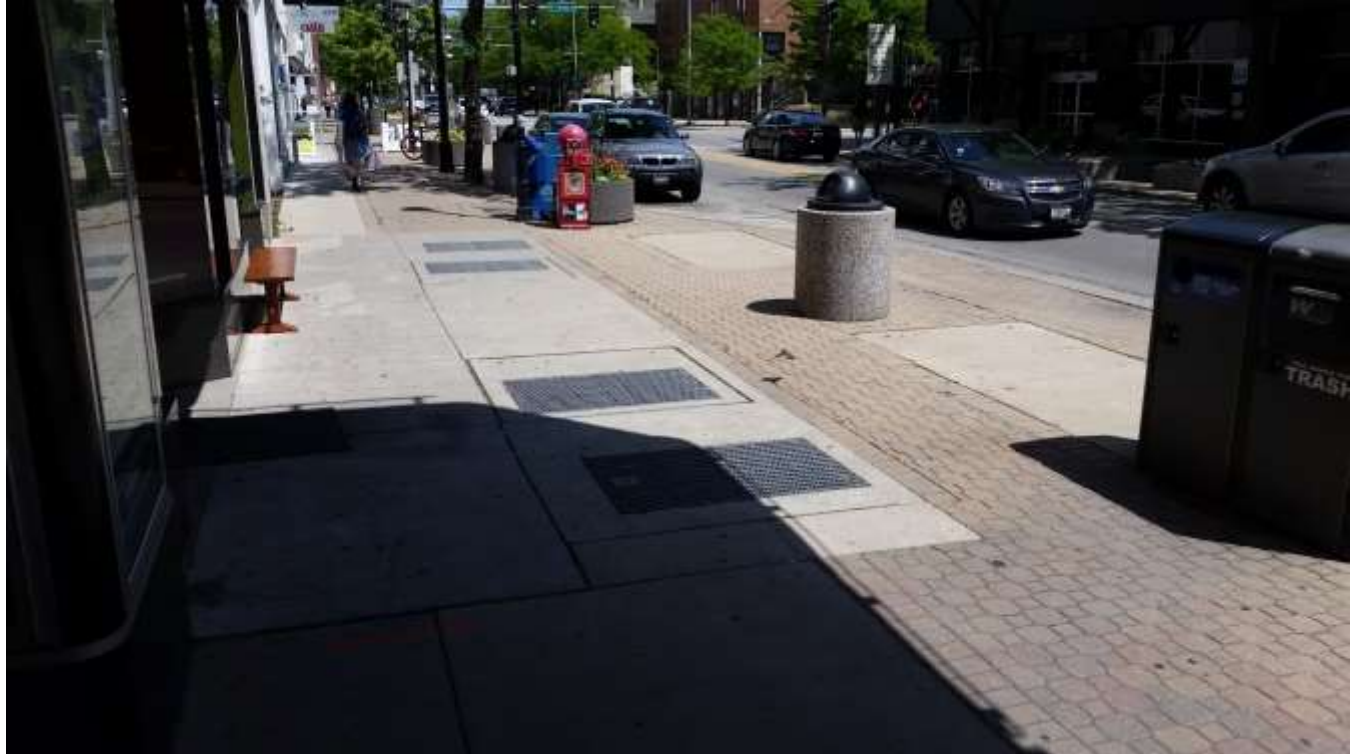
1022 W Lake St (theater)

Suspect area believed to a utility vault based on the data and the size was 21 x 33 feet

This image is from the north south direction. This is the utility vault area. There are several layers of reinforcement present and due to this the bottom of the concrete could not be determined.

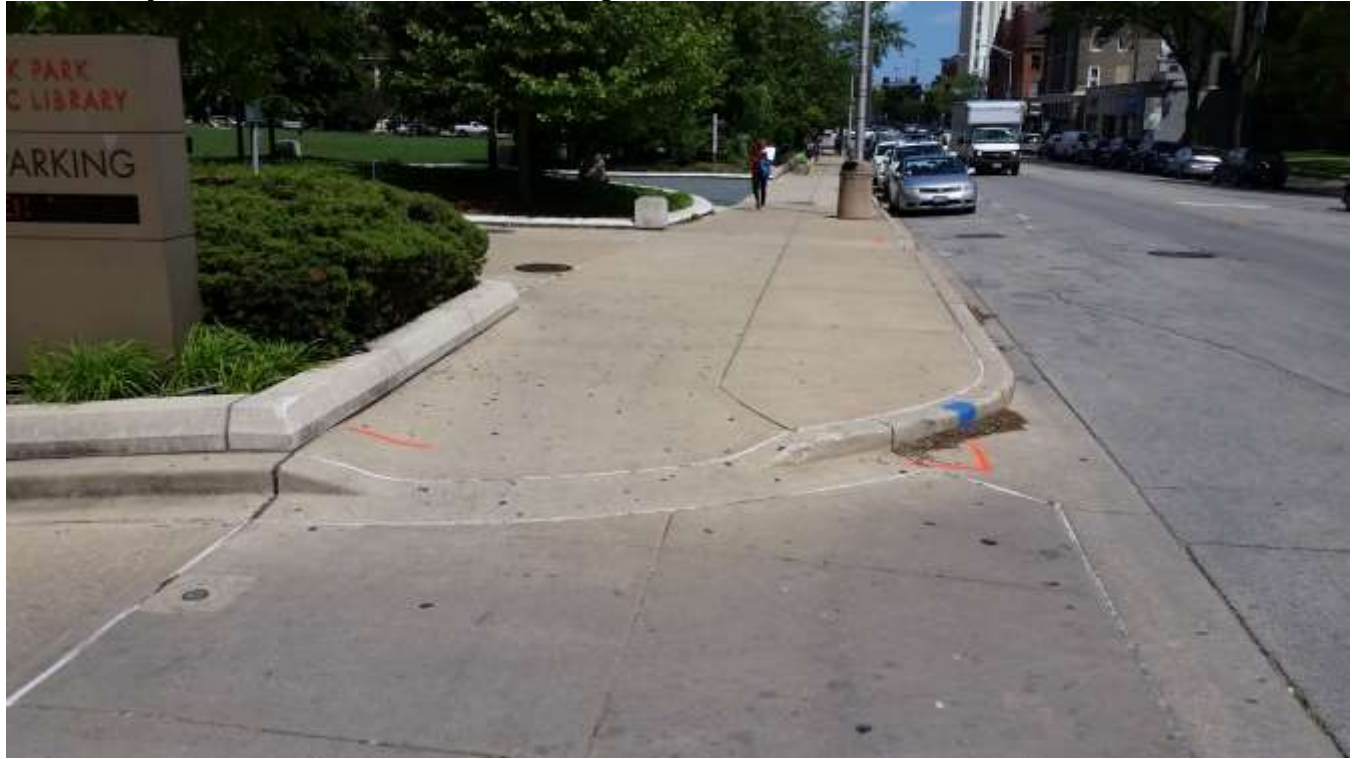
Suspect area believed to a vault based on the data and the size was 10 x 36 feet.

Area had several layers of reinforcement from wire mesh and rebar. The area may be a utility vault or extra reinforcement present due to the sidewalk construction.

This image is the north south direction. Two layers of reinforcement are present. Concrete thickness is approximately 5 to 6 inches.

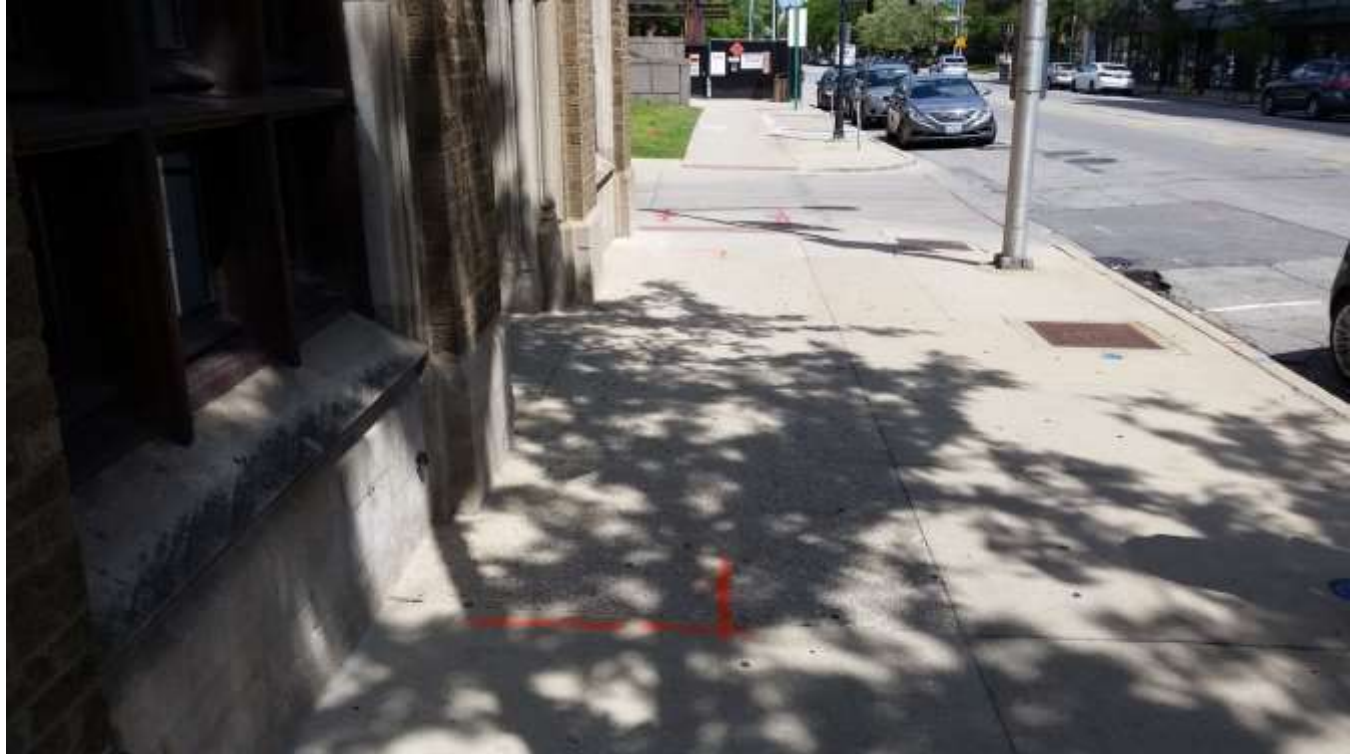
720 W Lake St

Suspect area based upon the data unknown anomaly was present, anomaly may be vault or other unknown the size was 4 x 24 feet

This data was from the east to west scan, there is anomaly at approximately 4 inches consistent with that of a void, no reinforcement is present. Anomaly may be a change in soil type or other unknown. If the anomaly is a vault the surface would be the top of the concrete sidewalk. Further investigation will be required to determine what anomaly is.

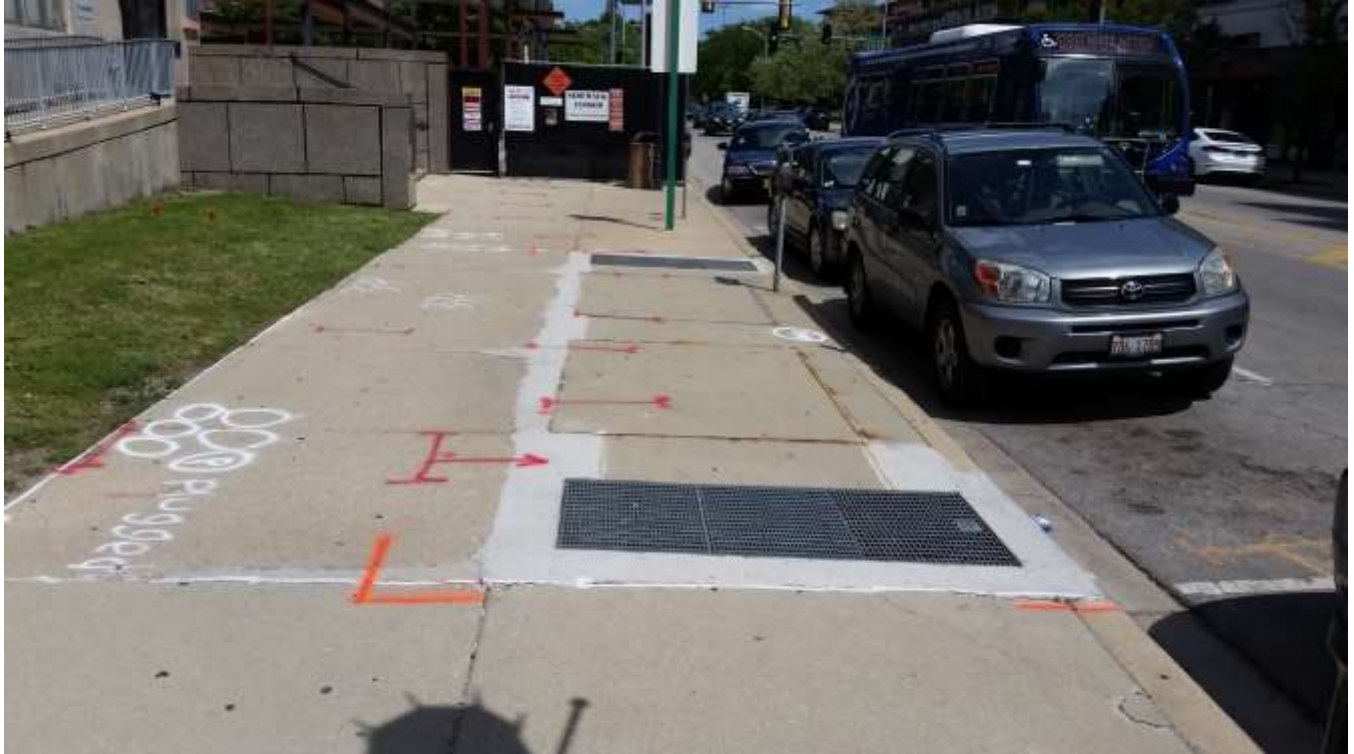
714 W Lake St

Suspect area believed to a utility vault based on the data and the size was 8 x 30 feet.

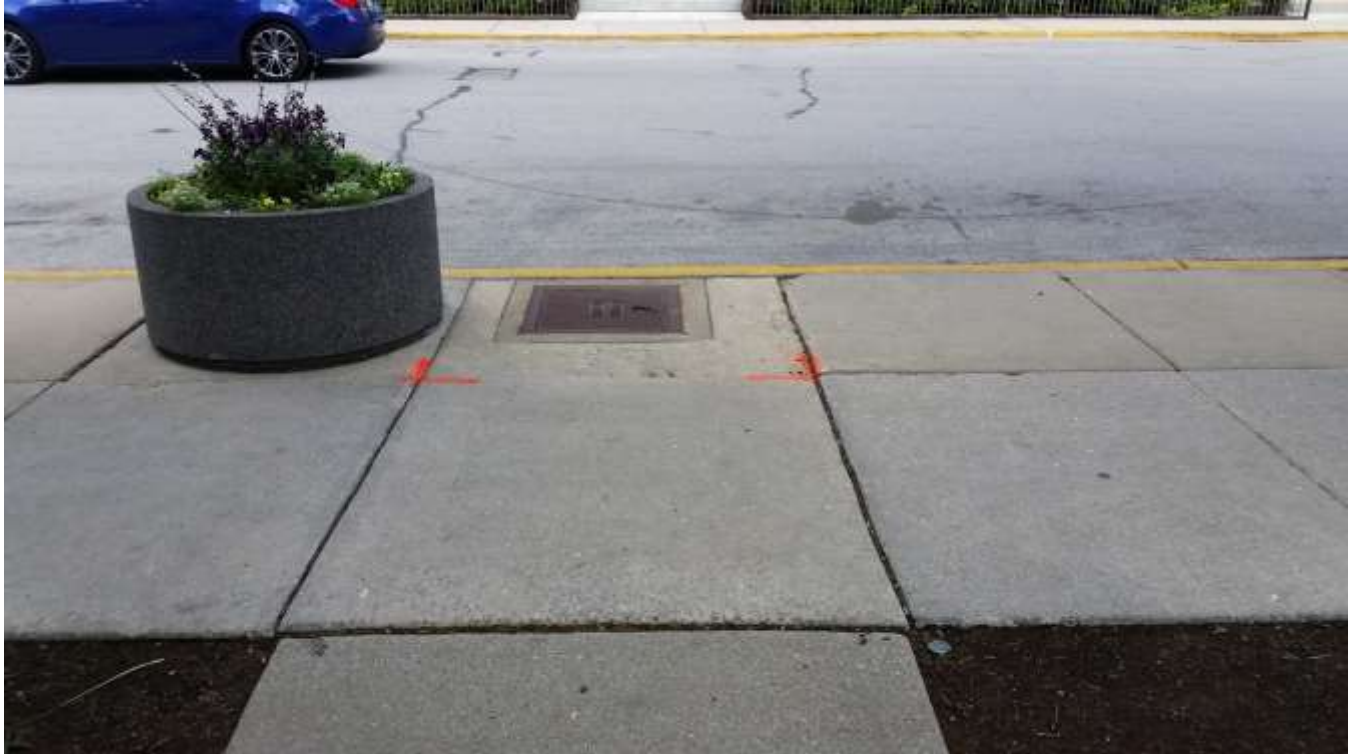
Marion St

Suspect area believed to a utility vault based on the data and the size was 5 x 5 feet.

This is the north south direction around the utility vault. There is reinforcement present; depth of concrete was unable to be identified here

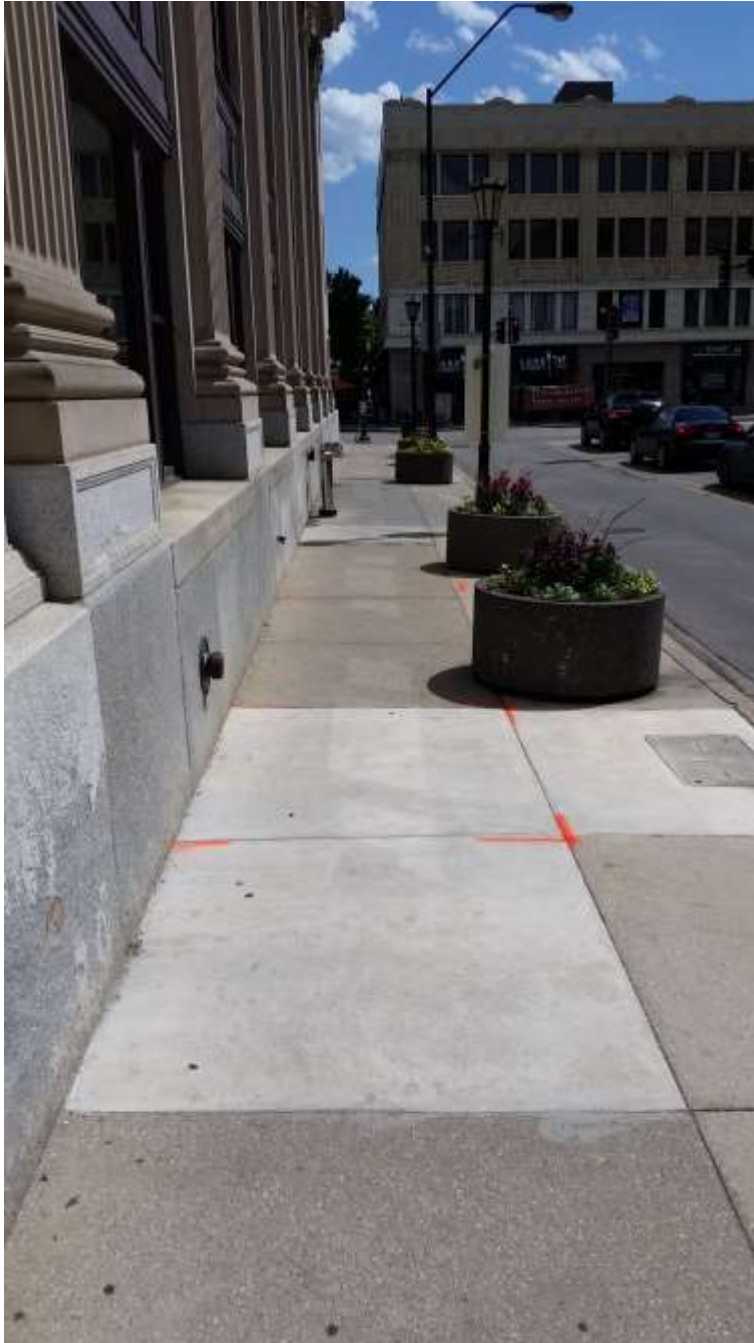
North End

Suspect area believed to a vault based on the data and the size was North end 5 x 6 feet Middle 5 x 40 feet and South end 5 x 25 feet.
