# Oak Park Police Department Space Needs Analysis

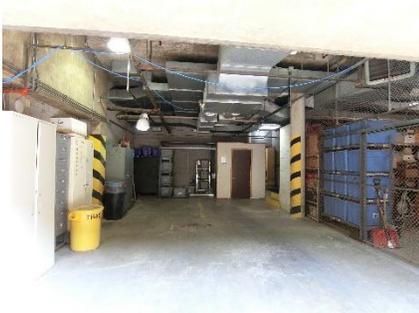
Sally Port

- The access into the booking room from the sally port has steps, which can be dangerous for both officers and arrestees, especially if the arrestee is intoxicated.
- Cells are not designed with anti-ligature (hanging) doors and fixtures.
- Officers take prisoners outside of the lockup area to process them. The major flaw of doing this is that it is located outside of the lockup area. If a detainee were to escape from an officer's custody, they can access many other areas of the Police Station, creating a potentially dangerous situation.

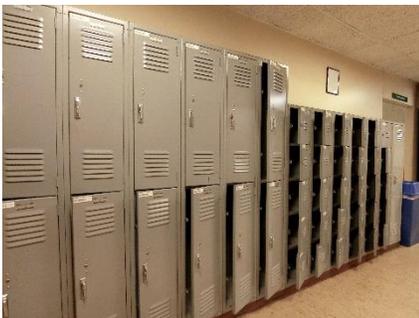
Evidence lockers located in hallway

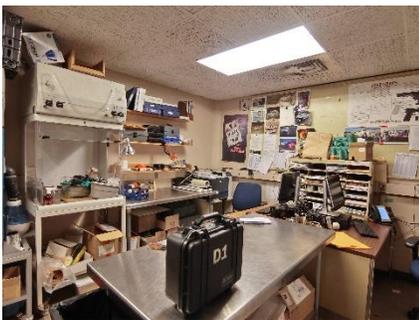
Evidence processing area

- **Evidence Processing (Identification):** When the Police Station was designed, there was no dedicated space for analysis of evidence. The current evidence processing lab was created in a former Photo Dark Room. The work performed by the police department includes collection of latent fingerprints, presumptive drug testing, collection and preservation of evidence, and forensic photography. Some evidence collected is prepared for outside analysis, for example, fingerprint and DNA identification work is outsourced.

The existing workspace is very small at 239 sq.ft. and requires 480 sq.ft. to have proper workspace. The current space

severely limits the capabilities of the Police Department and staff are forced to make do by doing things like using the floor as a worksurface. The need for scientific analysis of evidence continues to increase, and as processing of evidence becomes more sophisticated, significantly more space is required.

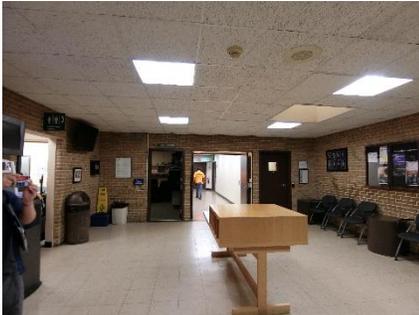
Unsupervised public corridor to elevator

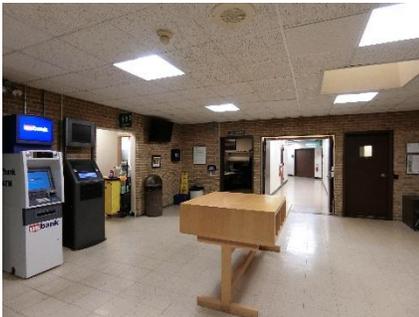
Views from front desk are limited

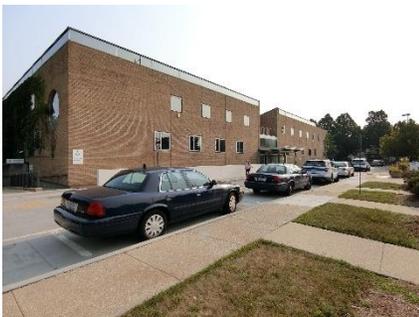
Unsecured parking for squad cars

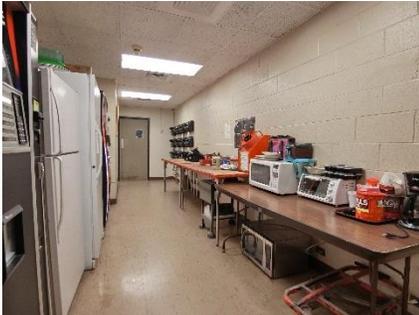
Staff Break area shared with gun cleaning

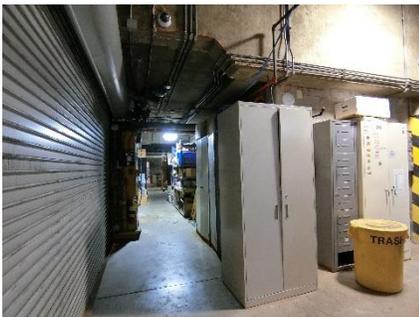
Other issues with the Sally Port:

- It is necessary to use steps to access Lockup Areas, which is dangerous when moving prisoners.
  - There are many items stored in the Sally Port which reduces the space available for defensive tactics if a detainee struggles. This poses a liability risk to the Village as it is the Police Department's responsibility for the well-being and safety of detainees.
- **Booking Room:** This space was designed at a time when ink fingerprints and Polaroid Cameras for mugshots were the norm. Now, the Police Department uses electronic fingerprinting (Live Scan) and digital photography for mugshots, which are

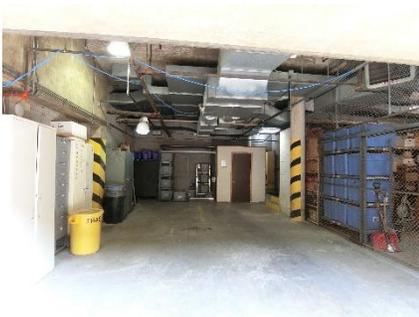
Unsecured access from Sally port to building storage

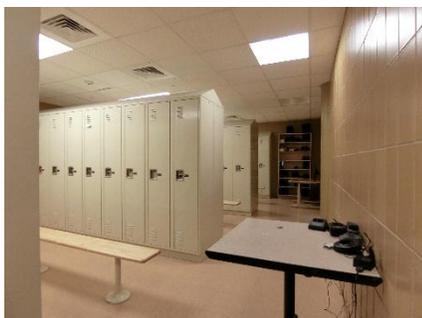
Men's Locker Room

- **Locker Rooms:** Since the building was constructed, the amount of gear issued to police officers has increased. Lockers now must store a multitude of items, including training manuals, bulletproof vests, specialized protective equipment, and weapons. This has necessitated a need for larger lockers. Today, the smallest locker typically provided for police officers is 24"wide x 24" deep.

The locker room lockers were originally 12"wide x12"deep. At some point, they were changed to 15"wide x12" deep, reducing the number of lockers and necessitating the creation of a male sergeant's locker room and a command locker area in other areas of the Police Station.

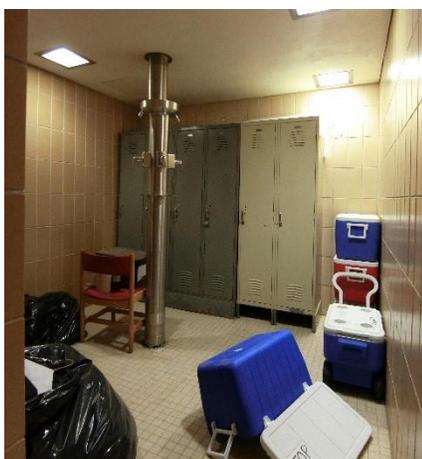
Men's Shower area

- Showers are "gang style," which are no longer permitted by code.

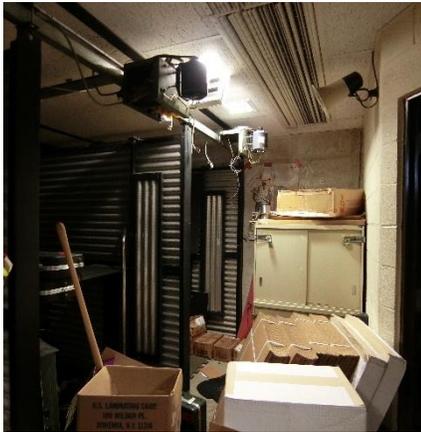
- **Firing Range:** The existing Firing Range was originally designed as a "static firing line range." This means Officers stood at a firing line (or booth) and practiced shooting. The type of bullet trap installed can only handle handgun rounds or small rifle rounds (.22 caliber). This type of range has not been used in law enforcement facilities for over 25 years because modern training now requires "tactical training" with the ability to practice shooting from anywhere on the range, utilizing handguns and rifles normally carried by Police Officers.

- The Firing Range is currently not in use due to HVAC issues.
- If this Firing Range were converted to a tactical range a new bullet trap capable of accommodating rifles will be required. Modern bullet traps are larger than the current one, so the shooting distance would be less than 25 yards, which is the longest qualifying distance required.
- A dangerous aspect of the Firing Range is that a person enters directly onto the range. Typically, there is a preparation room or man trap prior to entering a range.
- There is no storage for range props, targets, and cleaning equipment.
- The location of the Firing Range causes noise issues to the Village Offices above it, so there are restrictions on when it can be used.

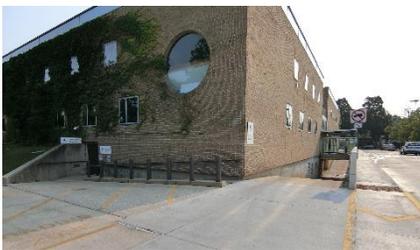
*Non-compliant ADA ramp*

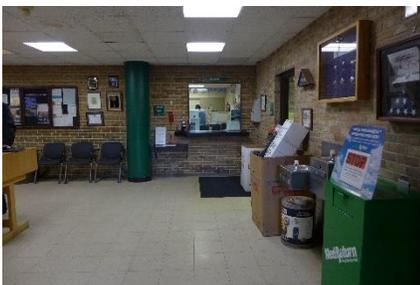
*Modified front counter*

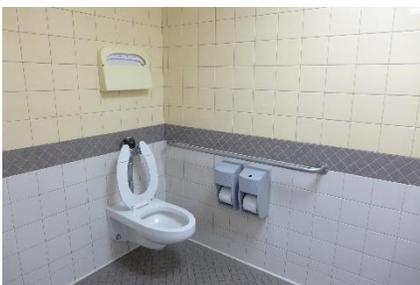
*Non-compliant ADA grab bars*

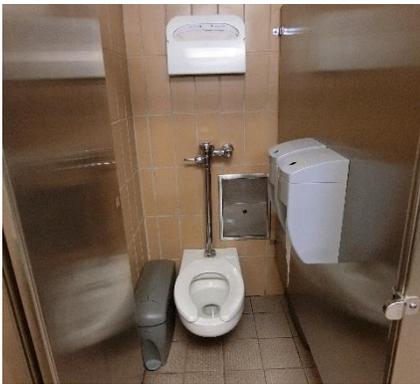
Inaccessible toilets in locker rooms

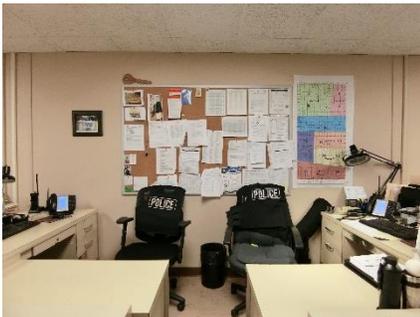
Inaccessible workstation

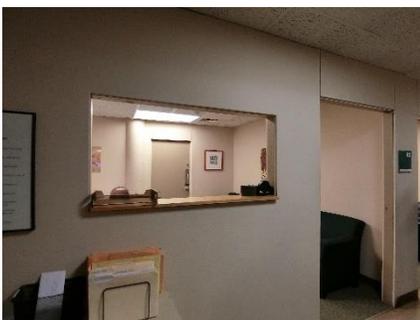
Non-ADA compliant service window

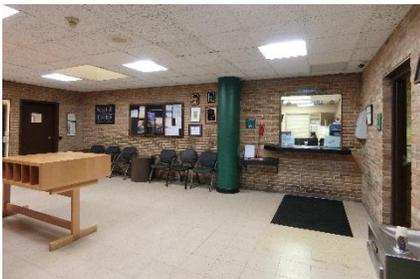
*Poor sight lines from the Front Desk*

- There is water damage located at the skylight within the public lobby.
- The door finishes are showing their age with chipping paint and damaged jambs.
- The flooring within the lockup area at the front desk is damaged.
- Due to the layout of the space, sight lines to lobby and the lockup cell are difficult.

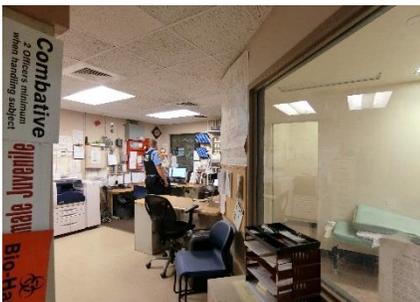
*Poor sight lines from Front Desk to  
Observation Room*

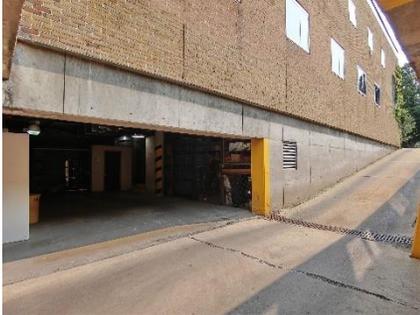
- Vehicular access to the sally port and parking garage is difficult with the current turning radiuses. The ramp is steep and creates issues with access for larger vehicles. The low headroom at the overhead doors leading into the sally port and garage limits the size of vehicles that can enter the area.

Difficult vehicular access to Sally Port

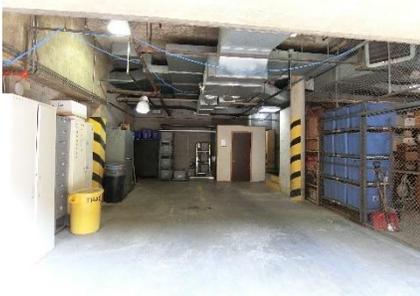
Walls within Sally Port lined with storage

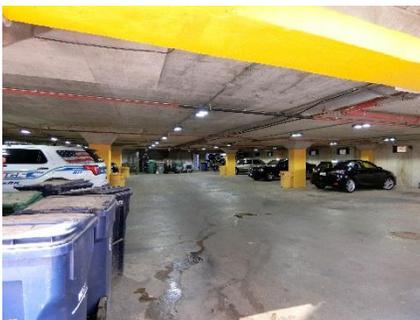
Steep slope and low head clearance at parking garage

- Snowplows and garbage trucks cannot access the bottom of the ramp and garage due to the steep slope and low headroom clearance.
- The floors and ceiling are showing signs of damage. The concrete around the trench drains is spalling and cracking. The concrete roof deck is spalling, exposing rebar which is rusting and corroding due to exposure to the elements.
- There is seepage in the garage which is likely caused by blocked or collapsed drain tile within the garage.
- The conduit surrounding the main data line connecting the communications tower to the building appears to be severely damaged and is exposing the cabling to water.

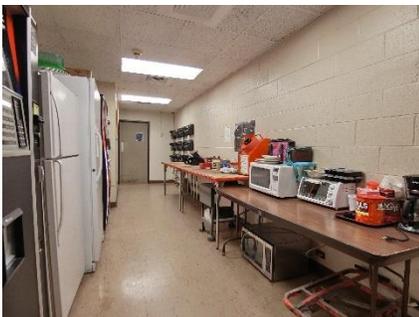
*Staff break area shared with gun cleaning*

- The staff break area is currently being shared with the gun cleaning area. This is not a safe situation. Gun cleaning should be in a dedicated area to prevent an accidental discharge from injuring others. Furthermore, having these functions together creates an unsanitary, hazardous environment with chemicals for cleaning guns comingling with food.
- Overall, the space is inadequate for either function. There is a lack of counterspace for gun cleaning, folding tables have been covered with cardboard to soak up the spills from the chemicals and solvents. There is no seating area or place for staff to gather during break times. The lack of natural light contributes to the overall gloomy feel of the space.

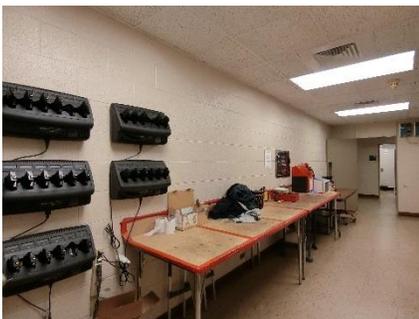
*Lack of seating and natural daylight at staff break area*

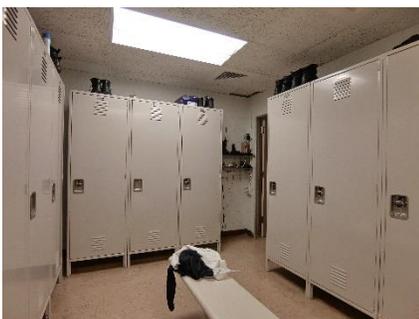
*Lack of storage within sergeant's locker room*

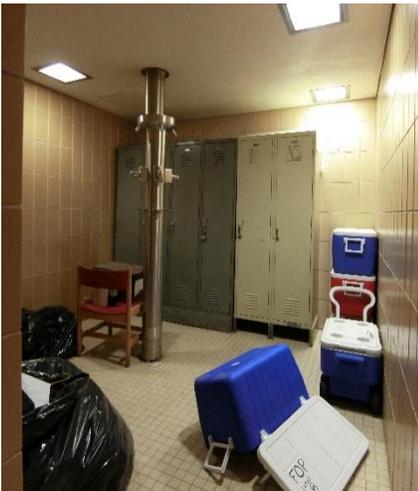
- In both the men's and women's locker rooms, the shower areas are being used for storage.
- The rooms are too small forcing the sergeants and administration lockers to be located elsewhere.
- The lockers are too small to provide proper boot storage and are insufficient in size for the officers.
- There is a lack of storage throughout for radios and equipment.

*Men's shower being used for storage*

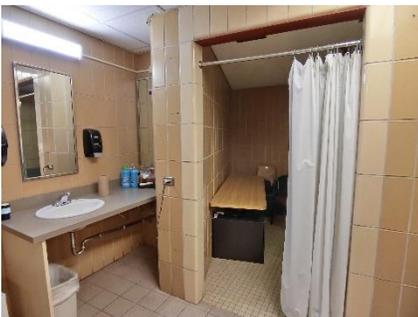
*Poor layout at vanity within women's locker room*

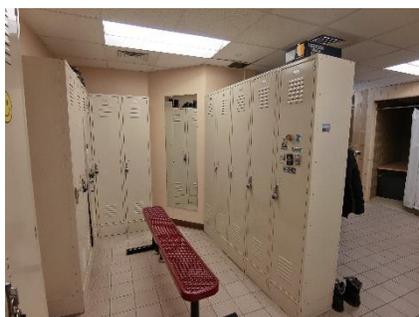
*Insufficient space for storage and circulation*

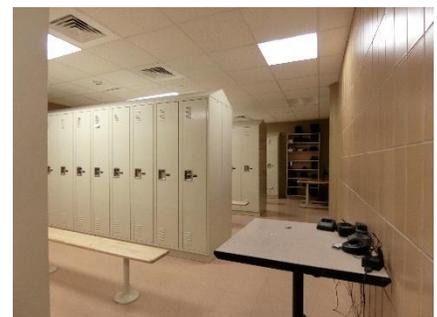
*Lockers size is insufficient*

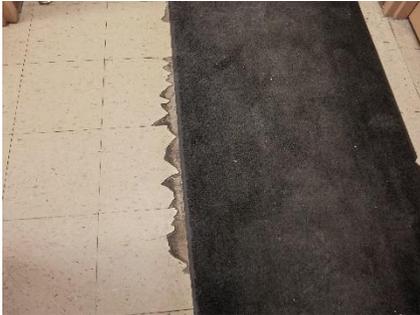
- An electrical and a mechanical storage room have been retrofitted to the west and south sides of the room. The result is a very tight space that makes circulating around the conference table extremely difficult. With no sound separation between the equipment and the conference room.
- The flooring has started to chip in the corridor outside the conference room.

*Chipped flooring outside conference room*

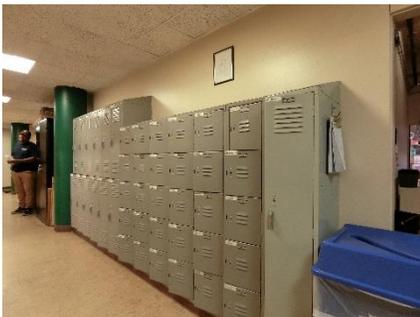
*Evidence lockers located in the main corridor*

- Due to overcrowding, the evidence lockers cannot be located near the bag and tag area and have been put in the main corridor. This location is not recommended as it requires moving evidence through the main circulation corridor.
- The bag and tag area is currently being shared with the evidence processing lab. The space is too small and does not allow for proper layout, circulation or processing space. There is insufficient space for storage and an overcrowding of equipment. In order to perform a task several items need to be relocated in order to access the required equipment.

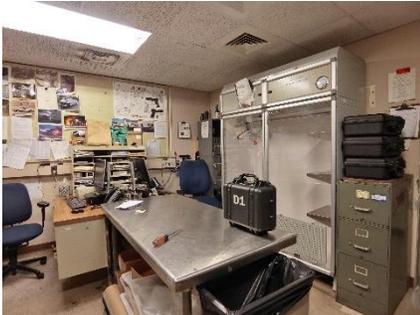
*Evidence processing is overcrowded*

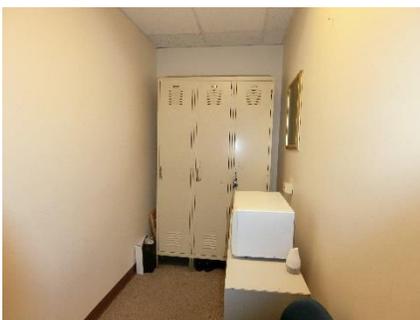
- Due to the insufficient break area, a makeshift coffee area and locker room has been created within the department behind a commander's work area.
- Closet doors have been removed in order to create a copy alcove space.

*Administration lockers and break area*

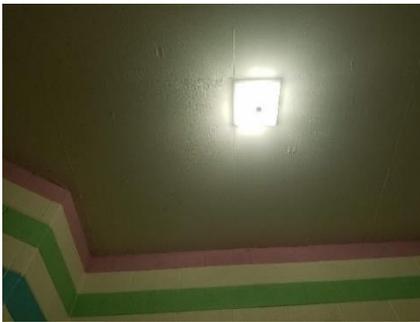
Typical detention cell lighting fixtures

The booking and detention areas of the police station do not have appropriately constructed vandal-proof detention rated light fixtures. The fixtures in the booking area are standard troffer fixtures and in the cells are exterior grade lights. The fixtures themselves are in fair condition.

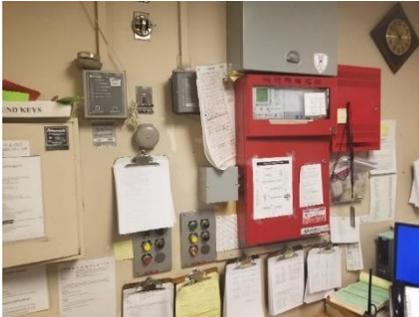
*Fire alarm main control panel*

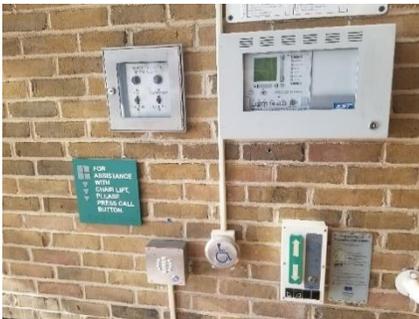
*Fire alarm annunciation panel*

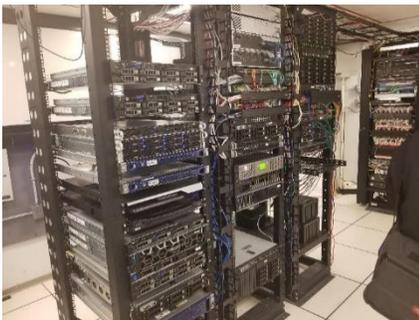
*Village server room & racks*

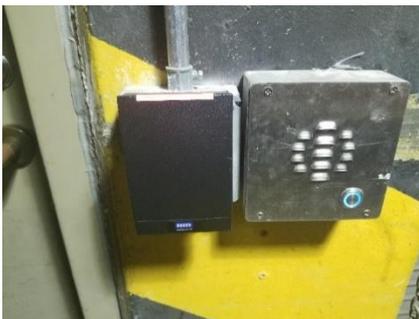
The building has a central sound/paging and intercom system with the head-end unit located at the front transaction counter. The system is quite old and in poor condition. Newer intercom devices, which may have taken the place of the old system devices, have been installed. There are modern card access devices and IP based security cameras installed throughout that are in fair condition. Typical expected useful service life of electronic telecommunications systems and equipment is approximately 7 to 10 years maximum.

*Intercom call and electronic security reader*
