# HISTORIC STRUCTURES REPORT: **FOLEY-RICE DEALERSHIP (1924-27)**

THE SCHOOL OF THE ART INSTITUTE OF CHICAGO  
HISTORIC PRESERVATION PROGRAM  
MAY 2008

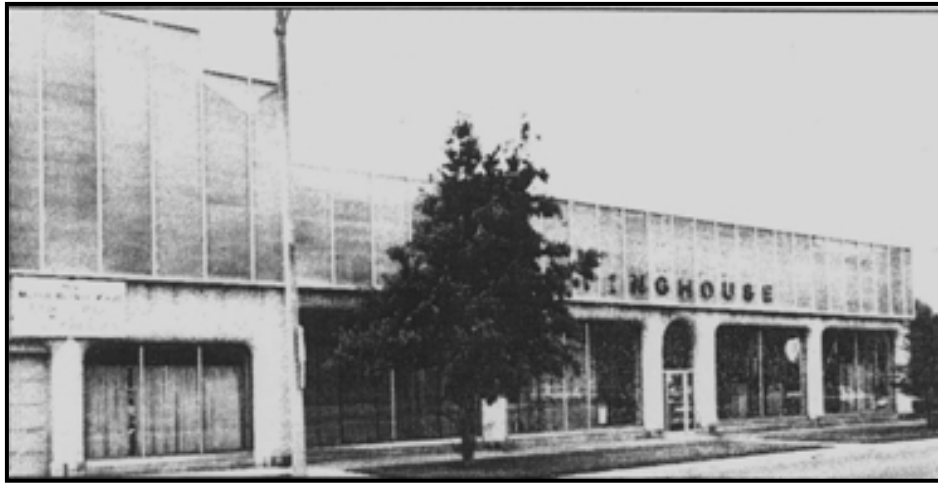
The building history indicates that the entire two buildings were covered in aluminum siding in 1967 [Figure II-17] and that Foley-Rice restored the façade in 1990 (plans found in the Appendix B).<sup>10</sup> Other changes include the showroom window in the 1927 building which had been a garage door in 1959. That window, to the east of the main entrance, is currently comprised of two glass doors, with a transom above and sidelights, but it is not clear when those changes occurred. In addition, at some point in time, the original ornate metal canopy of the 1924 building was removed and the doors were modified from the original two door entry with a glass transom above. Brackets which held the canopy are still evident on either side of the entry. Most of the windows are original with the exception of the display windows in the showroom.

**Figure II – 17: Foley-Rice / 1967  
Façade Alteration**

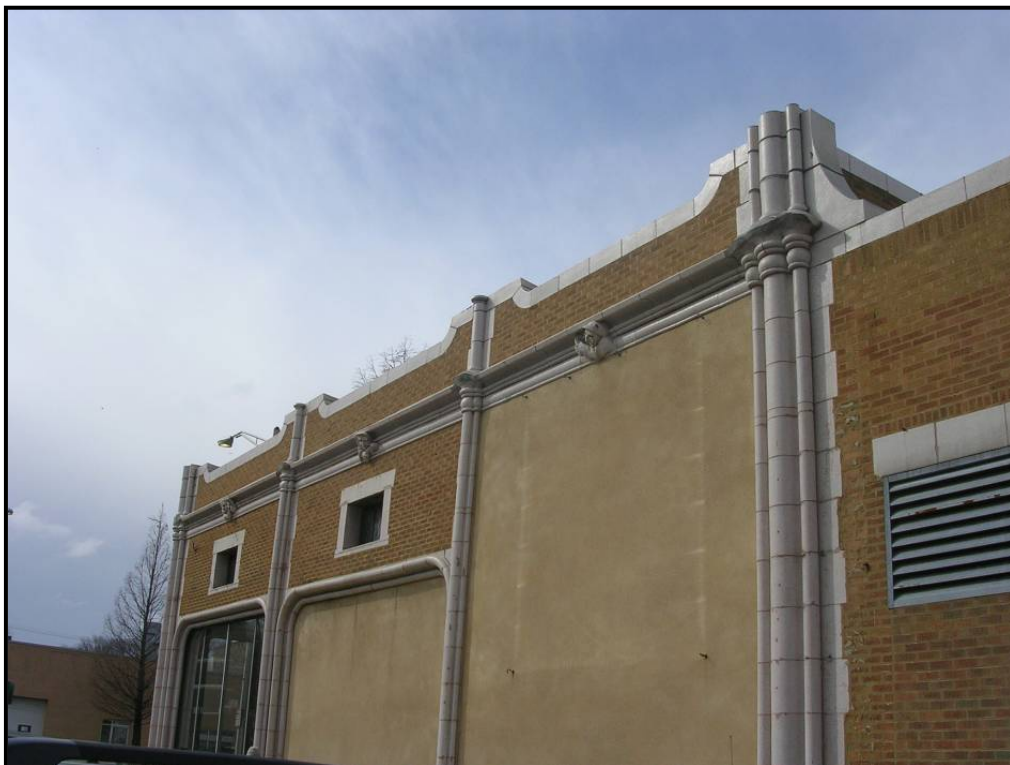
The east face of the building is a secondary façade. Its main use was as a service entrance for the repair area of the dealership [Figures III - 4 and III - 5]. At the roofline of the building, the parapet is notched in some places, giving the effect of a crenellation. This portion is capped by a flat, terra-cotta coping. The southernmost portion of the east façade features three bays carried around the corner of the building in the same configuration and materials as the storefronts on the building's South facade. While the southern-most window is still intact, the following two have been partially in-filled in with what appears to be tan-colored stucco—although further inspection would be required to determine if this addition is in fact, EIFs. Moving north down the façade, there is a terra-cotta lintel located above what appears to have once been a garage door opening, but has since been bricked in [Figure III-6]. This façade has a secondary entrance to the repair area of the building, and is accessed through a centrally located door with a large glass transom above it. As with the rest of the windows and doors on this side of the building, this door is topped by a rectangular terra-cotta lintel that lays flush with the surface of the brick, and has a shield-like crest at its center [Figure III-7]. The garage door on this façade has been replaced with a more recent aluminum model; however its original wood frame remains. The steel-sash awning window on this side of the building is the same configuration as those on the second floor of the south facade, and has a terra-cotta sill as well. The base of the building on this facade is less ornamental than the South facade, as it is constructed of cast-stone that has been scored at intervals to resemble masonry block.

**Figure III – 4: East Façade**  
**Primarily a service entrance with infill showroom window**

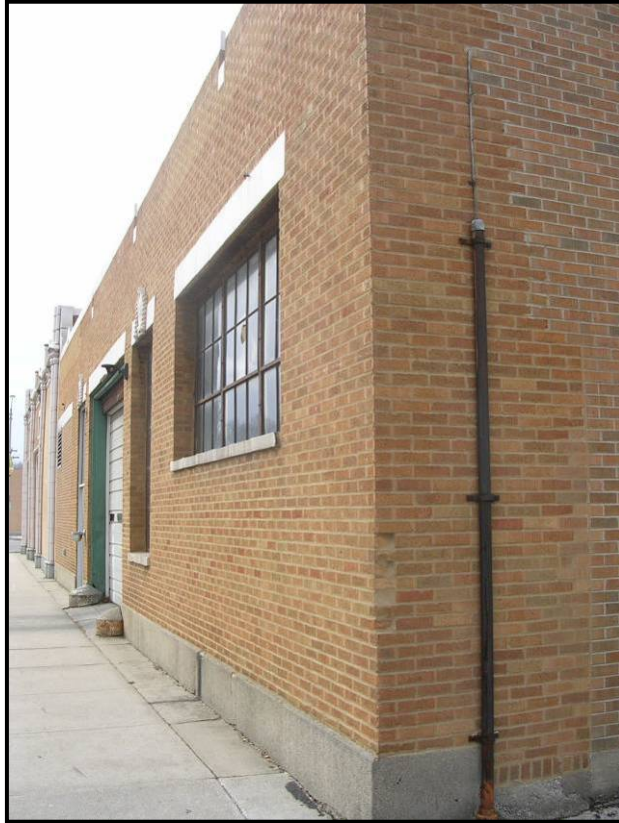
**Figure III - 5: East Façade  
Primarily a service entrance**

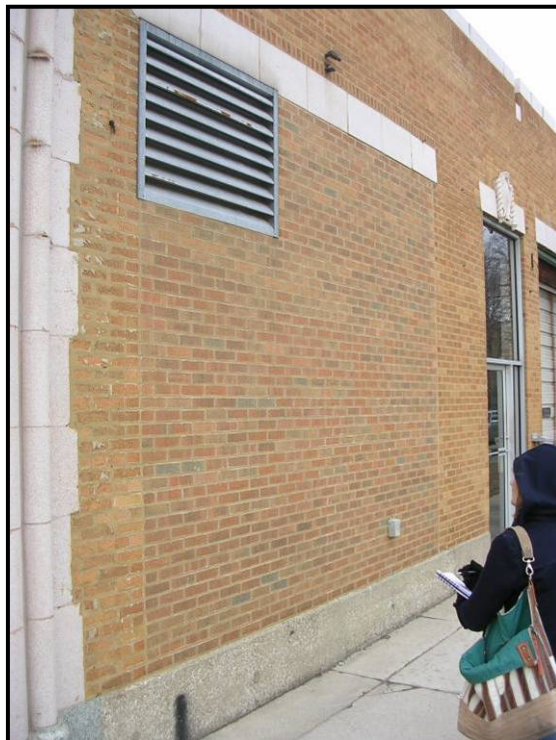
**Figure III – 6: East Façade  
What appears to be a bricked-up garage door**

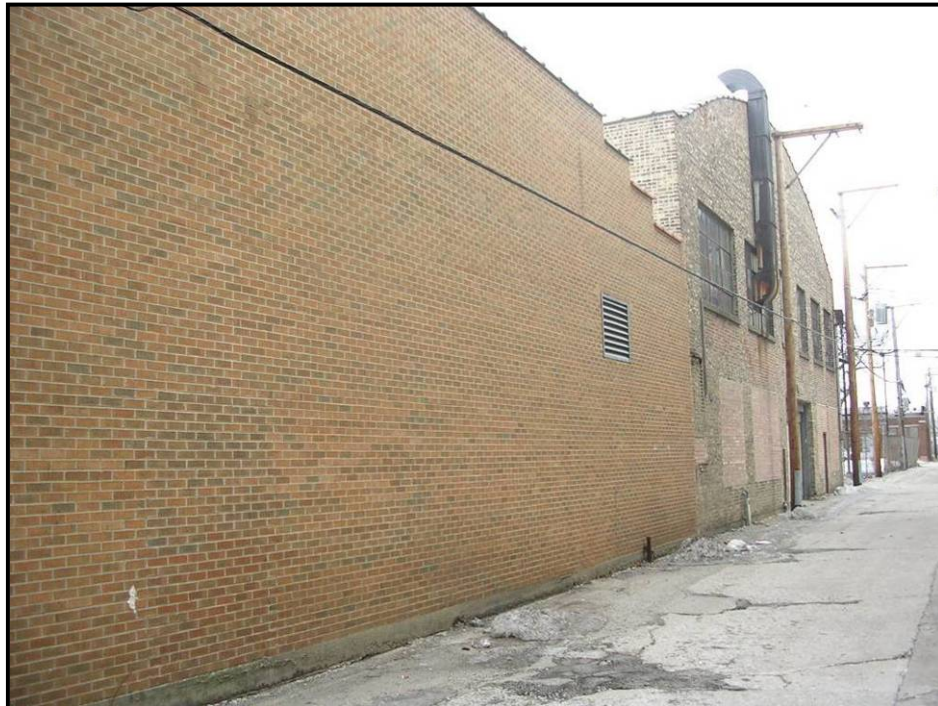
The North façade is the least important façade of the building, both due to its location which borders an alley and the extensive reconstruction of the 1924 building's rear, and the infill of many openings on the 1927 building [Figure III-8]. The entire façade of the 1924 building has been replaced by a red-brick wall with various aluminum ventilation grills. Upon further inspection inside of the building, it is obvious that significant portions of the original wall were removed, then filled with concrete masonry units and bricked in on the exterior. The parapet on this side has a stepped form to accommodate the vaulted ceiling in the repair area, and the coping used on this portion has a different profile from the glazed terra cotta used on the previous facades. The coping on this side of the building is orange in color, unglazed, and has a pronounced lip at each joint between the units.

**Figure III-8: North Façade**  
**Rear of Building**

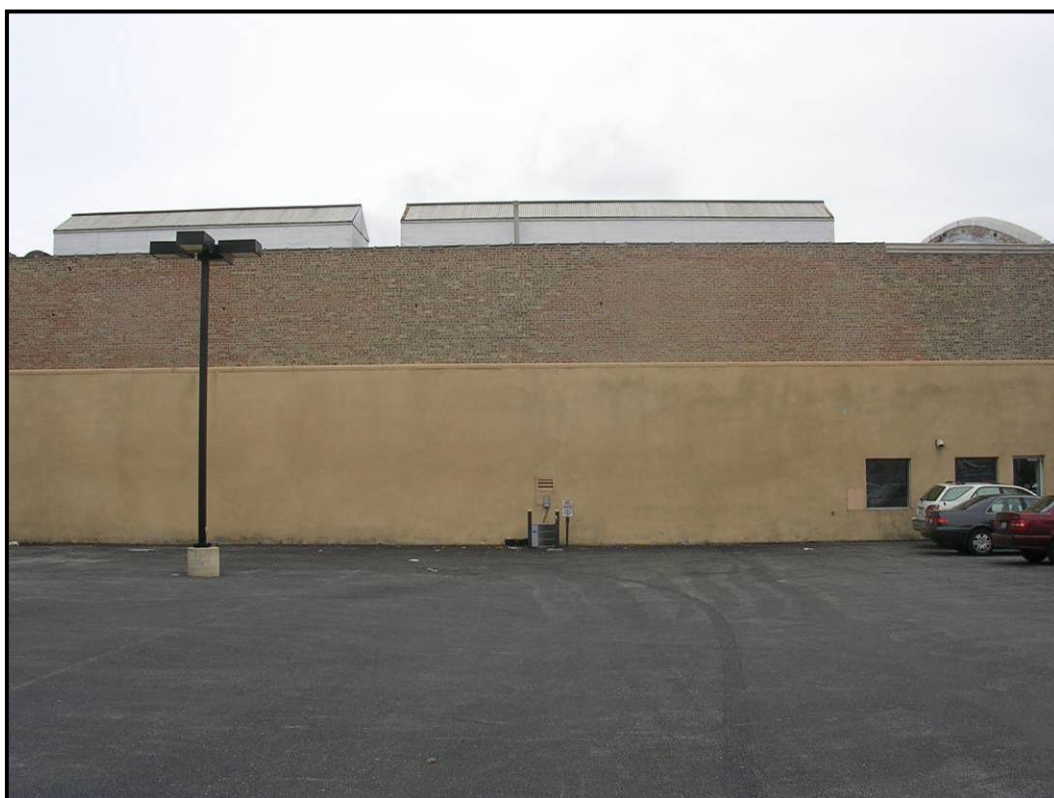
**Figure III-10: West Façade  
Covered in an external insulating finishing system**

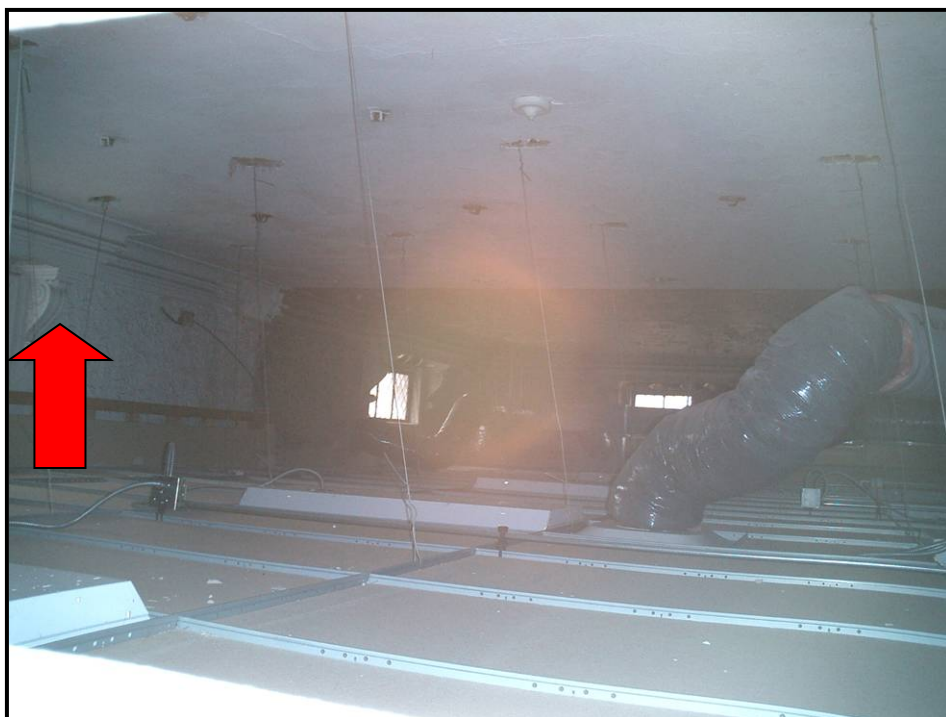
**Figure III – 13: Above the drop ceiling**  
**Note ceiling and window details from original photo [figure III – 11]**

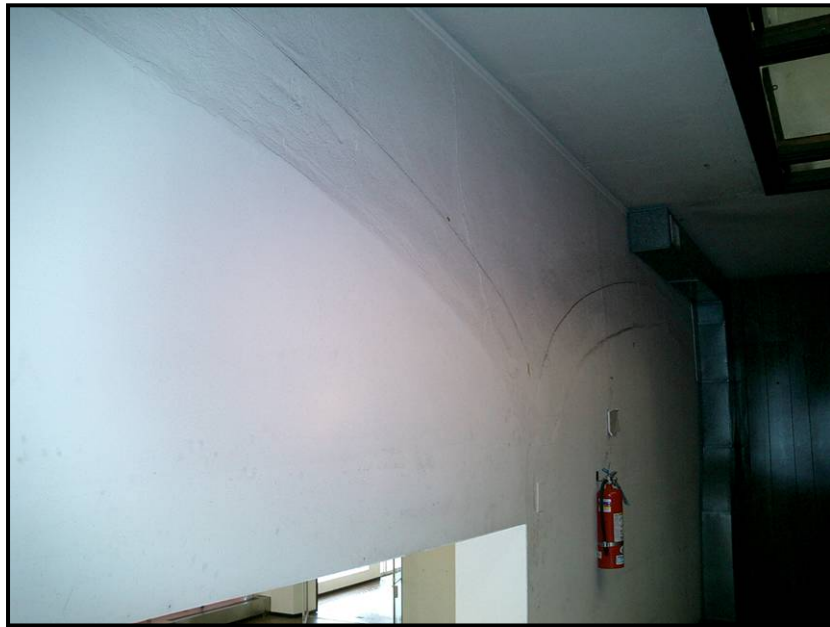
**Figure III – 16: Mezzanine arch that has been in filled**

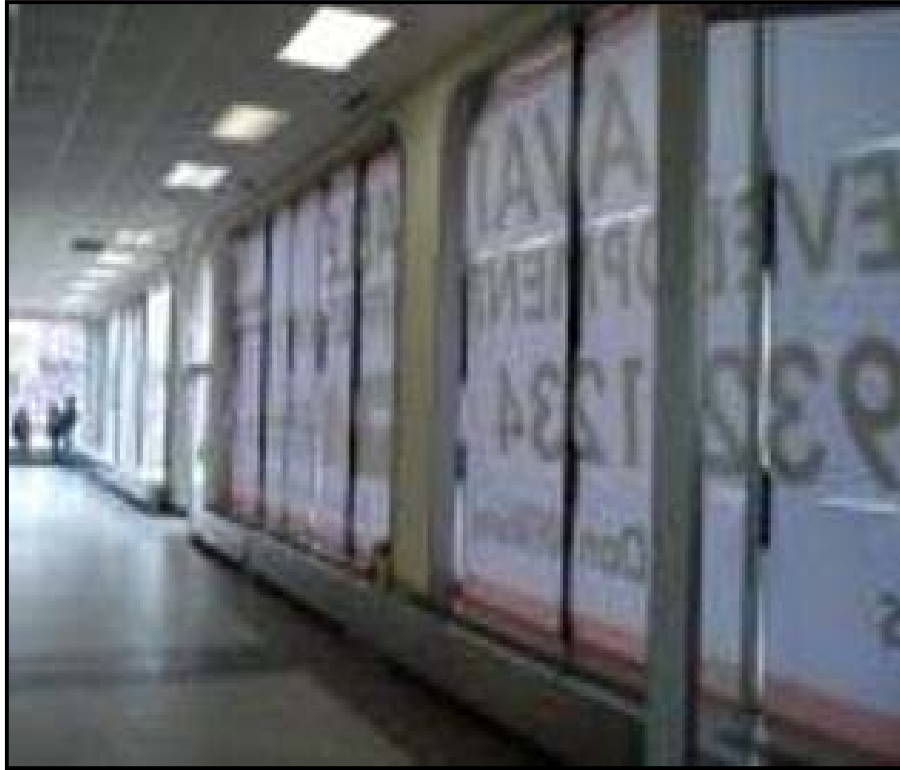
**Figure III - 18: East showroom**

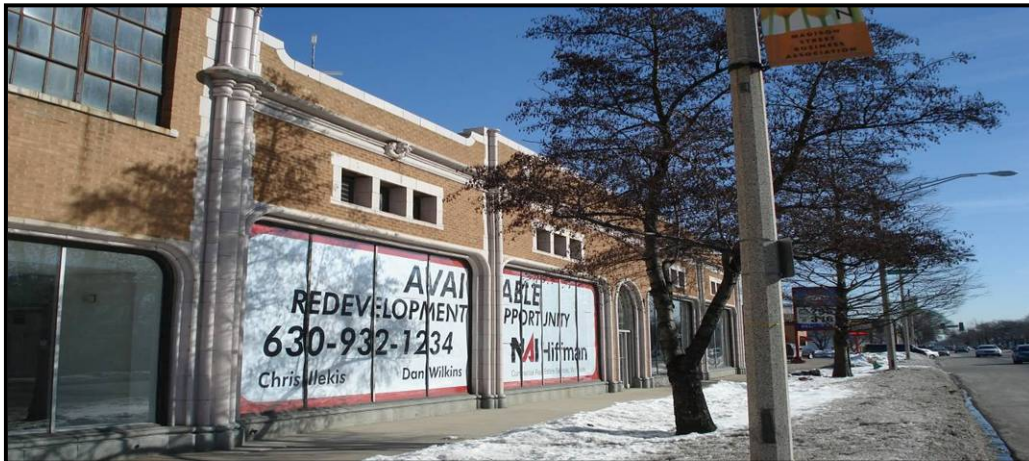
**Figure III - 19: Storefront windows along Madison Street**

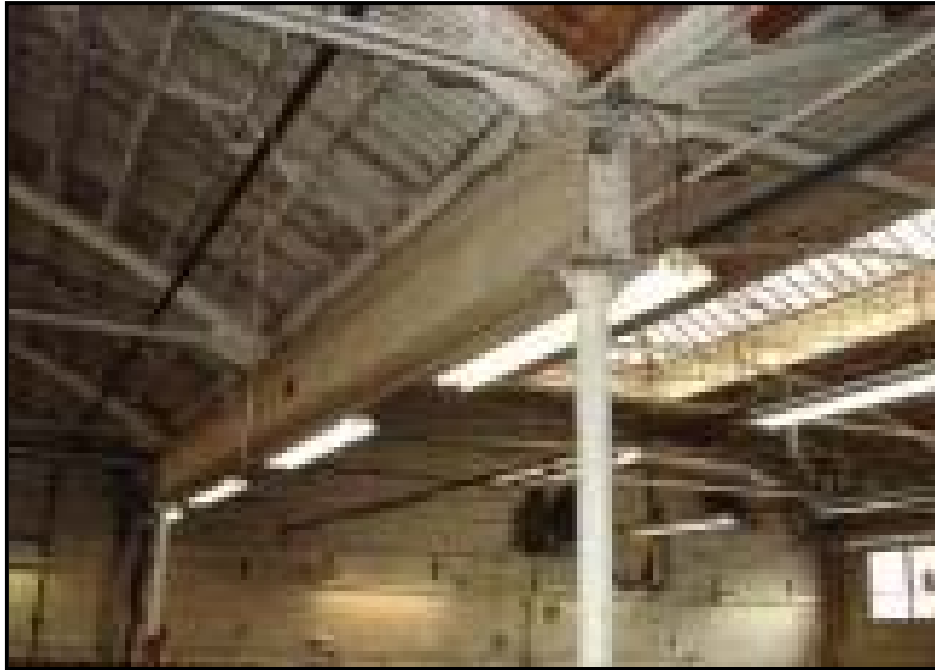
**Figure III-20: Steel frame construction of East service area**

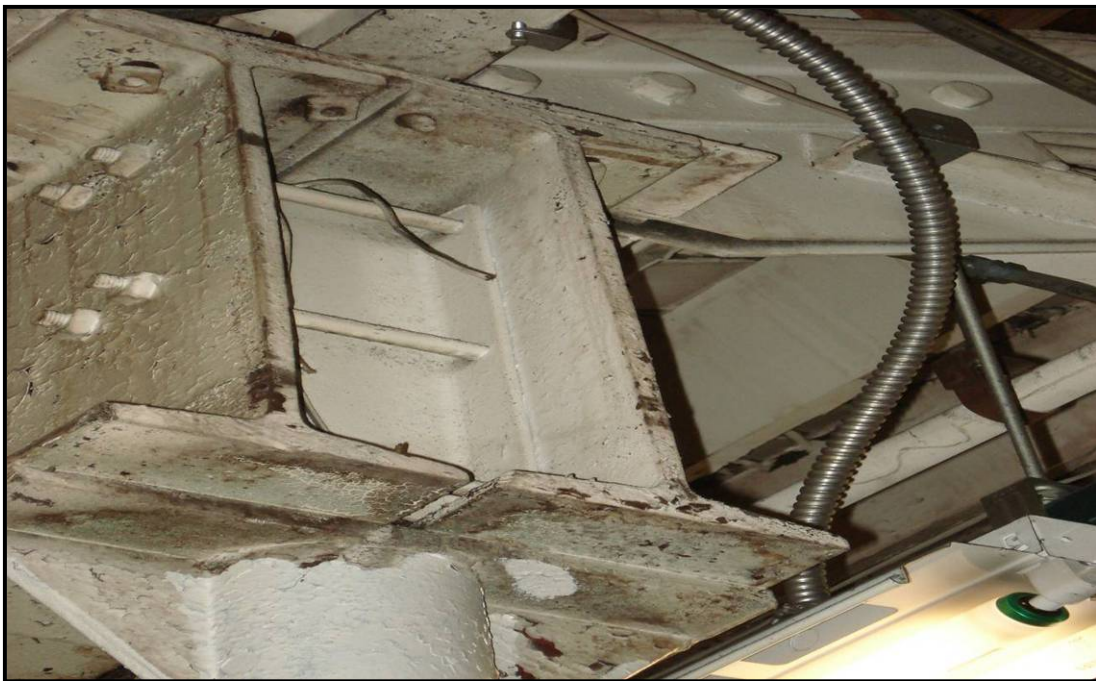
**Figure III - 21: Bolted steel trusses and steel columns, welded seat plates**

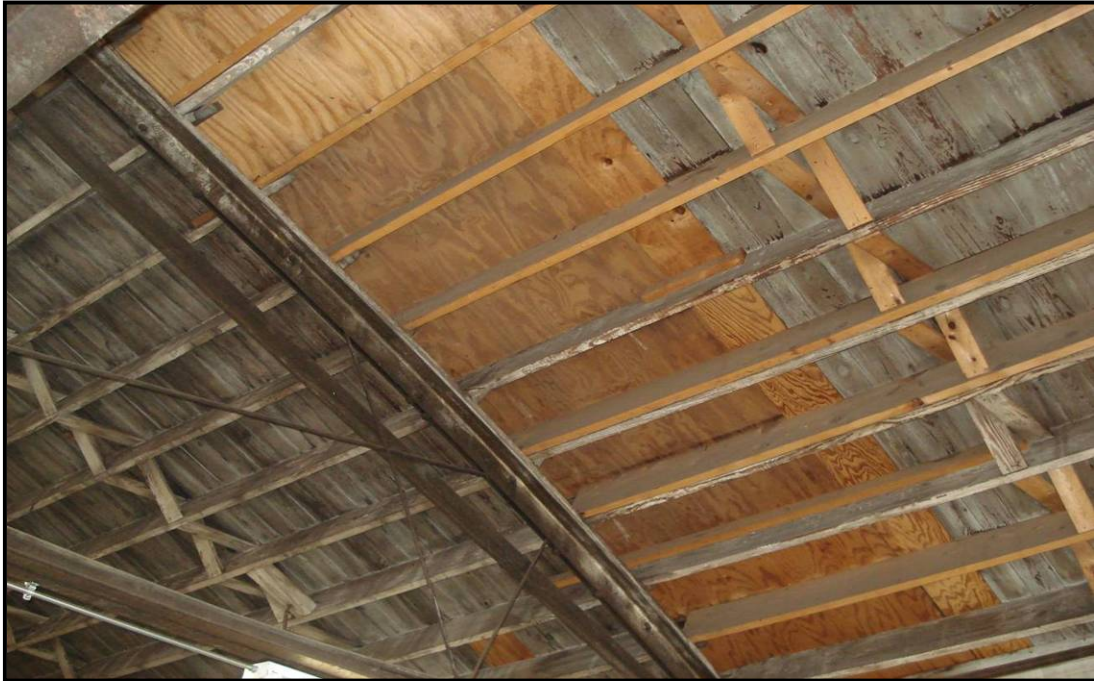
**Figure III - 22: Wood members: rafters, bridges, cross-bridges**

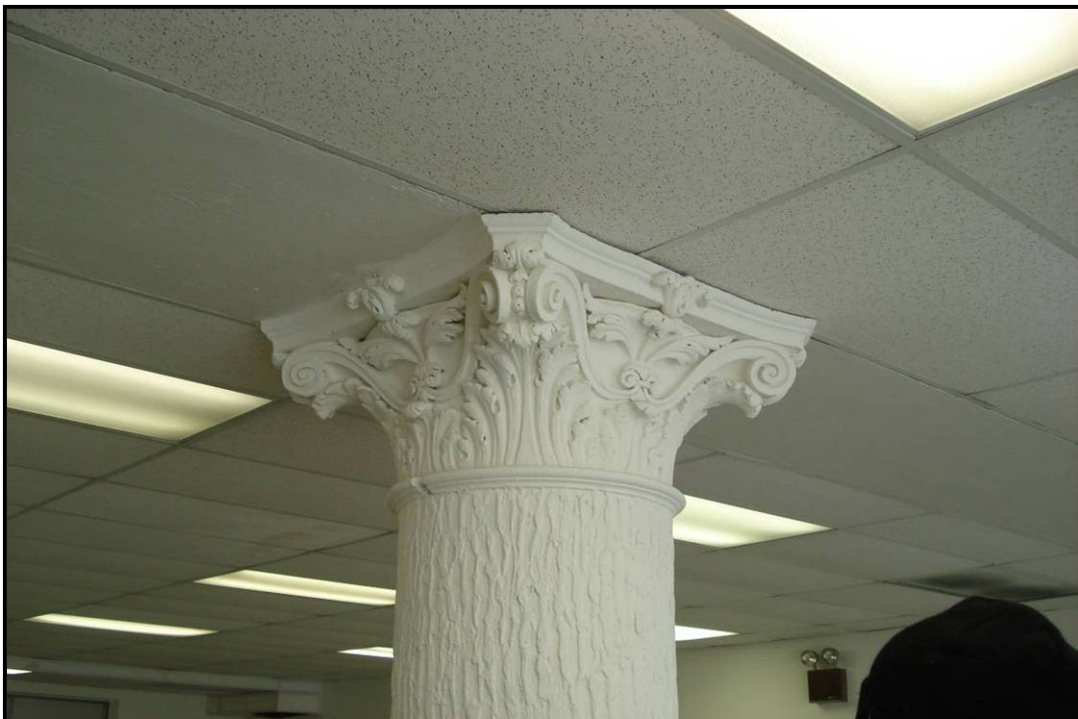
**Figure III – 23: West showroom decorative structural column**

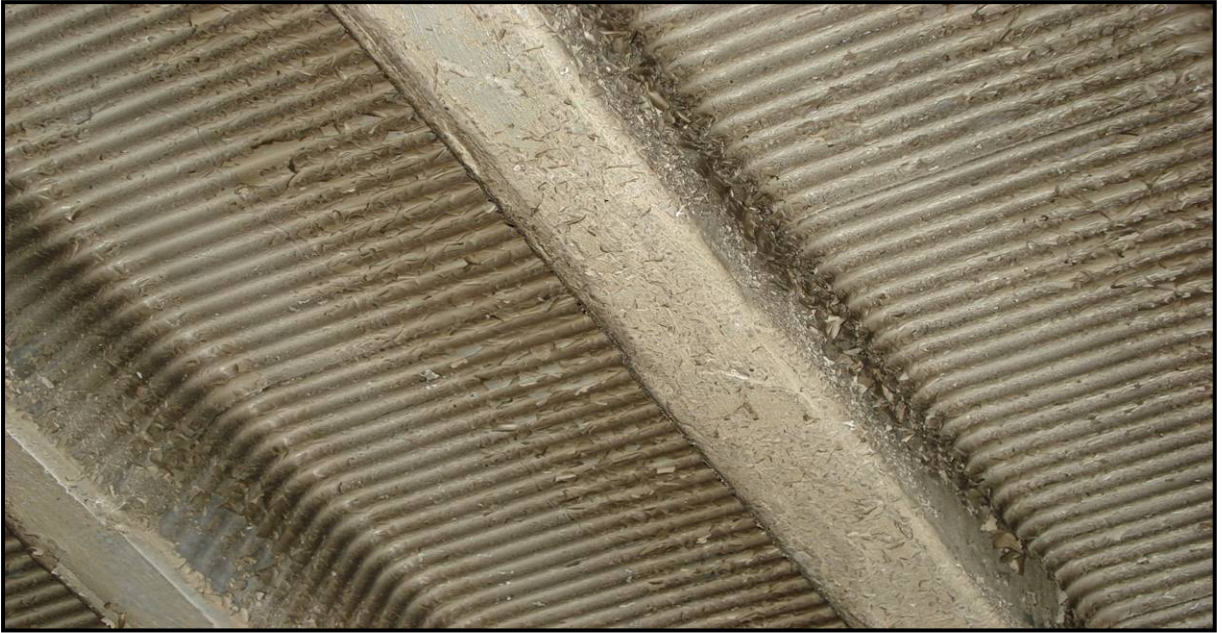
**Figure III – 24: Concrete One Way Joists**

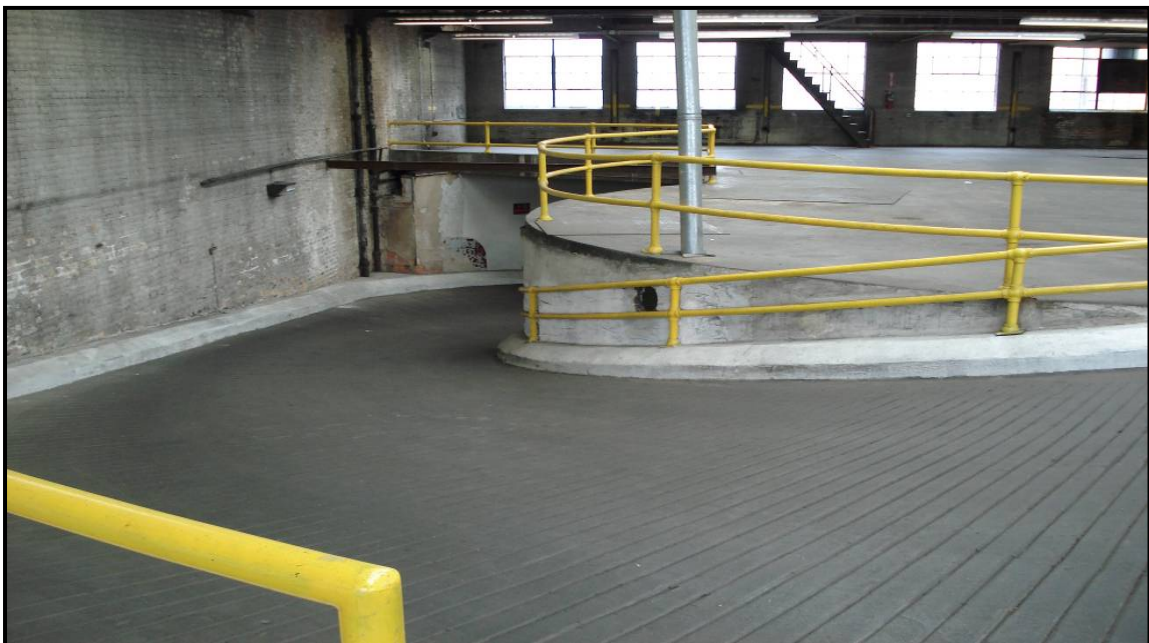
**Figure III – 25: Reinforced concrete structure/ramp to second level auto storage area**

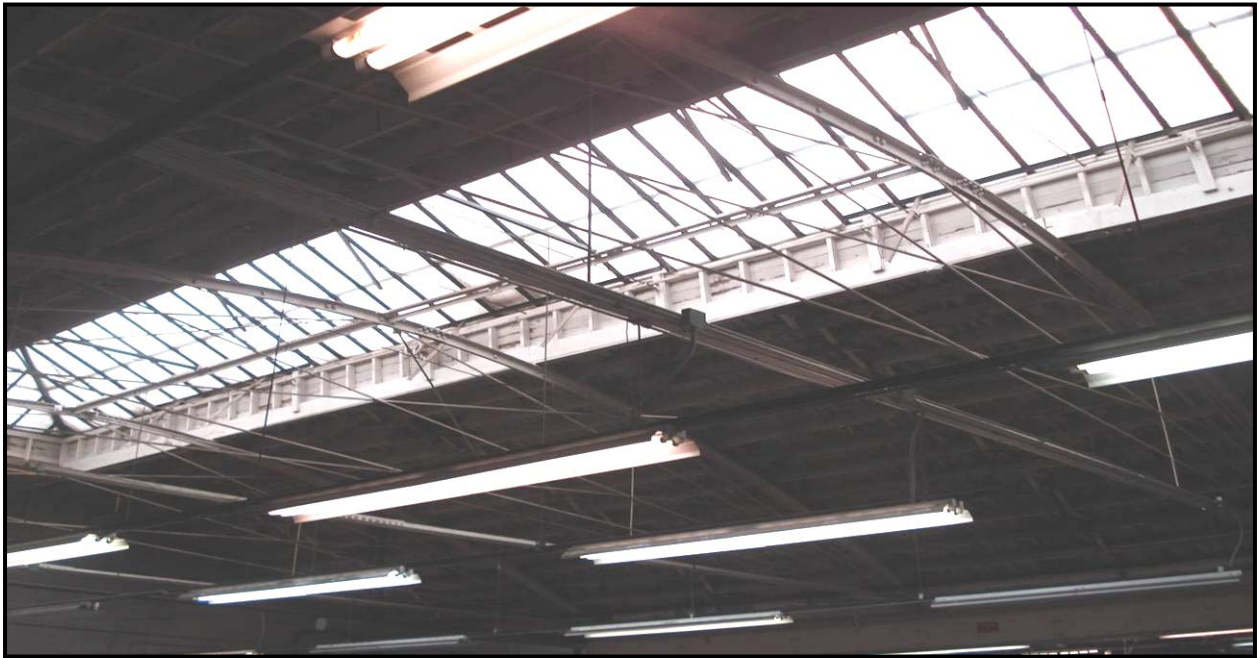
**Figure III – 26: East Ridge skylights**

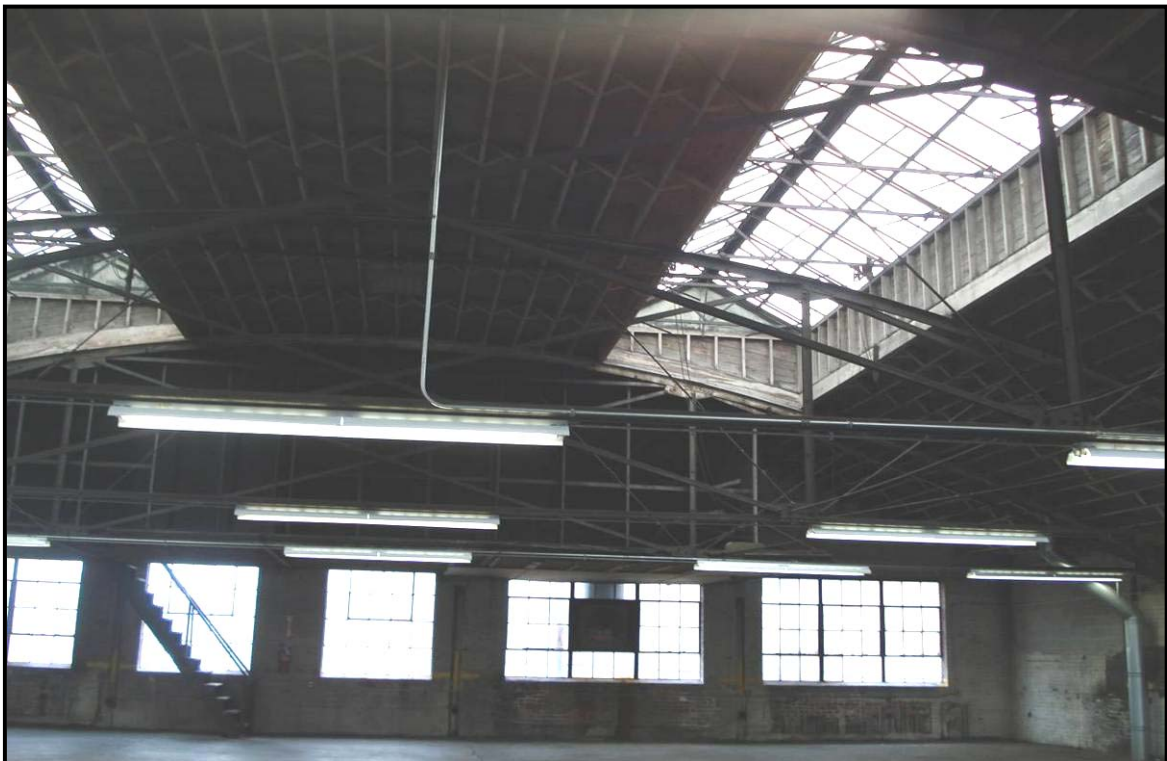
**Figure III – 27: West Ridge Ventilating Skylights**

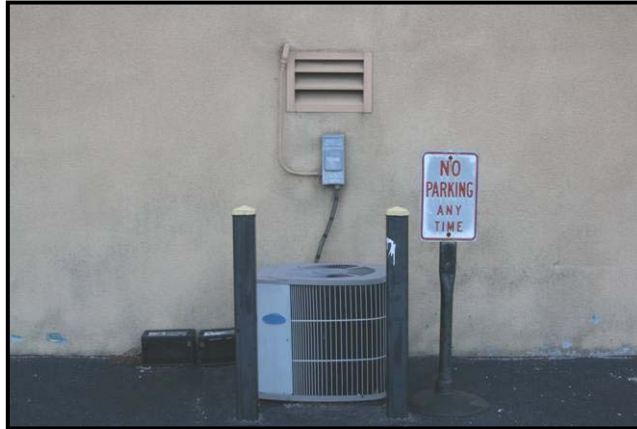
Figure III - 40: Outside AC unit

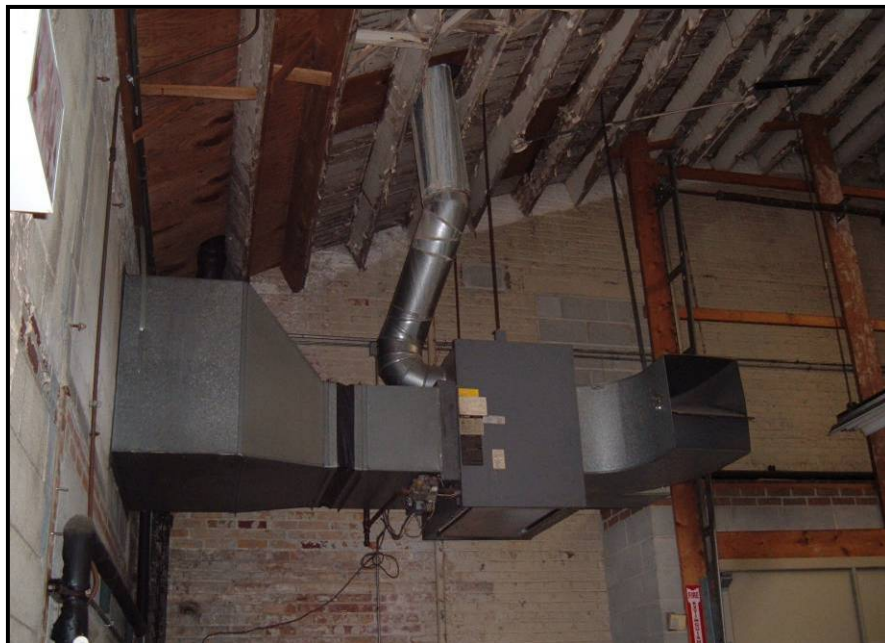
**FigureIII - 42: Trane Heater**

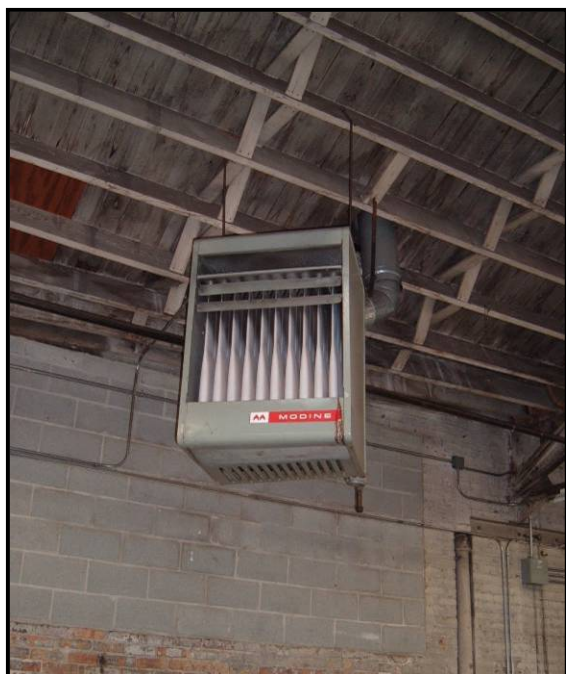
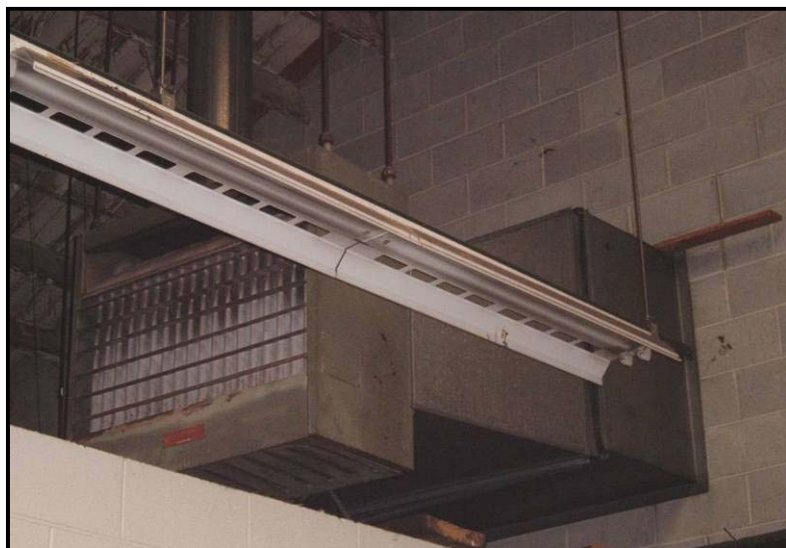
**Figure III - 43: Two of the Modine Heaters**

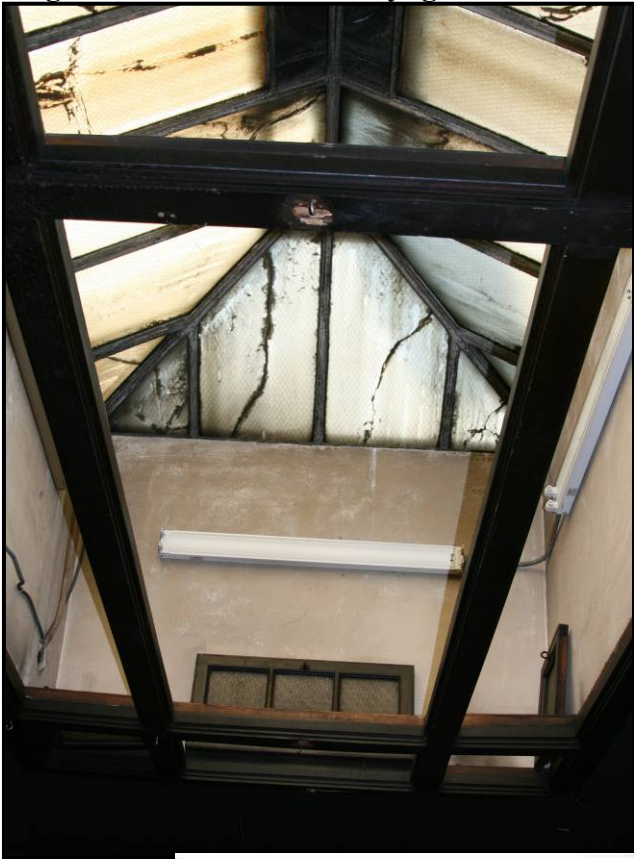
Figure III- 44: 2<sup>nd</sup> floor Skylight Showroom

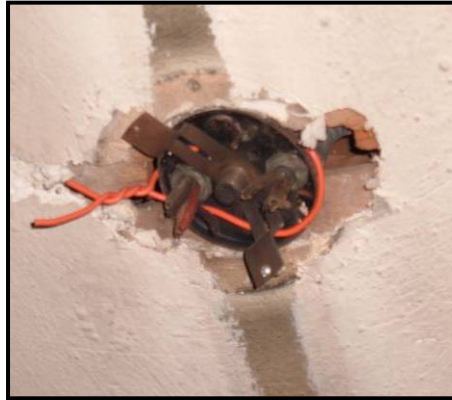
**Figure III - 45: original overhead light connection**

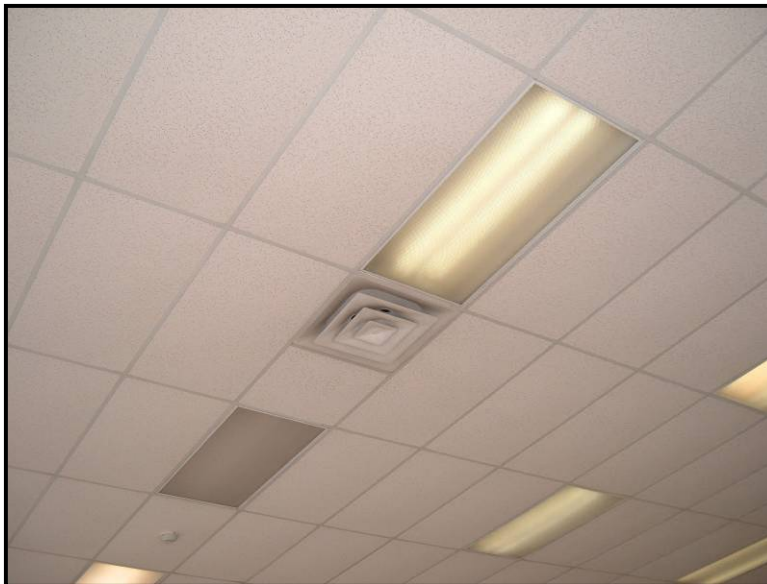
**Figure III – 46: Florescent lights**

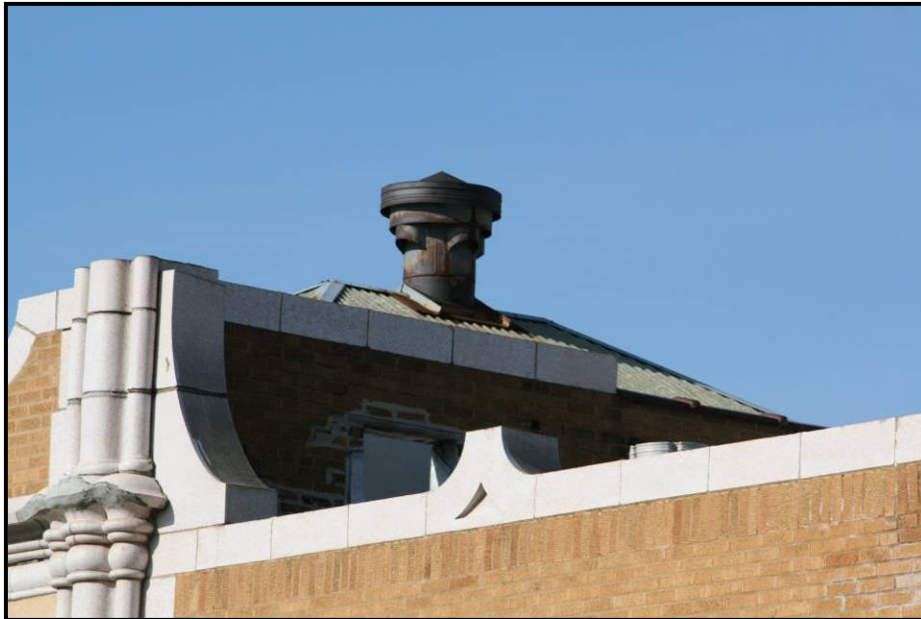
Figure III- 47: Showroom Skylight Ventilator

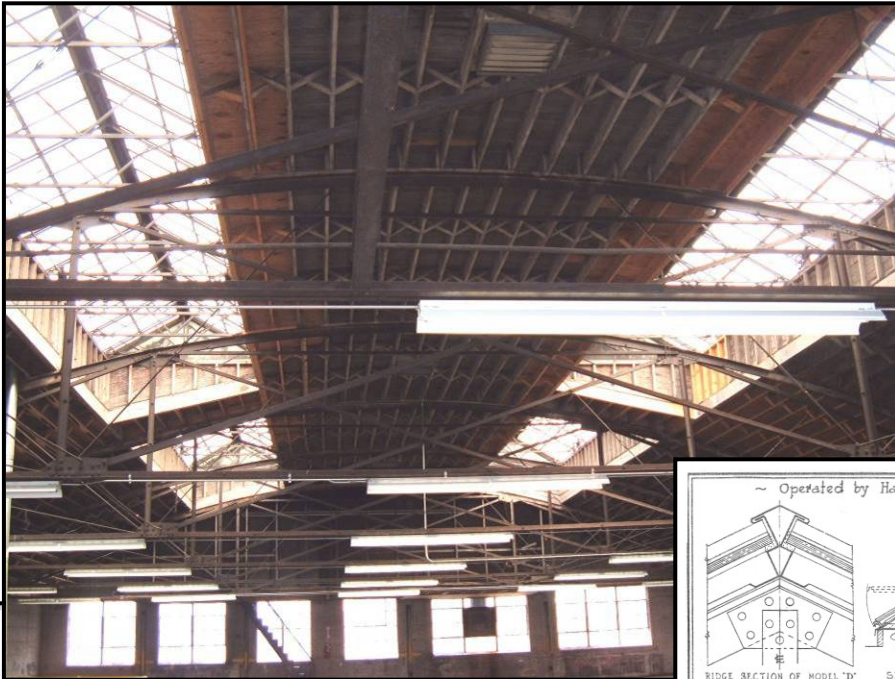
Figure III - 48: Service Area Skylights & Florescent Lights

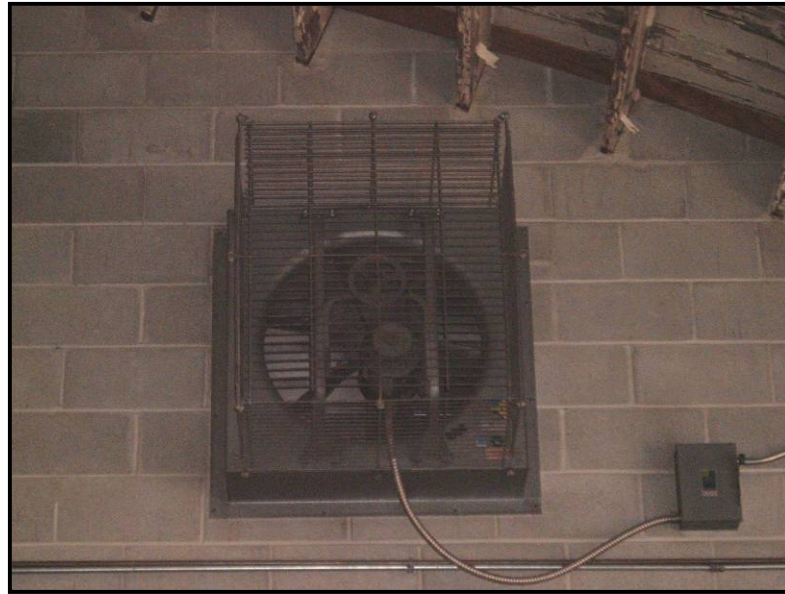
Figure III – 49: Exhaust Fans – Servicing Areas

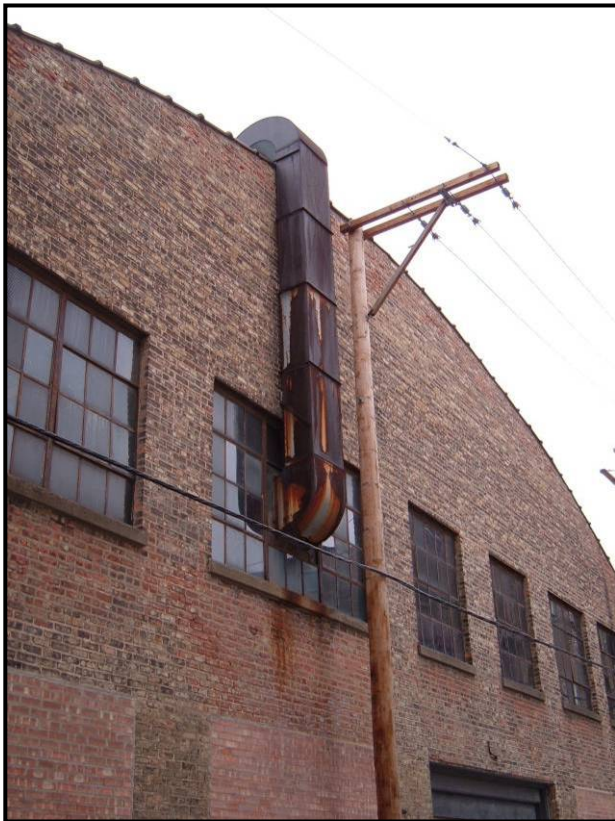
Figure III – 50: Exterior View of Exhaust System

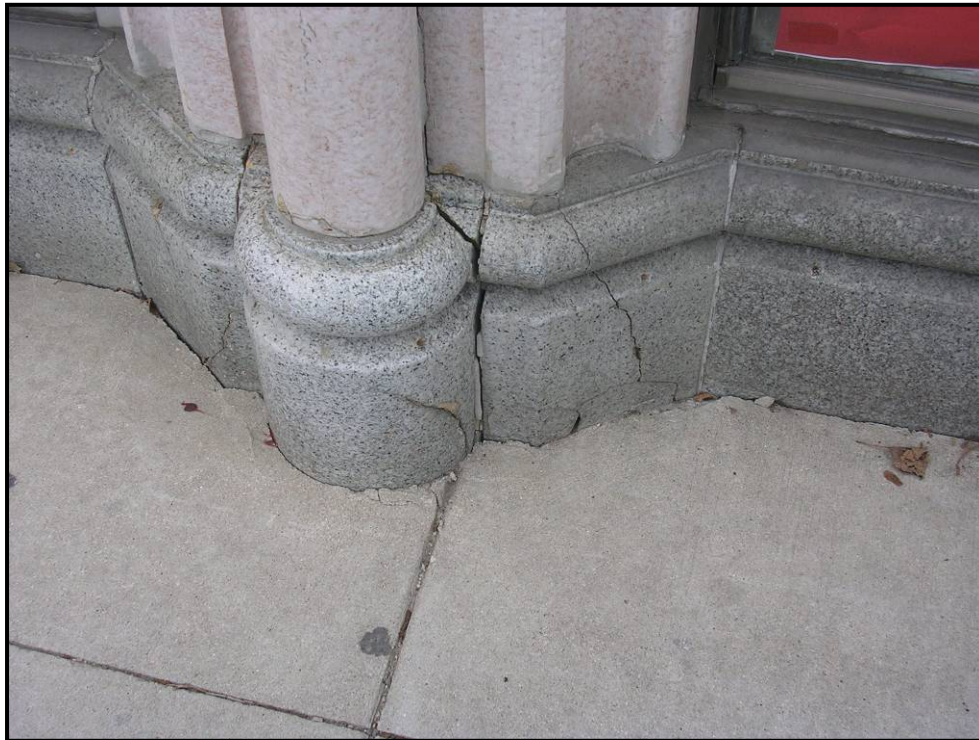
**Figure IV-6: Terra Cotta at the Base of the Building**

The terra-cotta throughout the façade has relatively limited areas of visible cracking mostly due to what appears to be interface issues. In one such case, the terra-cotta at the corners of the building on the south facade has cracked in the same location—at the corner of the display window’s trim [Figure IV-4]. This could be due to the unequal distribution of the building’s load putting too much pressure on the terra cotta at these locations. It could also be caused by differential movement or differential stress in the pieces. Directly above this failure, the terra cotta quoining on the top, left hand corner of the wall is out of plumb with the rest of the building [Figure IV-5]. It appears that attempts have been made to correct this by filling the area of separation with sealant, therefore, this damage could have been caused by the building settling, but further inspection would have to be done to determine the exact cause. The green terra-cotta at the base of the building, demonstrates some relatively extensive cracking [Figure IV-6.]. This cracking could be due to the concrete sidewalk being placed directly against the terra cotta. The concrete may have bonded to the terra cotta and then cracked it as the concrete shrunk during drying. Many of these cracks at ground level also occur at the base of the terra-cotta colonette clusters around the window—possible a result of the load being exerted on these members at ground level.[cag8]

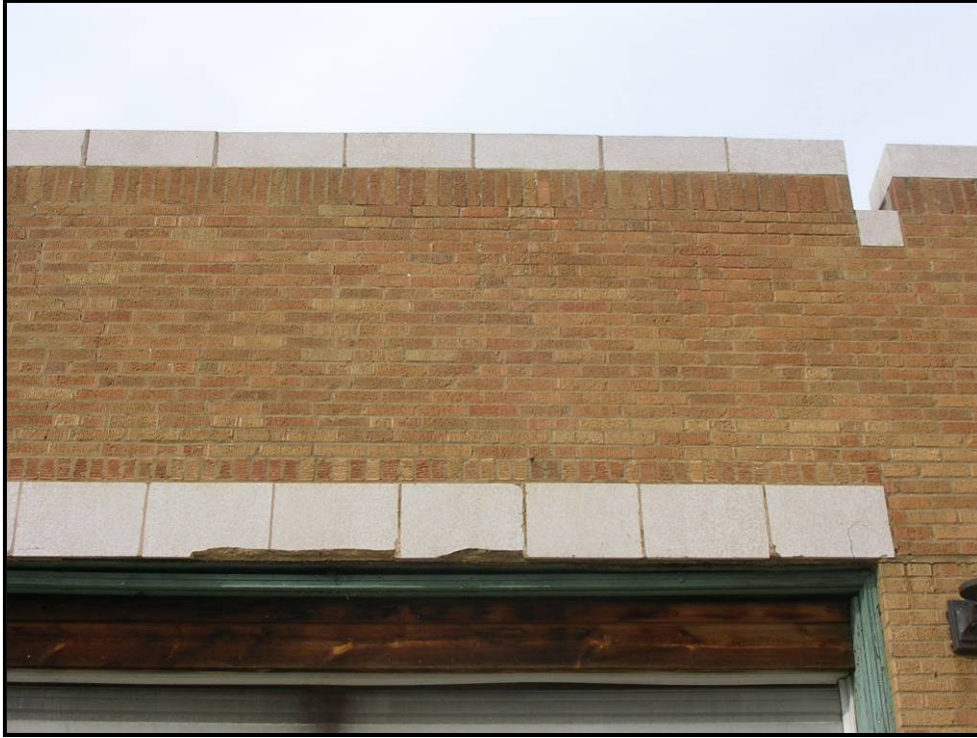
**Figure IV – 7:**

Non-structural conditions in the terra cotta include some limited staining and spalling at door and window openings in which the terra-cotta rests on [cag9]steel lintels [Figure IV-7.].

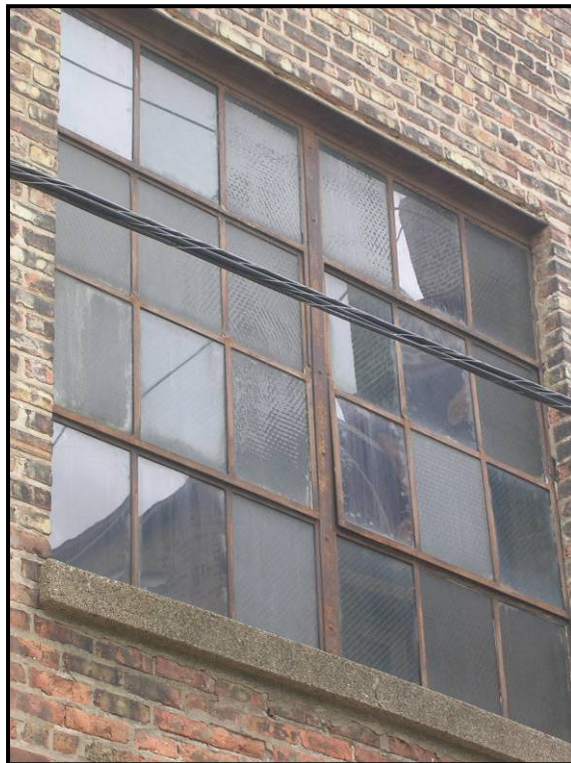
**Figure IV – 8:**

The most prolific window-type used throughout the building is the steel-sash awning window. The steel on these windows shows considerable surface corrosion and in some cases has stained the masonry surrounding the openings [Figure IV-8]. The glass in these windows was installed from the inside with putty that has significantly deteriorated—to the point of crumbling when touched in some locations. The glass itself in the windows is an assortment of replacements throughout the years—the original appears to be a wire safety glass with a pebbled surface, with later replacements including plain wired safety glass, Plexiglas, and plain glass panes. The diamond-pane leaded glass windows on the south facade were not readily accessible at the time of the inspection; however, no signs of distress were evident based on limited observation from grade. Further inspection is necessary to determine their exact condition. The showroom windows appear to be unstable due to the deterioration of the original steel mullions [Figure IV-9]. These mullions show significant corrosion at the base, likely due to the temperature

differences caused by the framing system's proximity to the radiators indoors and the single pane glass's poor insulating properties. These temperature differences cause condensation to form on the metal frame and collect at the base, resulting in corrosion of the steel over time. This loss at the base of the window framing system has caused the window to deflect. Minimum pressure exerted on the window results in bowing of the entire framing system. Repair and stabilization of these windows should be a top priority. This condition may have been the reason that an additional aluminum mullion was at some point installed at the center of each large showroom window for additional support; consequently, this addition has not adequately addressed the problem.
